# National Transportation Safety Board

## Marine Accident Brief

**Accident No.:** DCA-04-MM-020

**Vessel:** U.S. Passenger Vessel *LeConte*, O.N. 555601, IMO No. 7318925, registered length 217.5 feet, overall length 235 feet, 328 gross tons (domestic), 3,124 tons (International Tonnage Convention [ITC]), inspected, built in 1973

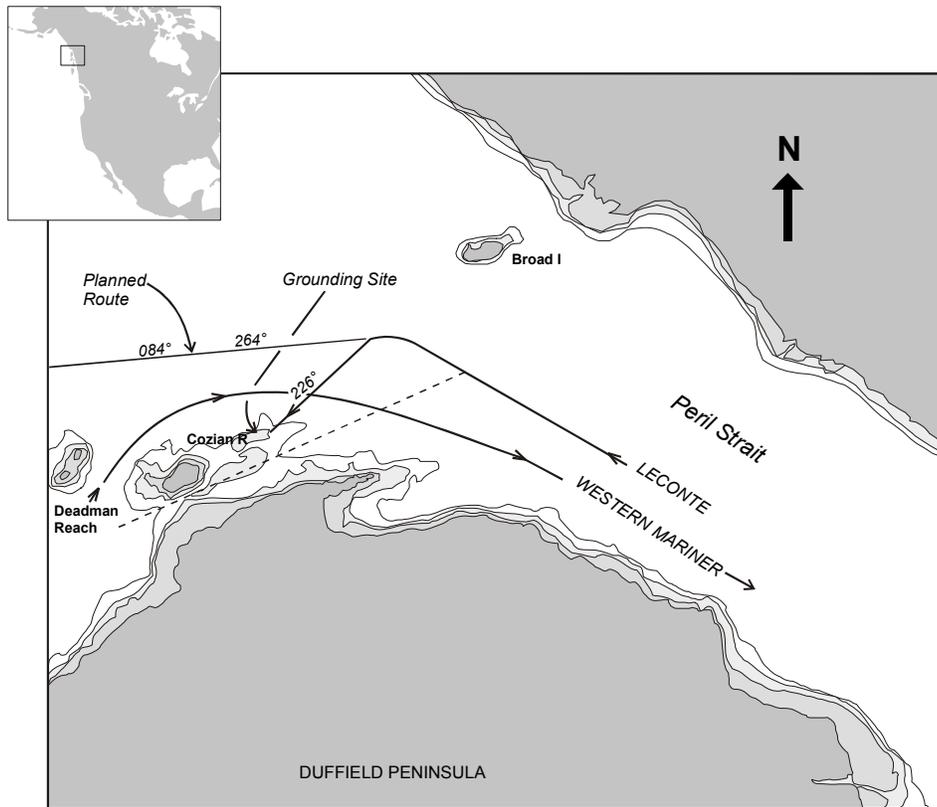
**Figure.** Accident site showing routes of *LeConte* and *Western Mariner*. Dashed line duplicates solid line (labeled 245) found on *LeConte* navigation chart during investigation. Line could be acceptable routing inside Cozian Reef and Otstoia Island.

After clearing the *Western Mariner* tow, the chief mate turned the *LeConte* to a course of 226°. Neither the chief mate nor the master recognized that the 226° course headed the vessel to the right of the daymark for Cozian Reef and on a course toward the reef. The vessel, steering a course of 226° at about 15.5 knots, grounded on Cozian Reef about 0955. The captain of the *Western Mariner* did not observe the grounding.
