# National Transportation Safety Board

## Marine Accident Brief

<b>Accident No.:</b>	DCA-05-MM-021
<b>Vessel:</b>	Uninspected small passenger vessel, <i>Sydney Mae II</i> , official No. 647664, length 38 feet, gross tons 24, fiberglass hull, built in 1980
<b>Accident Type:</b>	Sinking
<b>Location:</b>	Pacific Ocean, at entrance to Umpqua River, near Winchester Bay, Oregon, latitude 43°40.0' N, longitude 124°13.5' W
<b>Date:</b>	September 19, 2005
<b>Time:</b>	2030 Pacific daylight time
<b>Owner:</b>	Pacific Pioneer Charters, LLC, Winchester Bay, Oregon
<b>Property Damage:</b>	\$120,000 (total loss of vessel)
<b>Injuries:</b>	3 passenger fatalities (2 recovered; 1 missing, presumed fatal)
<b>Complement:</b>	1 crew (captain) 4 passengers

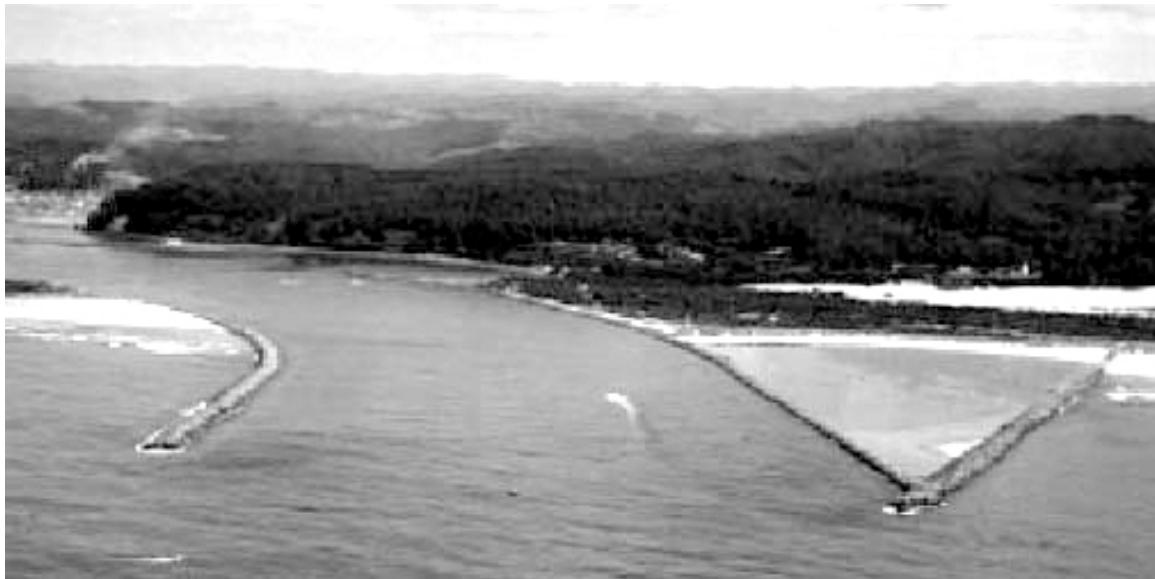
**Figure.** Looking east from the Pacific Ocean toward Winchester Bay, Oregon. North jetty is to the left of the photo, training jetty is to the right, and south jetty is to the far right. Photo courtesy Oregon State Marine Board, *Boating in Oregon Coastal Waters* <<http://www.marinebd.osmb.state.or.us/CoastalWaters/Umpqua.htm>>.

The Umpqua River entrance is bordered by a jetty system (refer to the figure). Various warnings about navigating in and around these areas (due to large swells, breaking seas, and strong currents) are listed in the *United States Coast Pilot*,<sup>11</sup> in Coast Guard and Oregon State Marine Board publications, and on those agencies' websites.
