Marine Accident Brief

Accident No.: DCA-06-MF-013

Vessel: Hong Kong–registered container ship *New Delhi Express*, official No. HK-1610, IMO No. 9301770, 853 feet long, 39,941 gross tons, steel construction, built in 2005

Accident Type: Grounding

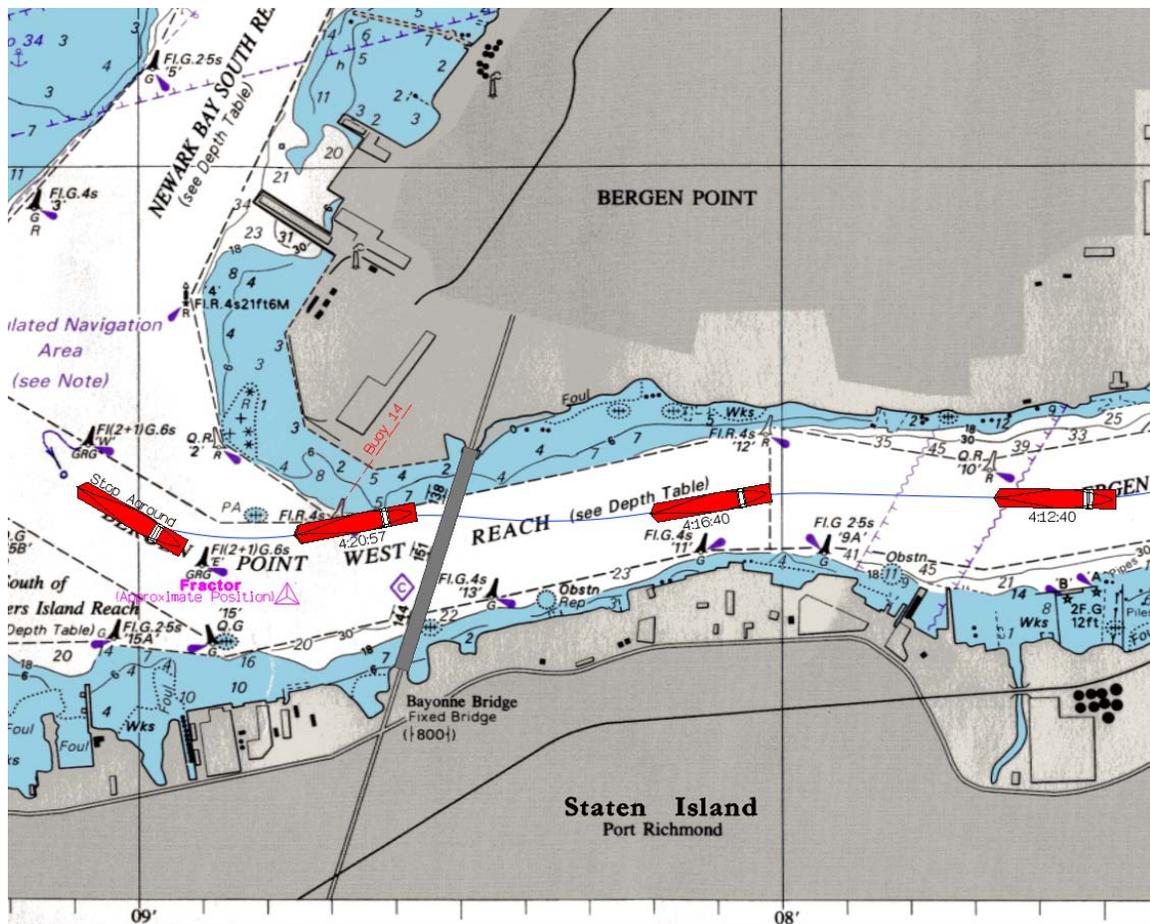
Figure 3. Westward track of the *New Delhi Express* through the Kill Van Kull to its grounding position. The vessel model is dimensionally correct and indicates the vessel's position at referenced times along its track (blue line). Immediately east of the *New Delhi Express*'s "stop aground" position is the approximate position of the drill/dredge boat *Fractor*. Latitude and longitude for the *New Delhi Express* were obtained from voyage data recorder (VDR) data. The vessel track is overlaid on the navigation chart used aboard the *New Delhi Express* (*United States—East Coast, New York, Arthur Kill, Kill Van Kull and Newark Bay*, Admiralty chart 4357, 4th ed. [Taunton, United Kingdom: United Kingdom Hydrography Office, June 2005]). The *Fractor*'s position was approximated from an image generated by the Coast Guard vessel traffic service, New York Harbor, using data from the automated identification system (AIS).¹²

Shortly afterward, with the vessel's bow swinging to the left back into the channel, the *New Delhi Express* began listing to starboard. None of the bridge team, including the pilots, had felt the vessel touch the ledge. But the list quickly increased to approximately 10° to starboard. The pilots continued to maneuver the vessel away from the ledge and back into the deeper water. The crew was ordered to sound the tanks, which revealed that the *New Delhi Express* was holed in both the empty No. 4 fuel oil tank and the No. 5 water ballast tank and was taking on water. The increased weight in the empty fuel oil tank and the 10° list to starboard caused the vessel to come to rest on the bottom in the center of the Bergen Point West Reach (figure 3).²¹

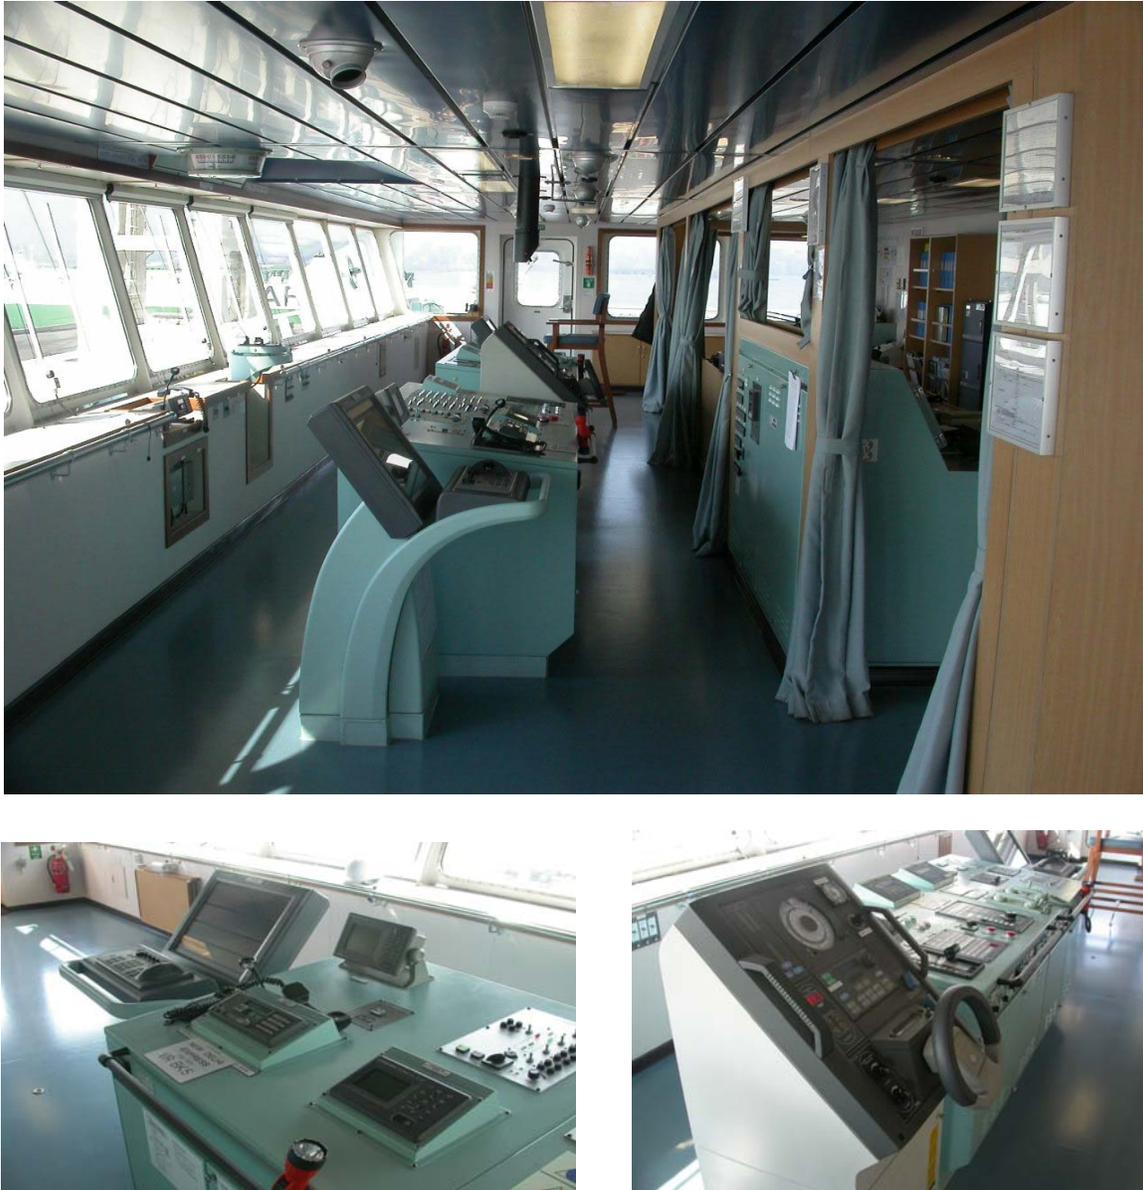
Figure 4. Bridge of the *New Delhi Express*. Top photo shows the overall layout. Bottom left photo shows the docking pilot's position at the port radar. Bottom right photo shows the helmsman's station (bridge telegraph knob is immediately to right).

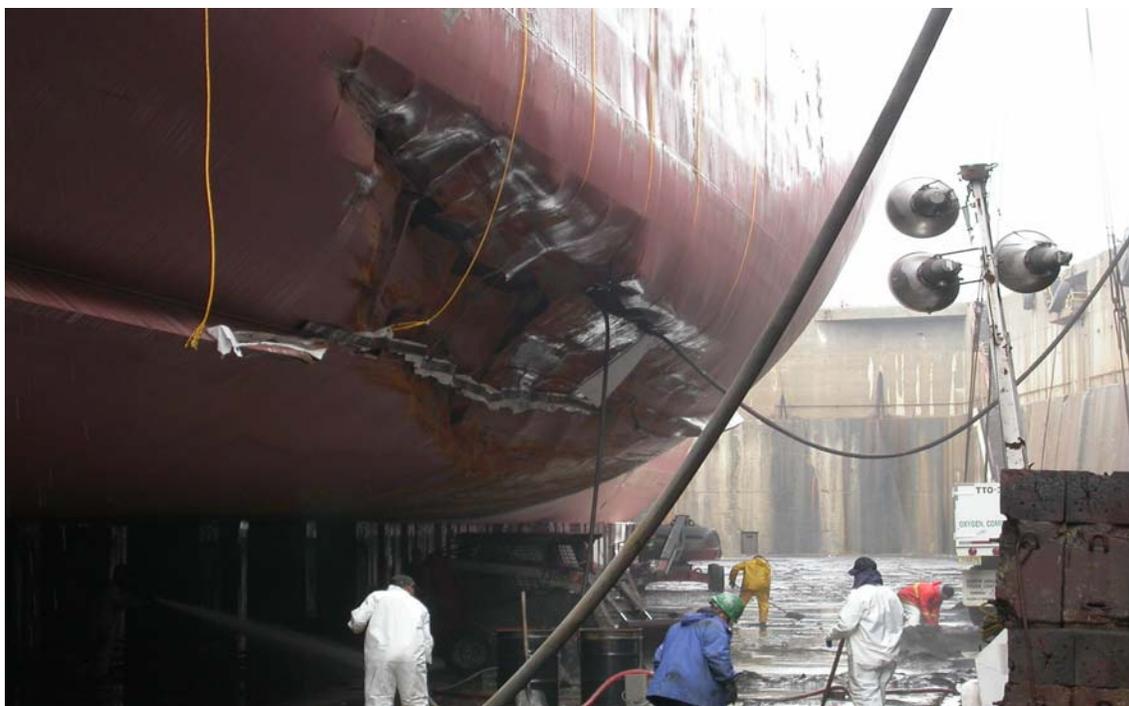
The *New Delhi Express* incurred serious damage along 85 feet of the starboard side at the turn of the bilge (figure 5).²² The accident displaced part of the vessel's bilge keel²³ and breached the No. 4 heavy fuel oil tank and the No. 5 water ballast tank. Because the fuel oil tank was empty, no oil was released into the water. A residual amount of unpumpable oil was removed at the drydock²⁴ before repairs began. The vessel's owner estimated repair costs at \$1.5 million. The shipyard used approximately 52 tons of steel to repair the damage.

Figure 5. Damage to the starboard side of the *New Delhi Express*. The impact with the submerged ledge breached an empty heavy fuel oil tank and a water ballast tank. No oil was released into the water. Repairs cost an estimated \$1.5 million and required about 52 tons of steel.
