National Transportation Safety Board

Marine Accident Brief

Collision between M/V Maersk Wisconsin and Tug and Barge Unit in Kill Van Kull

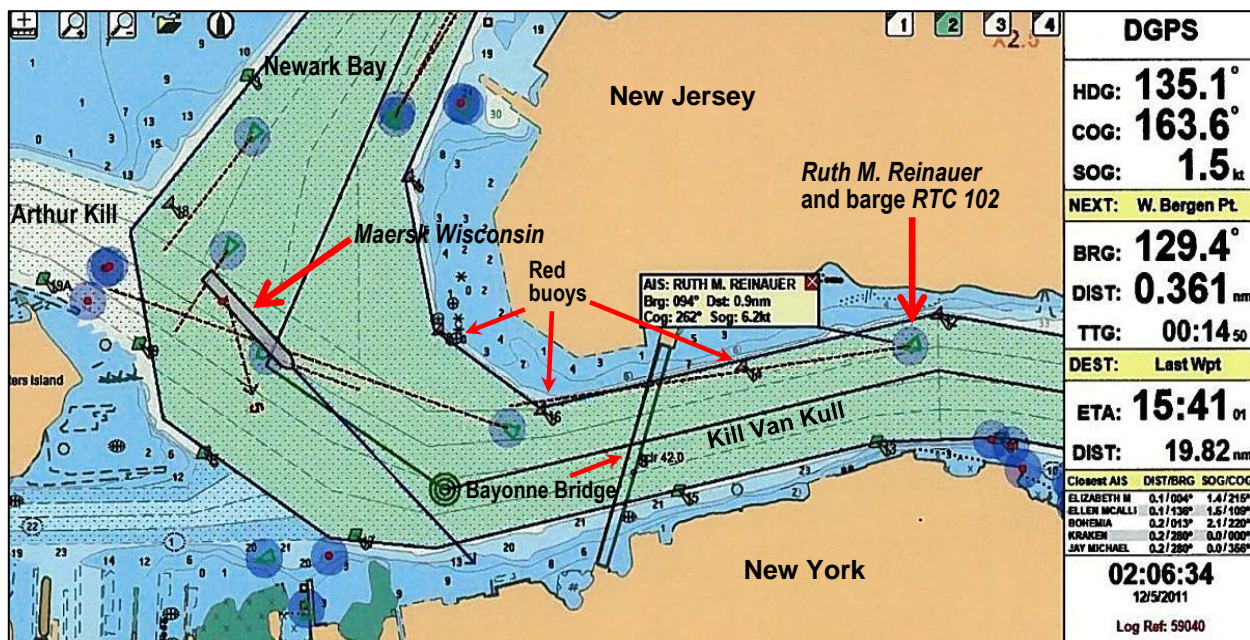
Screen image obtained from a pilot's laptop computer on board the *Maersk Wisconsin* with labels added indicating landmarks and waterways as well as vessel positions about 7 minutes before the collision.

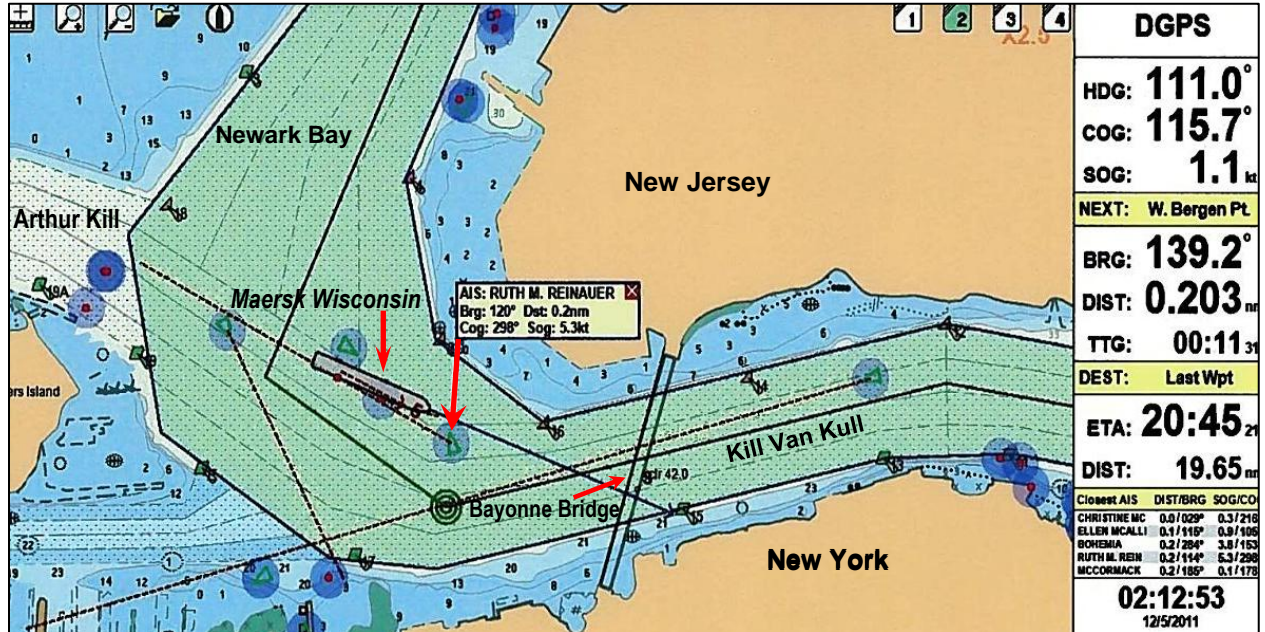
Less than a minute later, the *Ruth M. Reinauer* mate radioed, “Hey captain, have your tugs push you away” but received no reply. On the *Maersk Wisconsin*, the pilot ordered, “Start thrusters and [engine] full astern.” The mate of the *Ruth M. Reinauer* attempted to use engines to maneuver his vessel to avoid a collision. About 0213, the bow of the *Maersk Wisconsin* contacted the port side midships of the barge *RTC 102*. At the time of the collision, the speed of the *Maersk Wisconsin* was less than 1 knot, and the speed of the *Ruth M. Reinauer* was about 5 knots.

Screen image from a pilot's laptop computer on board the *Maersk Wisconsin* showing position and navigational data at the approximate time of collision.

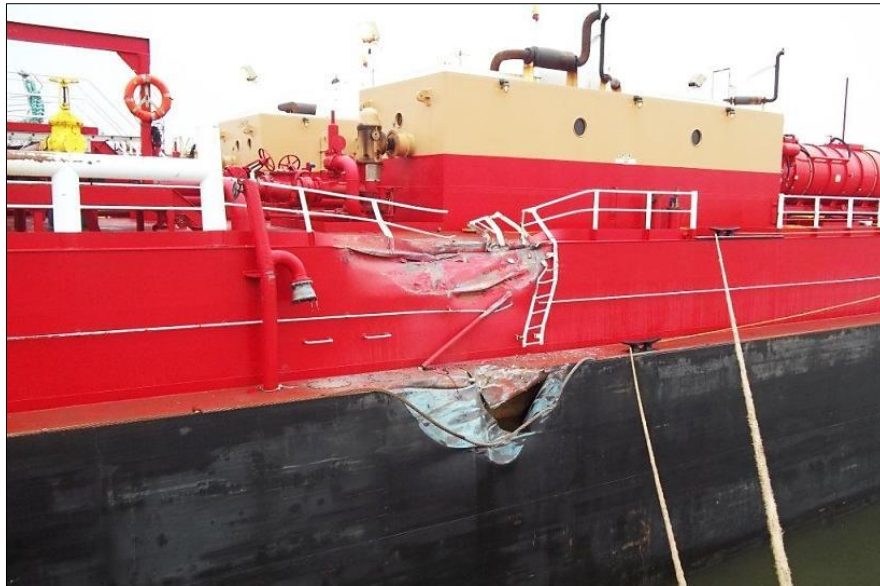
Both the containership *Maersk Wisconsin* and the barge *RTC 102* were damaged in the collision. On the *RTC 102*, two port side ballast tanks were holed at the deck level and sustained side shell plate damage and upset of internal framing. Some frame and plate damage was also noted in a cargo tank.

Portside damage to the *RTC 102*.

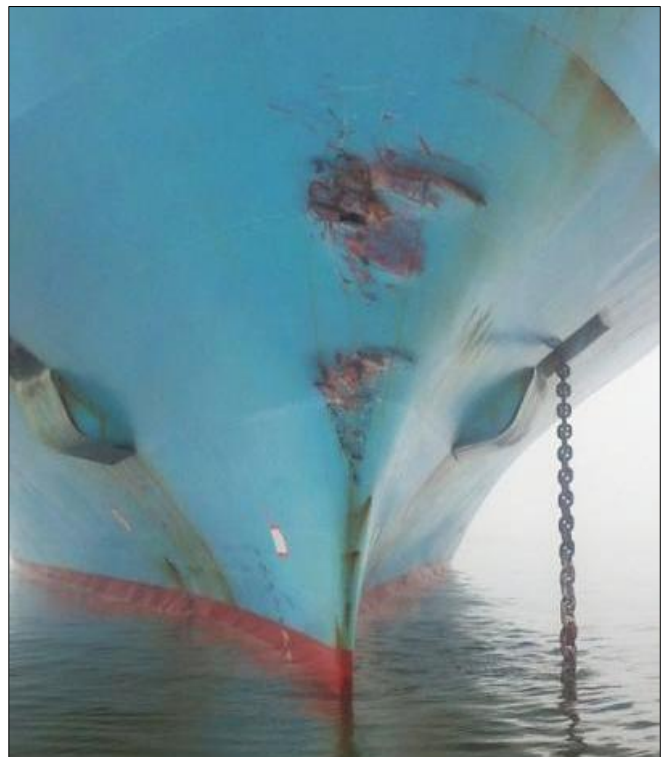
The bow of the *Maersk Wisconsin* (fore peak void) sustained shell plate damage and was holed about 23 feet above the waterline. Internal framing of that compartment was also distorted.

Damaged bow of the *Maersk Wisconsin*.
Photo by US Coast Guard
