# National Transportation Safety Board

## Marine Accident Brief

### *Collision of Canadian Bulk Carrier John D. Leitch with Law Enforcement Vessel*

<b>Accident no.</b>	DCA13LM002
<b>Accident type</b>	Collision
<b>Vessels</b>	Canadian-flag bulk carrier <i>M/V John D. Leitch</i> 35-foot Boston Whaler law enforcement vessel owned by Lorain County (Ohio) Sheriff's Office
<b>Location</b>	Black River, Section E, Lorain, Ohio 41°28.225' N, 082°10.612' W
<b>Date</b>	October 3, 2012
<b>Time</b>	1912 eastern daylight time (universal coordinated time – 4 hours)
<b>Injuries</b>	None
<b>Property damage</b>	More than \$500,000
<b>Environmental damage</b>	None
<b>Weather</b>	Southwest winds at 15 knots, visibility estimated as more than 6 nautical miles, air temperature 63° F (US Coast Guard and National Weather Service data)
<b>Waterway characteristics</b>	Black River: 15-mile-long navigable waterway maintained by the US Army Corps of Engineers, width approx. 260 ft. at allision site, controlling depth 27 ft. at time of accident, water level reported as 12" above low water

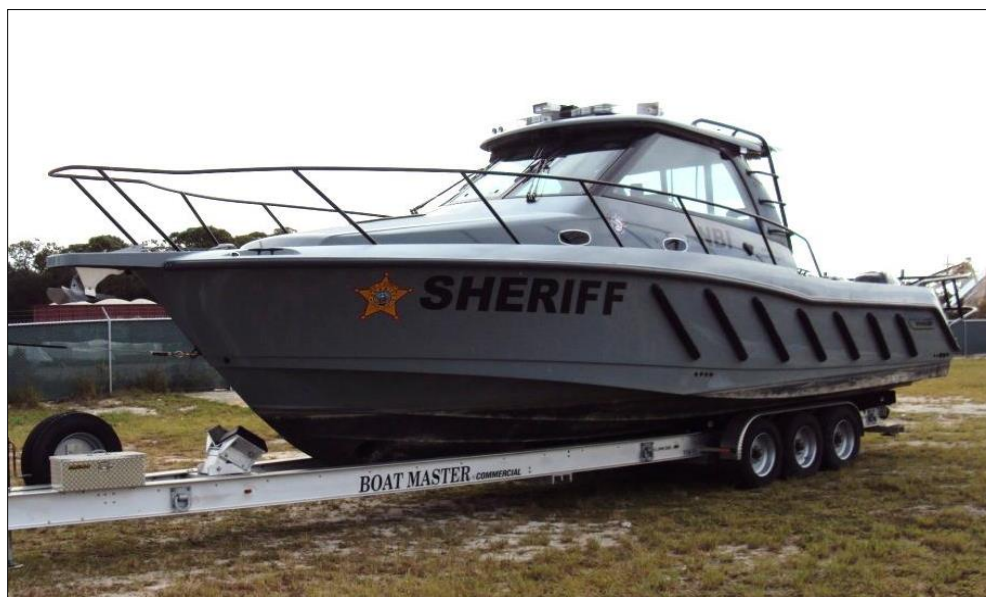
Lorain County Sheriff's Office Northern Border Initiative vessel on its trailer at the Boston Whaler repair facility in Edgewater, Florida.

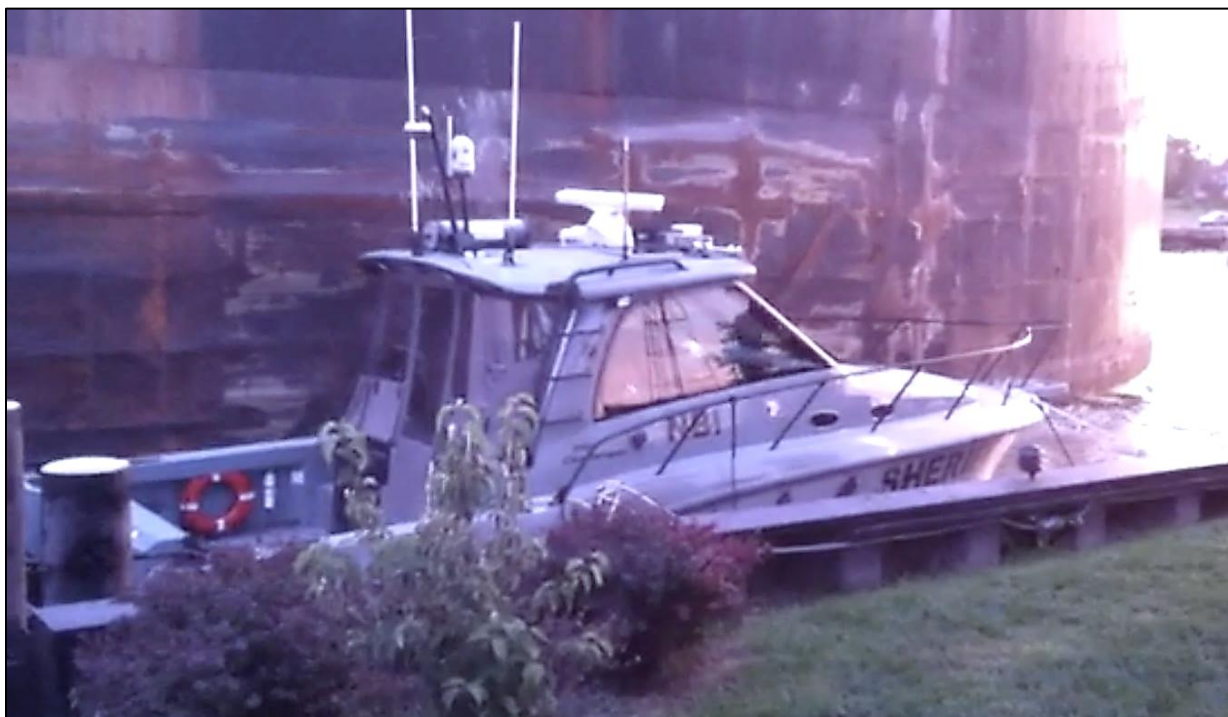
- *John D. Leitch*: Small scrapes along portions of the forward, starboard hull, with no plate inset.
- LCSO NBI vessel: Total damages to the LCSO NBI vessel exceeded \$500,000. A manufacturer's assessment of the damage determined that the aft port corner of the hull and inner liner and deck were crushed. The foam core, a structural component of the hull, was sheared and unrepairable. A complete replacement of the hull was recommended.
- Pile system: Minor damage and scraping.

Coast Guard photo of the hull of the *John D. Leitch* behind the Sheriff's Office law enforcement vessel shortly after the starboard bow of the bulk carrier contacted the LCSO NBI vessel.
