National Transportation Safety Board

Marine Accident Brief

Engine Room Fire On Board Towing Vessel *Patrice McAllister*

Accident no.	DCA-12-LM-014
Vessel	<i>Patrice McAllister</i>
Accident type	Fire
Location	Lake Ontario – 4 miles southeast of Point Petre, near Prince Edward Point, Ontario, Canada; 43°46.0' N, 077°02.0' W (Canadian territorial waters)
Date	March 27, 2012
Time	0229 eastern daylight time (coordinated universal time –4 hours)
Injuries	One fatality and five minor injuries
Environmental damage	None
Weather and sea conditions	Clear skies; winds 12 knots from 010°; 3.5-foot seas and good visibility; air temperature 27° F; water temperature 36° F.
Waterway characteristics	The accident occurred in open waters of Lake Ontario. The lake is 193 miles long, 53 miles wide, with an average depth of 283 feet.

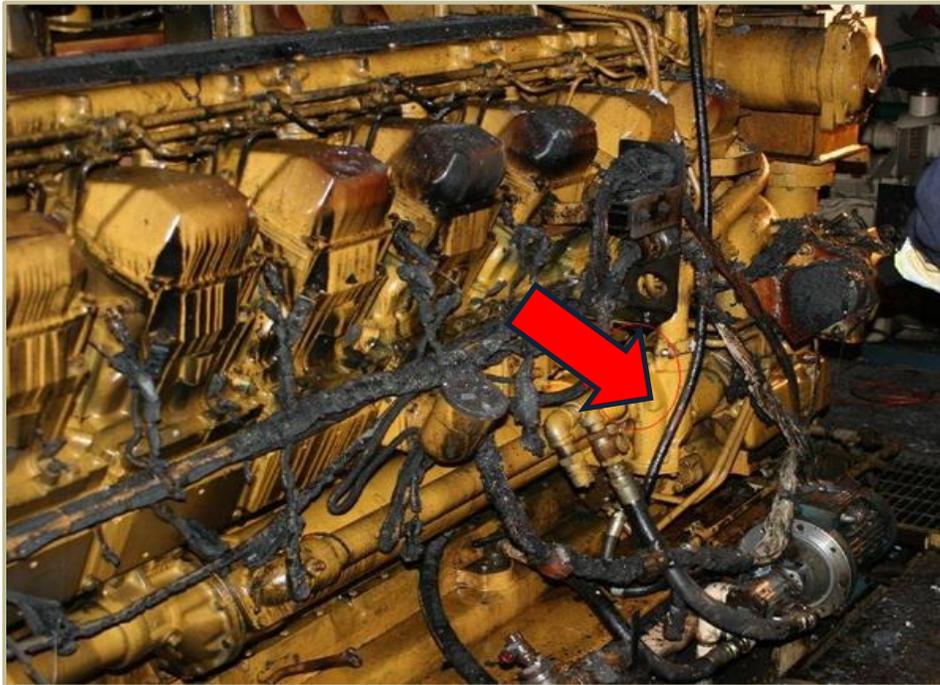
About 0229, a small hairline fracture in the port engine's pre-lubrication oil pump discharge line began spraying lubrication oil into the engine room. The oil spray made contact with the hot portside engine manifold and flashed into an oil spray fire.

The engine room fire resulted from a fracture in the port main engine's pre-lube pump discharge line. Photo by TSB.

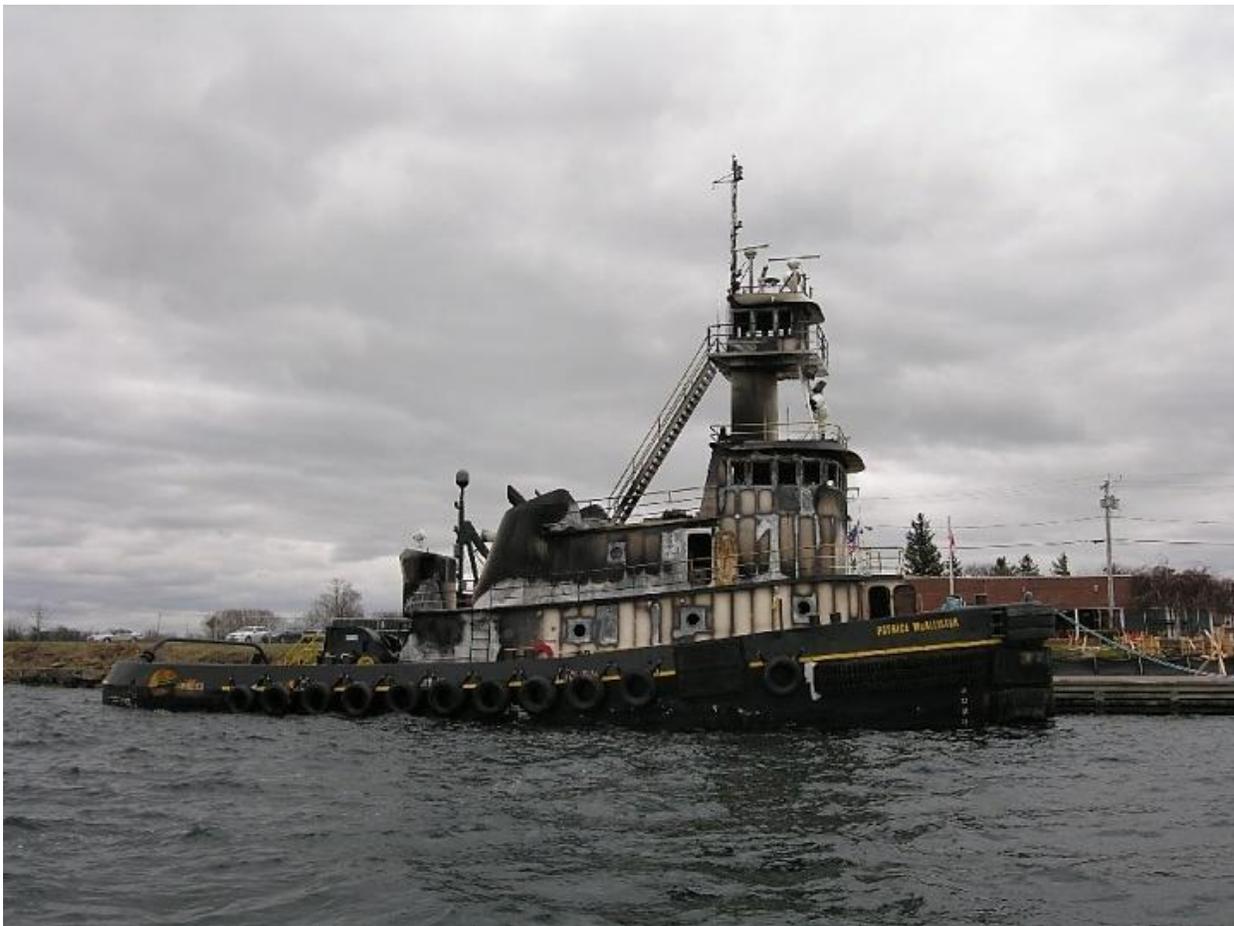
The fire-damaged *Patrice McAllister* after being towed to port. Photo by TSB.

The fire caused extensive damage to the entire vessel, including the lower and upper engine room, galley, crew mess, crew quarters, upper and lower wheelhouses, and internal and external deckhouse structures. Both the port- and starboard-side engines required extensive repair; all auxiliary equipment required extensive repair or replacement; the entire superstructure needed to be replaced; and so did all electrical equipment, interior and exterior fittings, and navigational and communications systems and equipment. According to the surveyor's report, total estimated cost for repair and towage to New York was about \$3,569,000.

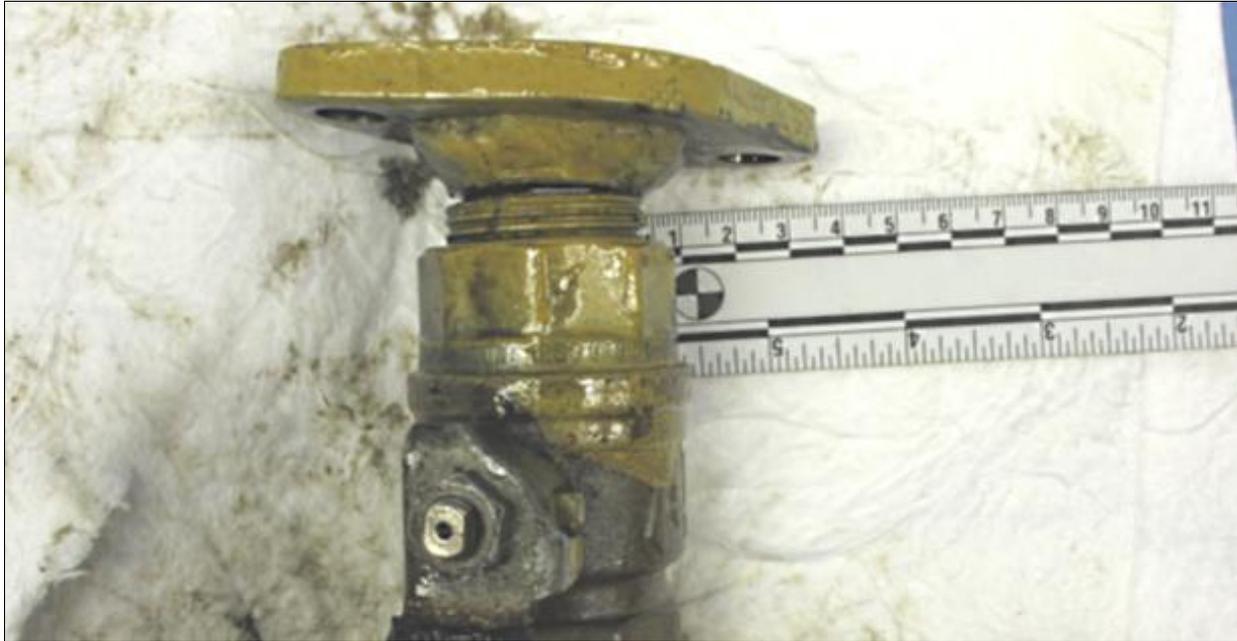
The NTSB materials laboratory in Washington, DC, examined the pre-lubrication oil pump nipple/flange assembly (“assembly”) for the port engine. The assembly exhibited a circumferential fracture adjacent to the fillet weld, which is a weld of about triangular cross

section that joins two pieces, especially perpendicularly. The fracture had progressed to about 75 percent of the assembly circumference, and was located along a thread root adjacent to the fillet weld. A scanning electron microscope revealed that fatigue was the only failure mode on the fracture surface. No indications of other failure modes, such as overstress or corrosion, were found.

The assembly, as received. The crack was located along a thread valley and spanned across about 75 percent of the assembly's circumference.

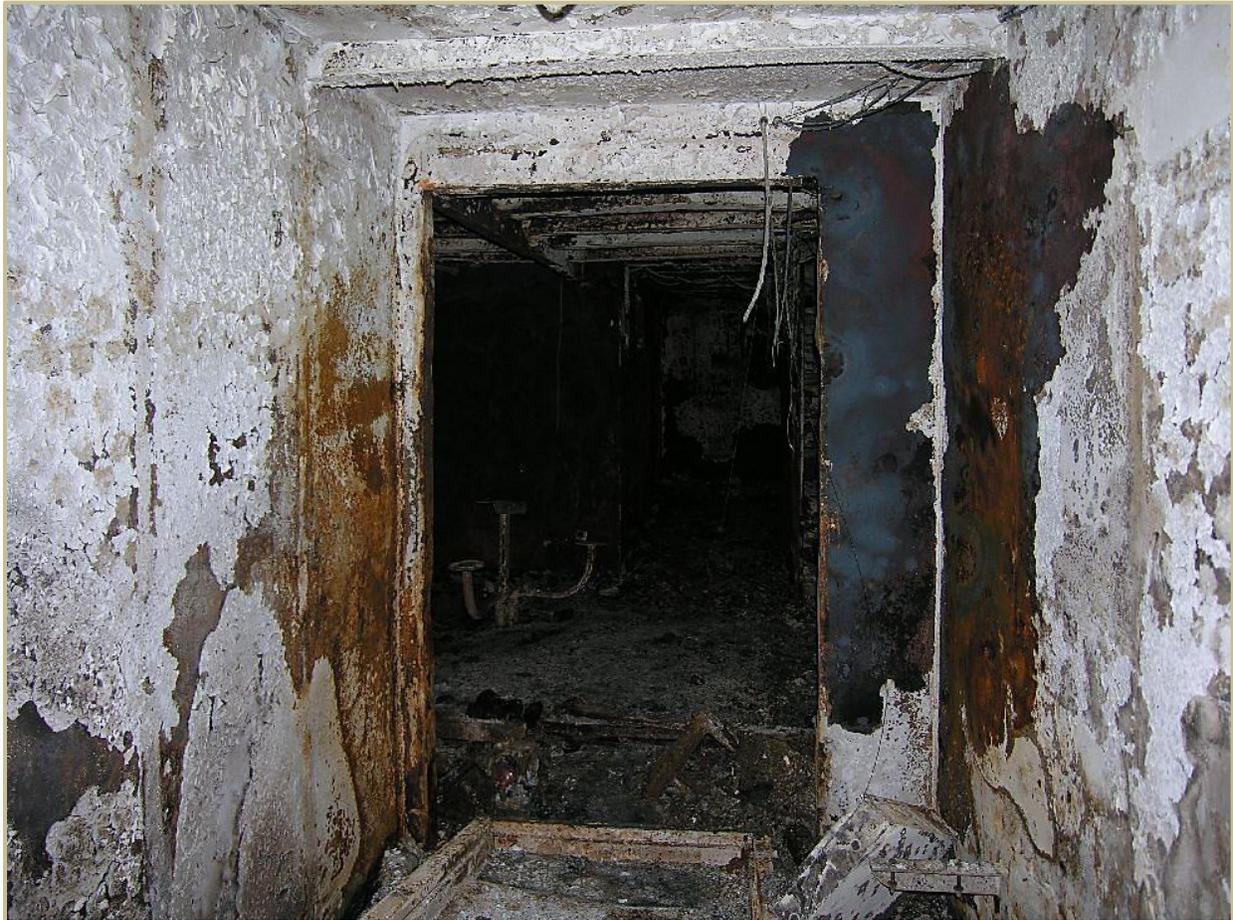
The steel door of the centerline passageway to the galley (main deck frame 25) is lying on the deck. The wooden door frame was consumed in the fire. Photo by TSB.
