National Transportation Safety Board

Marine Accident Brief

Fire On Board and Sinking of Liftboat *Mako*

Accident no.	DCA-12-LM-005
Accident type	Fire and sinking
Vessel	Offshore supply vessel (liftboat) <i>Mako</i>
Location	Atlantic Ocean, Gulf of Guinea, 6 miles off the coast of Nigeria 04°21.164' N, 005°47.053' E
Date	January 16, 2012
Time	0503 local time (coordinated universal time –1 hour)
Injuries	None
Property damage	Vessel was a total loss; estimated value of \$8,000,000
Environmental damage	Unknown
Weather	Foggy, winds 1–2 knots north, air temperature 80° F, visibility $\frac{3}{4}$ mile
Waterway characteristics	The Gulf of Guinea is the northeastern-most part of the tropical Atlantic Ocean. There are a number of active oil fields in this area off the coast of Nigeria.

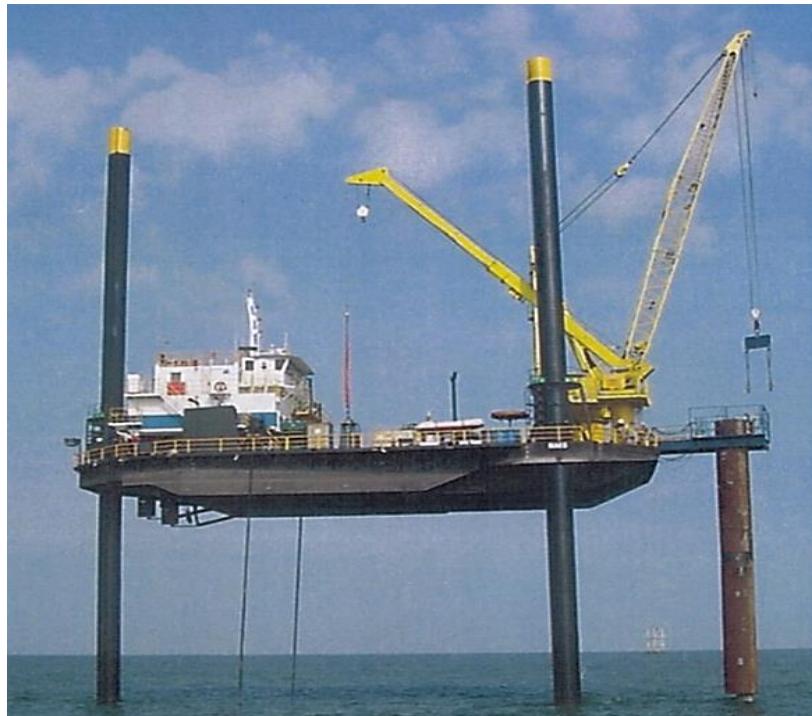
Liftboat *Mako* jacked up during operations. (Photo by Hercules Liftboat Company)

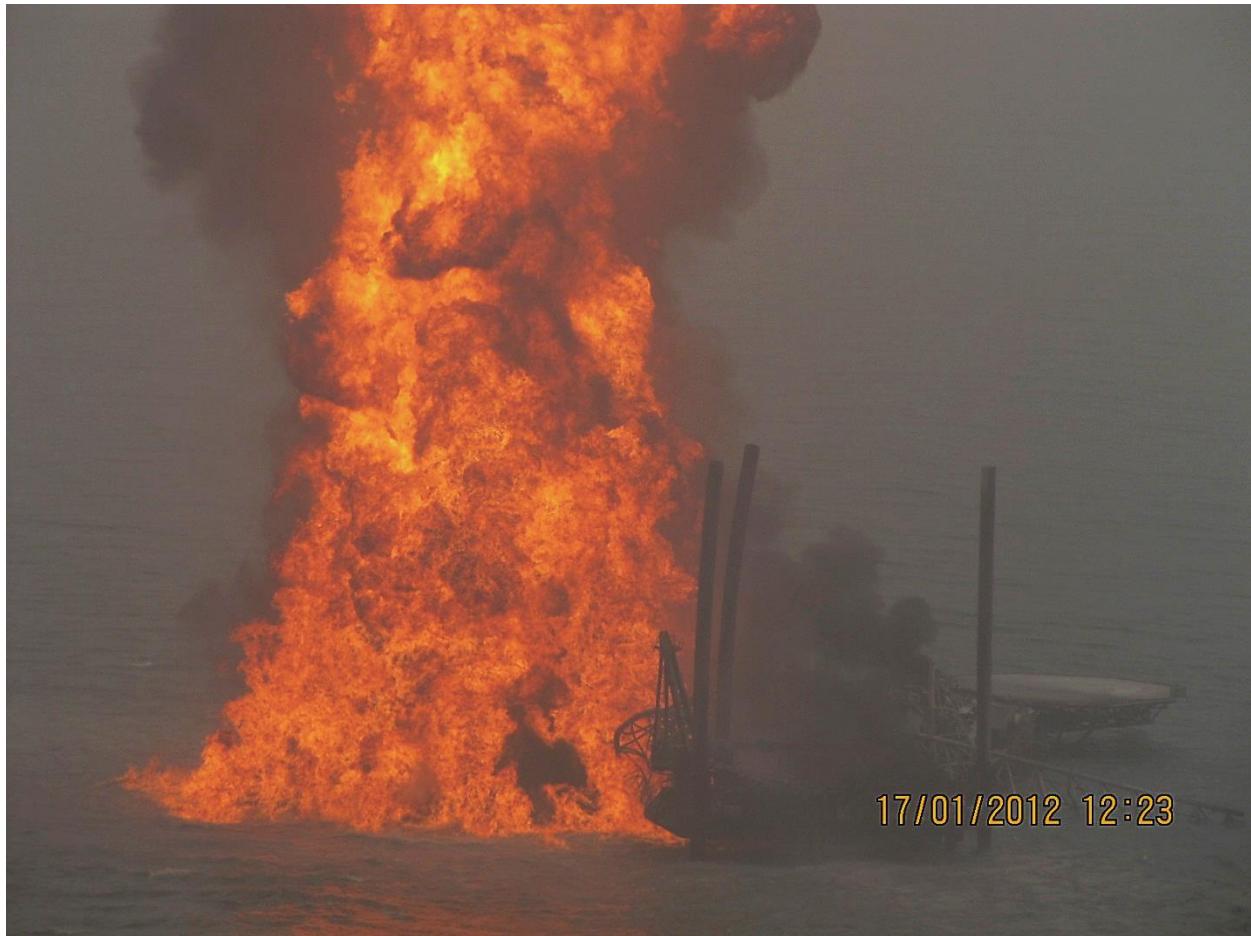
Photo of the fire, taken on January 17, 2012. The charred remains of the *Mako* are visible in the foreground, to the right of the flames. Photo provided by the US Coast Guard.

The *Mako* was consumed by the fire and eventually sank. The fire at the well continued to burn for about another month and a half, until March 2, 2012, when a portion of the well sealed itself. There were no fatalities or major injuries to personnel from the *Mako*; however, two workers from the *Endeavor* died.

The National Transportation Safety Board determines that the probable cause of the fire on board and sinking of the liftboat *Mako* was a blow-out of the well-head under the adjacent jack-up drilling rig *KS Endeavor*, which resulted in an uncontrollable gas fire that rapidly spread to the liftboat.
