National Transportation Safety Board

Marine Accident Brief

Grounding and Loss of the *FV Chevelle*

Accident no.	DCA-12-LM-011
Vessel name	<i>Chevelle</i>
Accident type	Grounding and subsequent loss of vessel (sinking)
Location	North jetty of Yaquina Bay entrance, Newport, Oregon 44° 36.7014' N, 124° 4.8587' W
Date	March 10, 2012
Time	1720 Pacific standard time (universal coordinated time – 8 hours)
Injuries	None
Damage	\$625,000
Environmental damage	Reported 0.25 by 0.5 nautical mile sheen from est. 3,000–4,000 gallons marine diesel fuel, which dissipated due to open water, weather, and seas
Weather and sea conditions	Winds 21–25 knots from the south, clear with visibility 2 nautical miles, air temperature 46° F, water temperature 48° F, west swell approx. 8–10 ft. with occasional breaking waves to 12 ft., tide ebbing with current up to 2.3 knots (rain at time of rescue)
Astronomical data	Sunset 1817, nautical twilight 1920
Waterway characteristics	Pacific Ocean entrance bar between two jetties: mean tidal range 7.2–1.3 ft. at bar entrance; designated by US Coast Guard as “regulated area” subject to heavy swells and rough seas

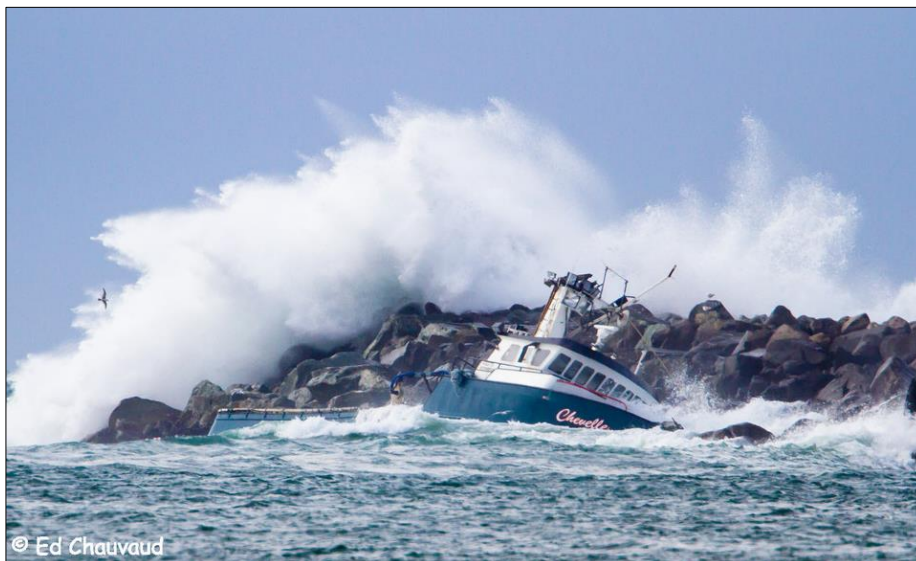
The abandoned fishing vessel *Chevelle* on the Yaquina Bay entrance north jetty the day after grounding. (Photo by Ed Chauvaud)

Just before the *Chevelle* crossed the jetty tips, the vessel took a large breaking wave over its starboard quarter, resulting in a severe heel and turning the vessel toward the north jetty. The master stated that the crab pots on the stern did not appear to shift at that time and the vessel began to recover. Another wave over the starboard quarter rolled the vessel again, leaving the *Chevelle* heeled further over and down by the head, and it did not recover. A witness said the crab pots appeared to shift. Such a redistribution of weight, along with water on the deck from the breaking wave, could have contributed to the severity of the heel and the inability of the vessel to right itself. The wave left the vessel touching the north jetty boulders bow-first but the vessel was not hard aground.

The master initially attempted to back down but was unable to free the vessel as subsequent waves drove it further against and up onto the jetty. At 1725, the master contacted the Coast Guard for assistance, and two 47-foot motor lifeboats (MLBs), designed for operation in heavy surf, launched to respond. At 1739, the *Chevelle* lost propulsive power, but its generator continued to operate. By 1948, a hull breach caused the vessel engine room and forepeak tank to begin flooding, and a stream of diesel oil was leaking from the hull.

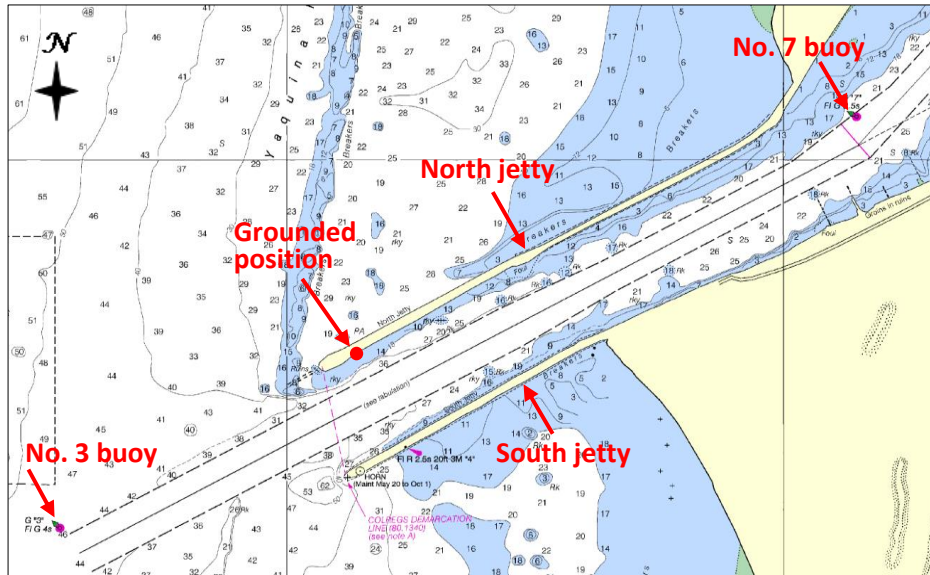
Excerpt from NOAA chart 18581, Yaquina Bay and River, indicating the north and south jetties, buoys 3 and 7, and the location where the *Chevelle* grounded, shown by a red dot.

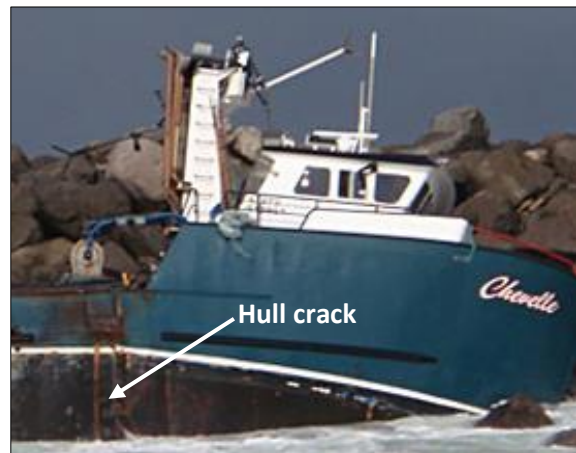
Bar conditions improved slightly during the next morning although a steep, choppy swell 4 to 8 feet at the tips remained, and the bar restrictions were continued for all recreational boats and UPVs. The rough weather prevented salvage or recovery, and the continued battering of the vessel resulted in a visibly expanding hull breach (see photo at right) and the loss of the vessel's crab pots. A light oil sheen developed on the water, which a Coast Guard overflight reported to be 0.25 by 0.5 nautical miles in area. The Coast Guard Sector Columbia River Incident Management Division (IMD) pollution response team implemented its geographic response plans to protect sensitive areas within Yaquina Bay. In response to the vessel's release of diesel oil, the Coast Guard implemented booming strategies, but the light nature of the oil sheen and adverse weather prevented the pollution response team from recovering oil.

***Chevelle* against the rocks of the north jetty with arrow pointing to crack in hull. (Photo by Coast Guard)**

The weather and bar conditions deteriorated by late afternoon, and the first bar report on the morning of March 12 described occasional breaks of 16 to 18 feet at the jetty tips and winds of 40 to 50 knots. The Coast Guard closed the port to all vessel types due to the weather under a captain of the port (COTP) order. The *Chevelle* was no longer visible after breaking in two and sinking overnight. Although bar and weather conditions varied over the next several days, the
