Marine Accident Brief

Collision Between Bulk Carriers *Mary Ann Hudson* and *Star Grip*

Accident no.	DCA-12-LM-019
Vessel names	Bulk carriers <i>Mary Ann Hudson</i> and <i>Star Grip</i>
Accident type	Collision
Location	Houston Ship Channel, Texas (City Dock 23)
Date	June 6, 2012
Time	0530 central daylight time (coordinated universal time – 5 hours)
Injuries	None
Damage	> \$500,000
Environmental damage	None
Weather	Clear; unrestricted visibility; calm winds; air temperature 82°F
Waterway information	The Houston Ship Channel extends from the city of Houston, Texas, to Galveston Harbor at the Gulf of Mexico, and is a busy shipping lane.

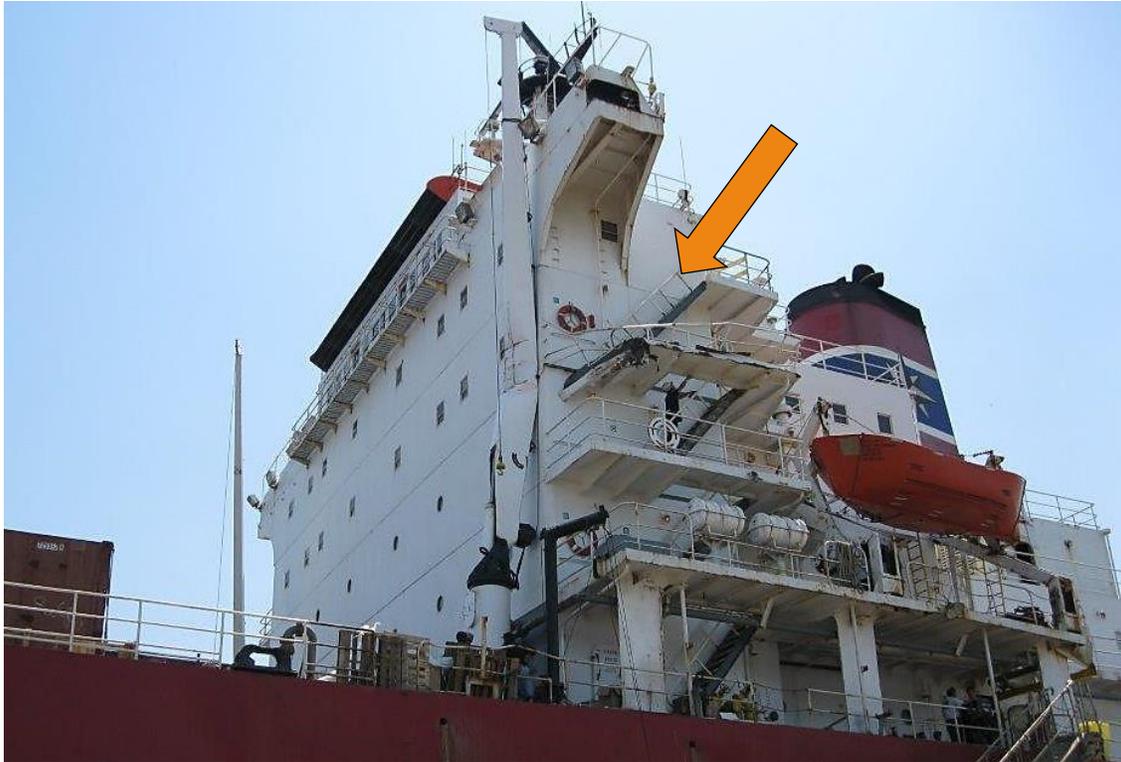
- *Mary Ann Hudson*: Damage to the port stores crane and the superstructure from contact with the *Star Grip*'s crane. The damage amount was estimated to be \$250,000.
- *Star Grip*: Extensive damage to the aft gantry crane (No. 2) including the cantilever arm, track rails, and wheels. The No. 2 crane was pushed into the forward gantry crane (No. 1). The damage amount was estimated to be more than \$250,000.

The damaged port stores crane, superstructure, and railings on the *Mary Ann Hudson*, marked by an overlaid arrow. (Photo provided by the Coast Guard)

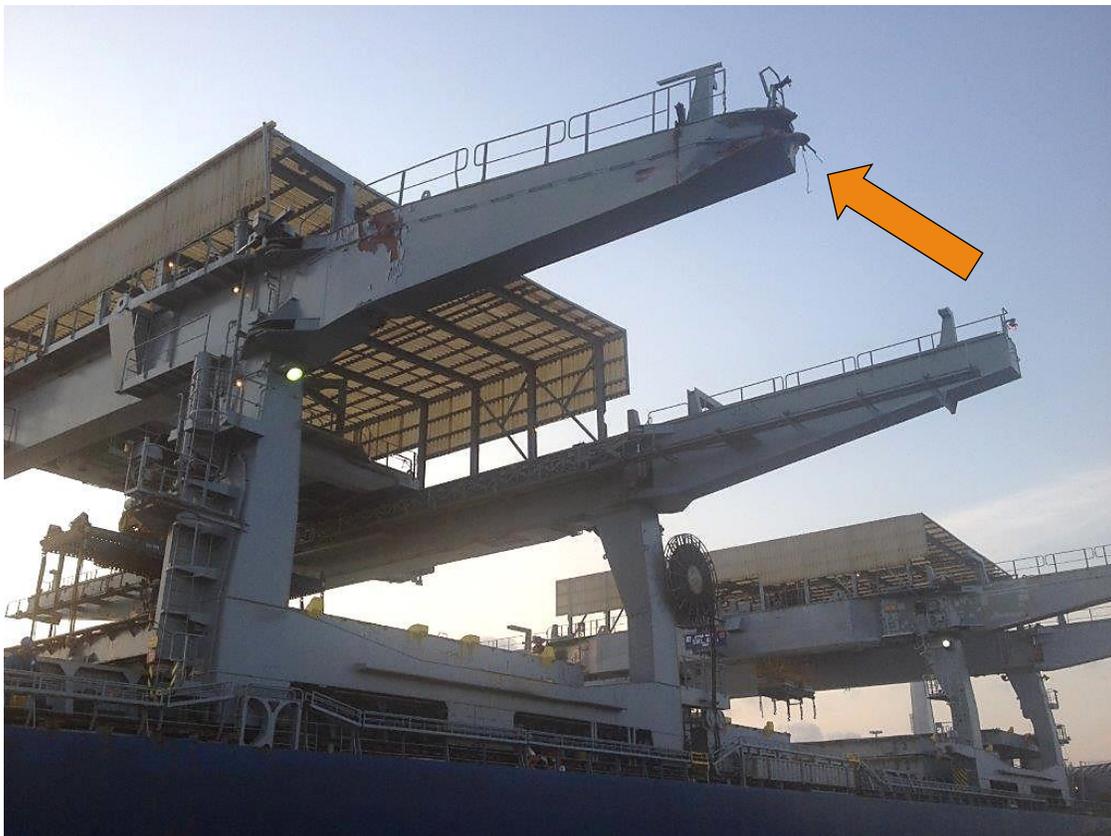
The damaged aft gantry crane on the *Star Grip*, marked by an overlaid arrow. The vessel is shown from its starboard side. (Photo provided by the Coast Guard)
