# National Transportation Safety Board

## Marine Accident Brief

### Bollard Failure Causing Breakaway of Cruise Ship *Carnival Triumph* from its Moorings, and Subsequent Collision with Dredge *Wheeler* and Towing Vessel *Noon Wednesday*

<b>Accident no.</b>	DCA-13-LM-015
<b>Vessel names</b>	<i>Carnival Triumph</i> , <i>Wheeler</i> , and <i>Noon Wednesday</i>
<b>Accident type</b>	Bollard failure; breakaway from moorings; subsequent collision
<b>Location</b>	BAE Systems shipyard, Mobile River, Mobile, Alabama 30°40.659' N, 88°1.975' W
<b>Date</b>	April 3, 2013
<b>Time</b>	1328 central daylight time (coordinated universal time –5 hours)
<b>Injuries</b>	1 fatal, 1 injured (both BAE Systems employees)
<b>Damage to vessels</b>	<i>Carnival Triumph</i> , \$2.7 million; <i>Wheeler</i> , \$200,000; <i>Noon Wednesday</i> , \$3,000
<b>Environmental damage</b>	None
<b>Weather</b>	Heavy rain with limited visibility. Air temperature 59°F. The National Weather Service had issued a Special Weather Statement at 1251 CDT, warning of possible wind gusts of up to 50 mph in the vicinity of the accident.
<b>Waterway characteristics</b>	The Mobile River, located in southern Alabama, is about 45 miles in

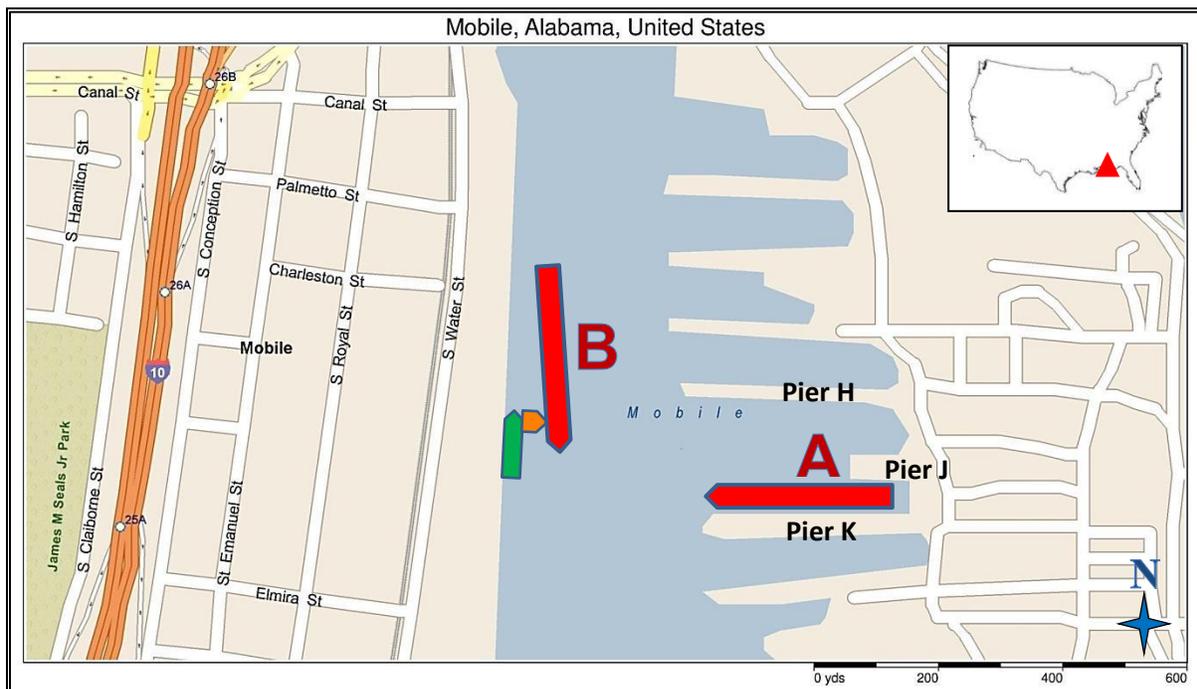
The approximate location of the *Carnival Triumph* before the collision is marked "A" (the ship icon is red), and its approximate location at the time of the collision (west side of the Mobile River) is marked "B." The dredge *Wheeler* is shown as a green icon and the towing vessel *Noon Wednesday* as an orange icon. Vessel icons and positions are not to scale. (Background by Microsoft Trips and Streets)

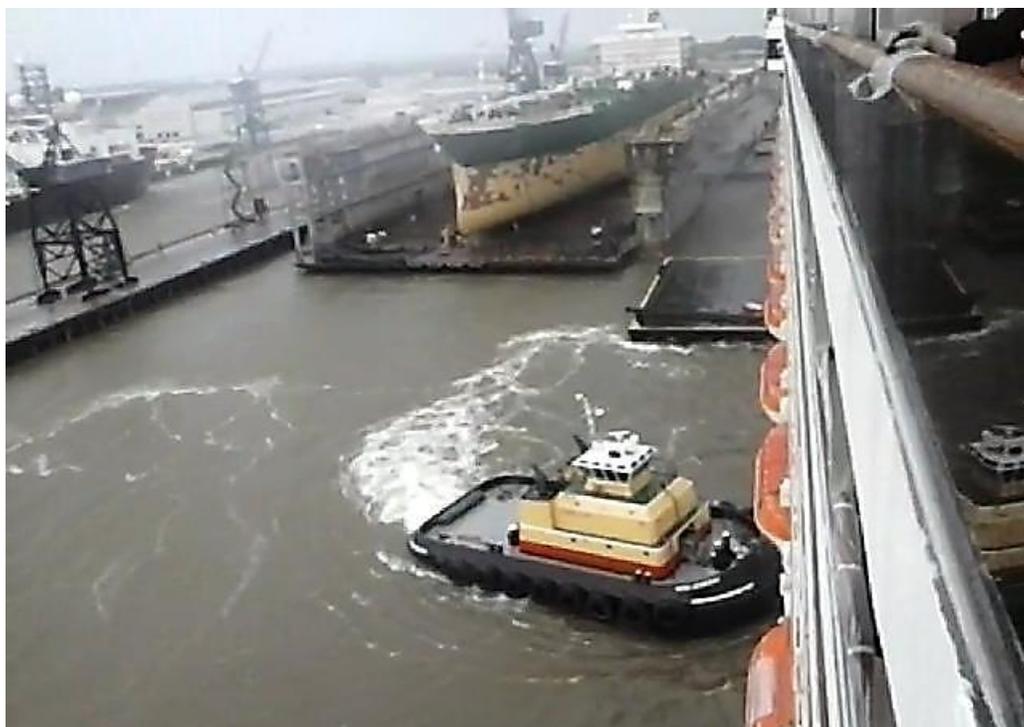
**In this image taken from the *Carnival Triumph* (starboard side, looking aft), the towing vessel *Noon Wednesday* is seen taking position on the hull. The dry-dock facility and the still-attached work barges are also visible in this image. (Photo provided by Carnival Corporation)**

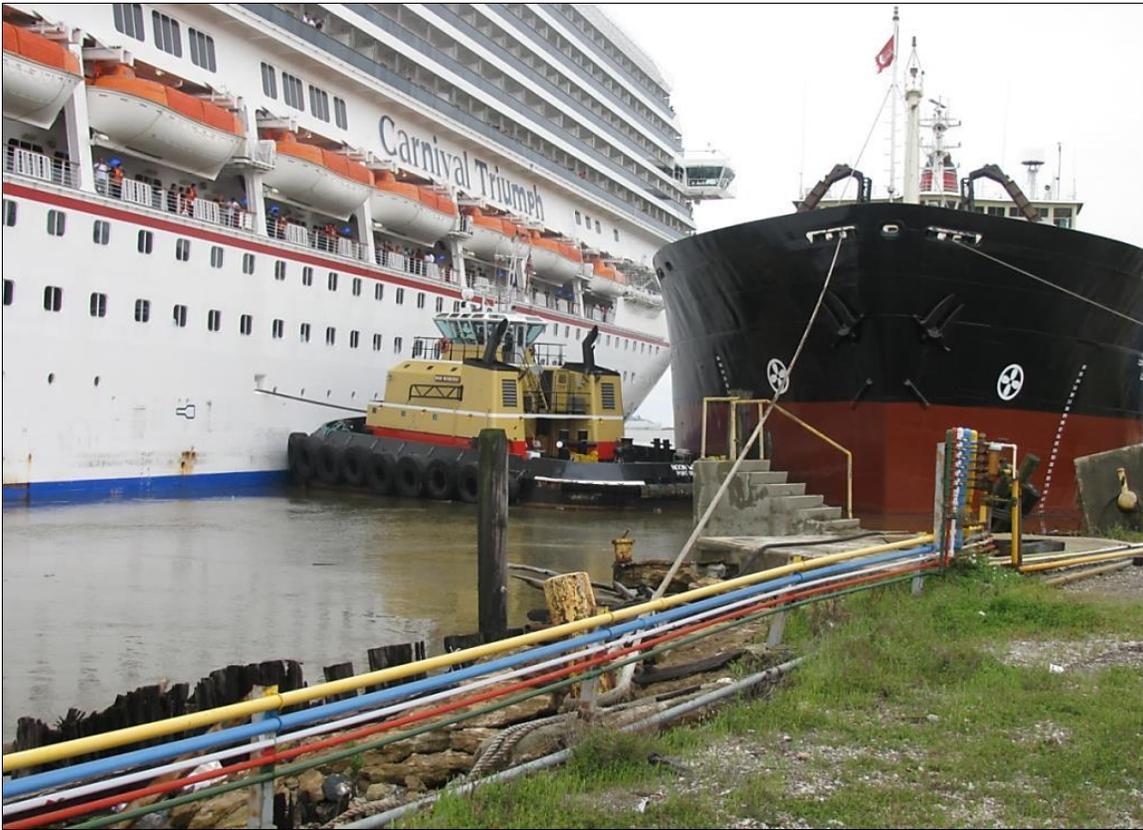
**This image, taken by Coast Guard investigators from the bulkhead of the Signal Ship Repair facility shortly after the collision, shows the positions of (from left to right) the *Carnival Triumph*, *Noon Wednesday*, and *Wheeler*.**

- *Carnival Triumph*: Damage at various points along the entire length of the starboard hull, just above the waterline, extending up to deck #5 aft, known as the Promenade deck, and deck #4 forward, known as the Atlantic deck. Damage included puncture and inset of the hull plating, and distortion of vertical and horizontal framing. The estimated damage amount was \$2.7 million.
- *Wheeler*: Damage to the forward portion of the starboard hull, including parts of the superstructure, which included inset of the plating and distortion of the framing. Some damage also occurred to dredging gear located on the main deck, starboard side forward. The estimated damage amount was \$200,000.
- *Noon Wednesday*: Minor damage to the aft tank, starboard corner, which included inset of the hull plating and some framing distortion. The estimated damage amount was \$3,000.

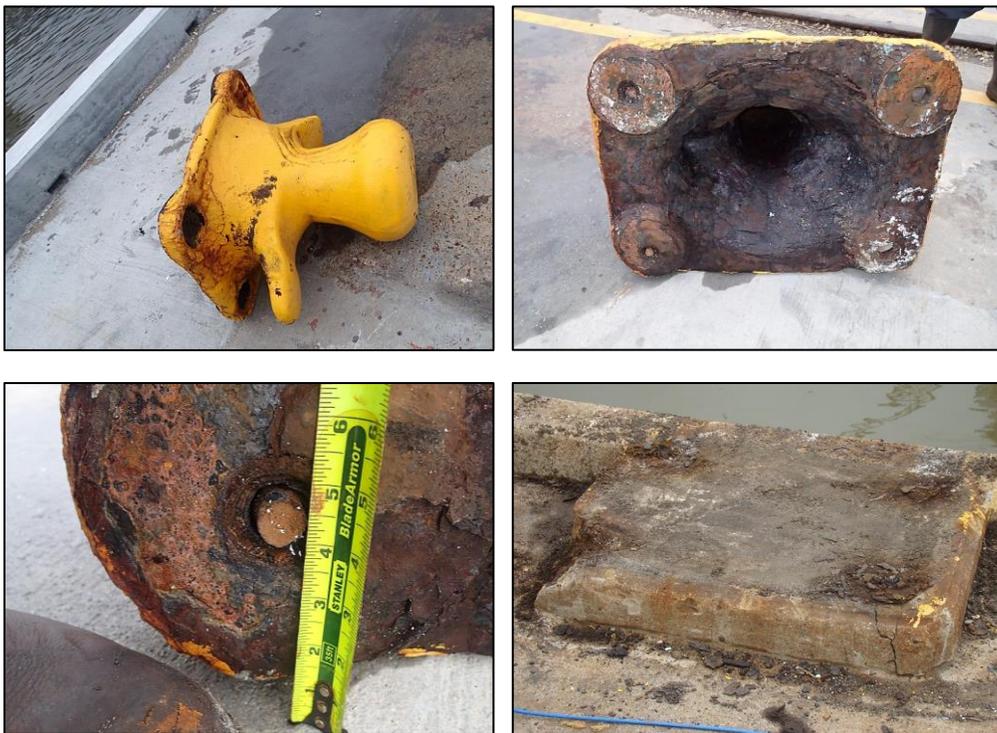
### Mooring bollards at the BAE Systems shipyard

Each mooring bollard at the BAE Systems shipyard, Pier K, was affixed to the pier using four large steel anchor bolts, 30 inches in length and about 1.5 inches in diameter, with backing plates encased in concrete. The two images in the upper row show side and bottom views of one of the bollards recovered after the accident. The image on the lower left shows a section of a fractured anchor bolt that remained in one of the recovered bollards. The image on the lower right shows a concrete base pad where one of the failed bollards had been mounted.

After the accident, a metallurgical consulting firm hired by BAE Systems performed a preliminary evaluation of the 16 anchor bolt sections that remained in the concrete base pads of the failed bollards on Pier K. The evaluation report identified three types of rupture conditions as

being present in the bolt specimens: brittle fracture, ductile rupture, and severe corrosion prior to ductile rupture. The report indicated that although some of the bolts had lost material from corrosion before the failure, further study would be necessary to determine whether the reduction in the bolts' cross-sectional area was a result of elongation from high force, corrosion, or a combination of both factors. The bolts and bolt parts were transferred to OSHA's Salt Lake Technical Center in Utah for further examination. As of the date of this brief, no findings have been issued.

The National Transportation Safety Board determines that the probable cause of the breakaway of the *Carnival Triumph* from its moorings and the subsequent collision with the dredge *Wheeler* and the towing vessel *Noon Wednesday* was the successive failure of multiple mooring bollards, which were known by BAE Systems to be in poor condition with an undetermined mooring load capability.
