National Transportation Safety Board

Marine Accident Brief

Sinking of Tall Ship *Bounty*

Accident no.	DCA-13-LM-003
Vessel name	<i>Bounty</i>
Accident type	Sinking
Location	Heel-over and abandon-ship: About 110 nautical miles southeast of Cape Hatteras, North Carolina, 33° 57.36' N, 73° 54.52' W Vessel last sighted: 123 nautical miles southeast of Cape Hatteras 33° 49. 6' N, 73° 44.3' W
Date	October 29, 2012
Time	Heel-over and abandon-ship: 0426 eastern daylight time (coordinated universal time -4 hours) Last sighting: 1920 eastern daylight time
Injuries	3 serious 2 fatalities (1 deceased crewmember recovered; captain missing and presumed dead)
Damage	Total loss; value estimated as \$4 million
Environmental damage	Minor, due to remaining fuel on board
Weather	At 0426: Winds 50–60 knots with gusts of 90 knots; air temperature 73°F; overcast, visibility of 1–2 nautical miles; seas >20 feet; water temperature 78°F
Waterway characteristics	Atlantic Ocean

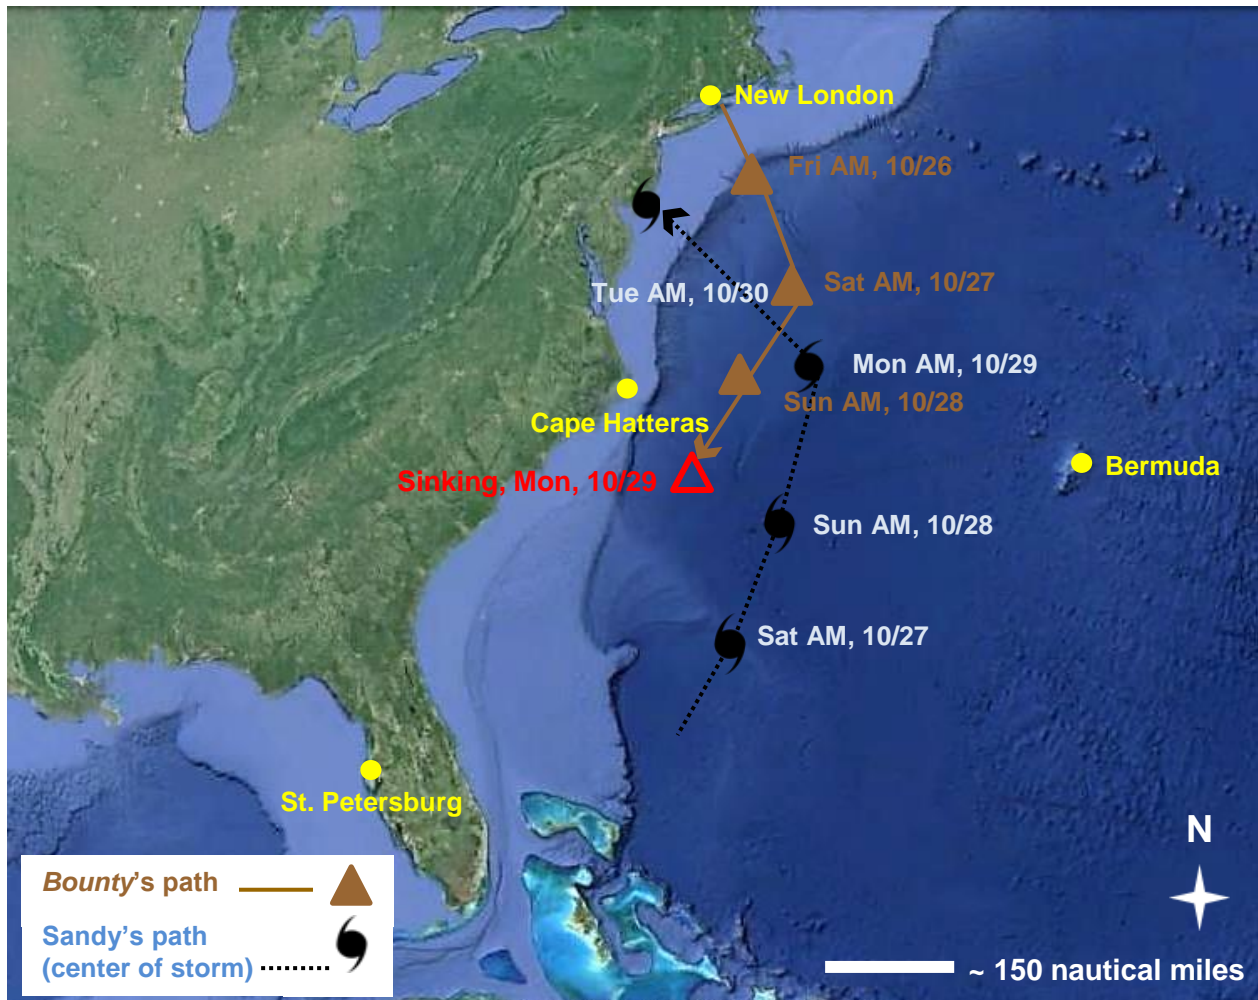
Satellite image showing the approximate southbound path of the *Bounty* and the approximate northbound path of Hurricane Sandy. (Background by Google Earth)

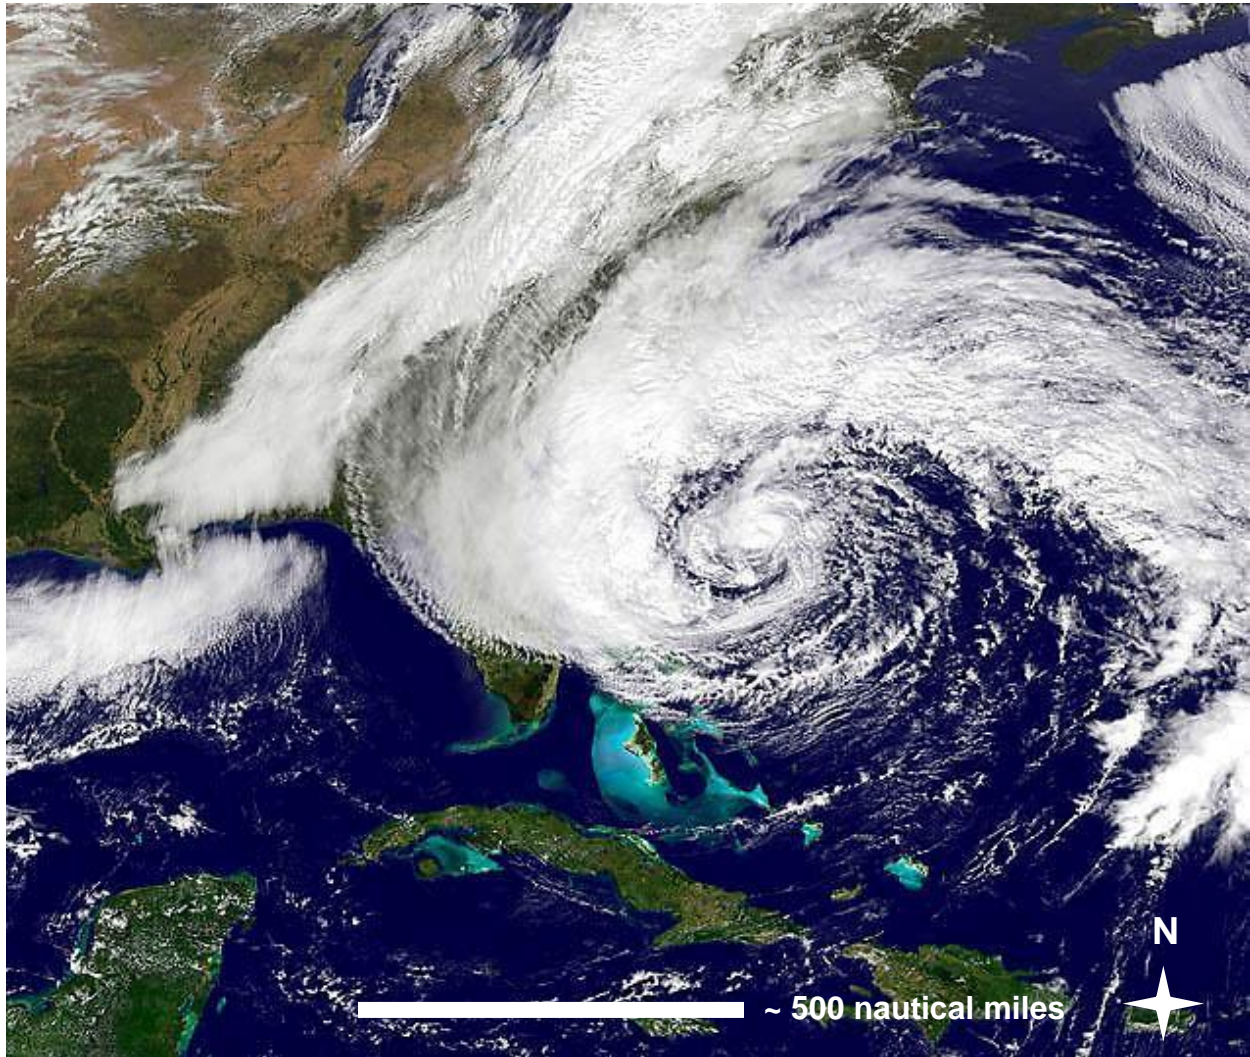
Satellite image of Hurricane Sandy on October 27, showing the large expanse of the storm. A National Weather Service advisory, issued at 1100 that day and sent in an email to the captain, stated that tropical storm-force winds extended up to 450 miles from the center of the storm and were already near the North Carolina coast.

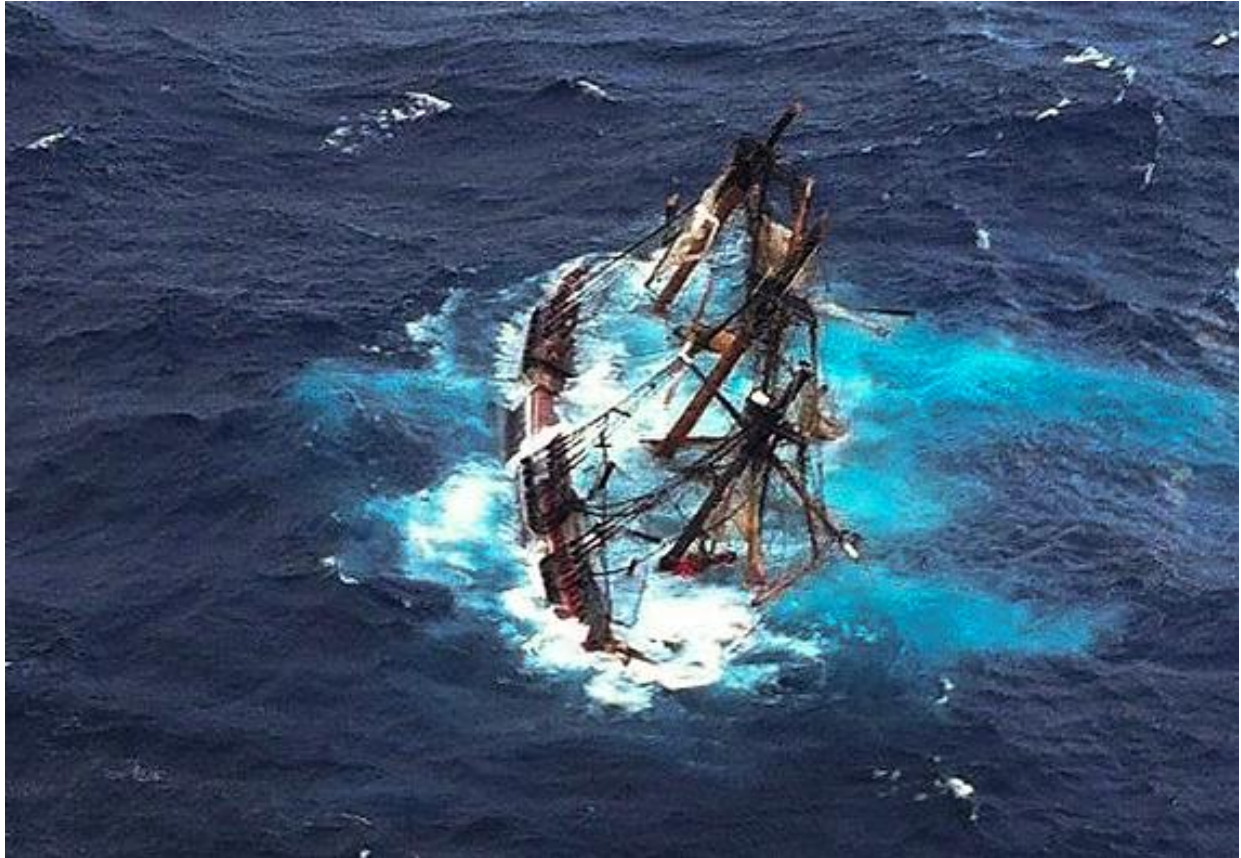
The *Bounty*, photographed from a Coast Guard aircraft above, before the vessel sank.
