National Transportation Safety Board

Marine Accident Brief

Grounding and Sinking of Towing Vessel *Stephen L. Colby*

Accident no.	DCA14LM002
Vessel	<i>Stephen L. Colby</i>
Accident type	Grounding and sinking
Location	Upper Mississippi River, near mile 497, LeClaire, IA 41°35.8' N, 90°20.6' W
Date	November 25, 2013
Time	1555 central standard time (coordinated universal time – 6 hours)
Injuries	None
Damage	\$3.9 million
Environmental damage	US Coast Guard estimated 2,096 barrels of petroleum product recovered from vessel and river Vessel carried est. 2,156 barrels of petroleum product when it sank—2,128 barrels of diesel and 28 barrels of lube oil
Weather	Mostly cloudy, winds southwest 12 mph and gusting to 29 mph, visibility 10 miles, air temperature 35°F
Waterway information	The Upper Mississippi River is upstream of Cairo, IL. Pool 14, location of the accident, is a body of water between US Army Corps of Engineers Lock & Dam 13 and Lock & Dam 14. The Coast Guard noted shallowest water depth was 9.88 ft, water temperature 37°F at time of accident

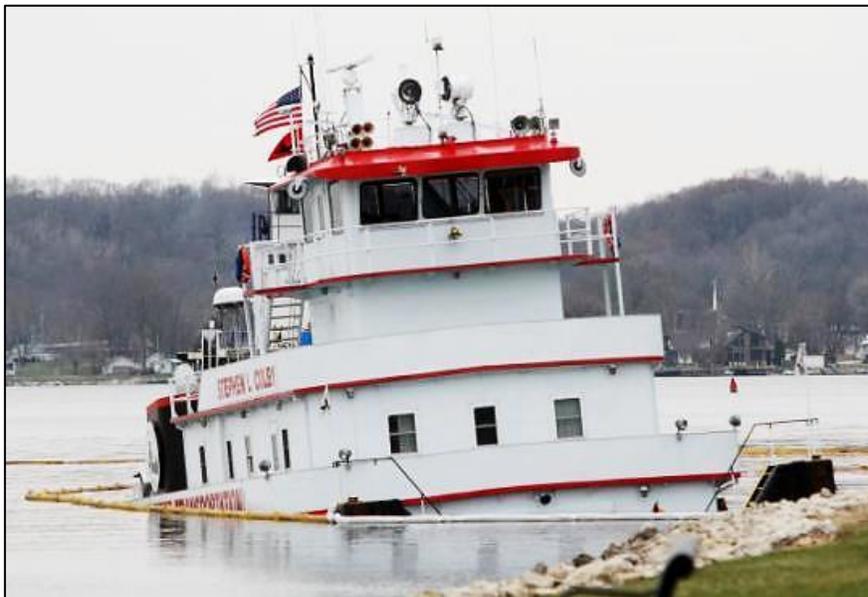
The superstructure of the *Stephen L. Colby* remained above the waterline when the vessel came to rest on the Mississippi River bottom near LeClaire, Iowa. (Photo from Quad Cities Times)

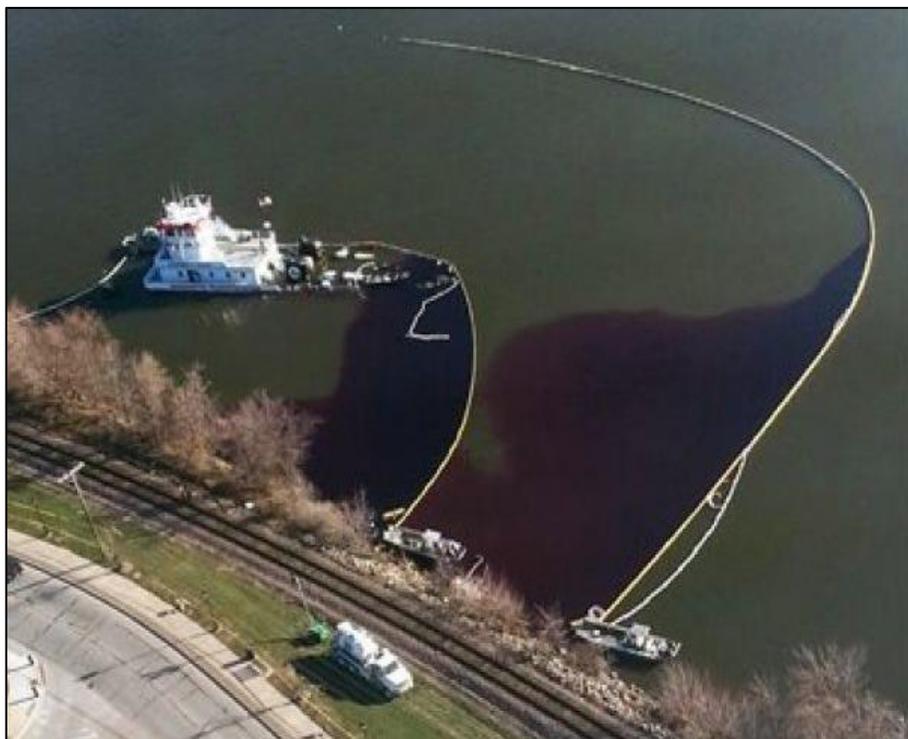
The *Stephen L. Colby* in the days after the sinking, with oil boom deployed to capture petroleum product released from the vessel. (Photo from US Fish and Wildlife Service)

Oil response and salvage operations continued for about 2 weeks after the accident. Salvage divers performed temporary repairs to the hull in the engine room, where an opening about 34 x 30 inches was found just port of the centerline. Divers also completed temporary repairs to a smaller fracture in the hull plate in the pump room and sealed a preexisting fracture in a forward ballast tank. On December 11, 2013, the vessel was towed to dry dock in St. Louis, Missouri, where it arrived December 17 for further repairs.

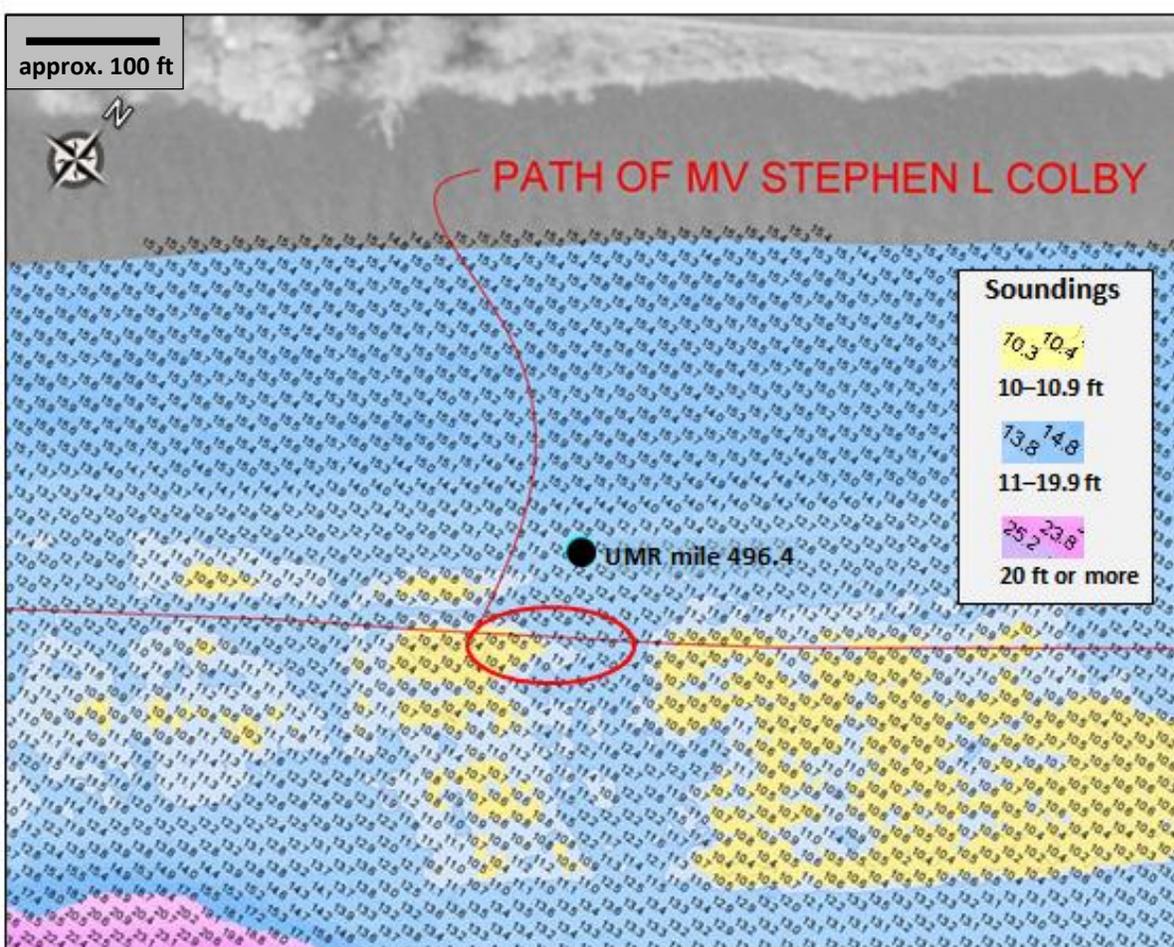
The USACE conducted soundings and a side-scanning sonar survey of the waterway near the accident site but did not locate any unknown hazards or obstructions on the river bottom. Using automatic identification system (AIS) data obtained from the *Stephen L. Colby*, the USACE overlaid the vessel's trackline on the sounding results. The results indicated the vessel had remained within the navigable channel before the accident (see below).

The shallowest water depth recorded along the vessel's path at the time of the survey was 10.4 feet. Correction to reflect the water level at the time of the accident resulted in a calculated depth of 9.9 feet. According to Coast Guard information, Marquette Transportation reported the draft of the *Stephen L. Colby* at the time of the accident to be 9 feet both forward and aft, leaving an underkeel clearance of 8 to 11 inches when the *Stephen L. Colby* was at idle speed.

Although the squat effect was not calculated in this situation, this hydrodynamic phenomenon—caused when a vessel passes through shallow water at speed—very likely reduced the vessel's underkeel clearance even further. (See box on squat, next page.)

Investigators used AIS data from the *Stephen L. Colby* to determine the vessel's course through the channel. The northeast path of the towing vessel (red line running left to right) is overlaid on a chart of depth soundings taken the day after the accident. The red oval indicates the approximate site of the accident. (Data plot by Coast Guard)
