National Transportation Safety Board

Marine Accident Brief

Sinking of Fishing Vessel *Long Shot*

Accident no.	DCA14LM001
Vessel name	<i>Long Shot</i>
Accident type	Sinking
Location	Gulf of Mexico, 150 nautical miles southwest of Panama City, Florida 28°23.0' N, 87°46.0' W
Date	November 15, 2013
Time	Vessel abandoned at 2030 central standard time (coordinated universal time – 6 hours)
Injuries	None
Damage	Total loss of vessel; estimated value of \$150,000
Environmental damage	None observed; potential loss of an estimated 750 gallons of diesel fuel on board
Weather	Northwest winds at 15 knots; clear skies; visibility of 6 nautical miles; air temperature 65°F; seas at 10–12 feet
Waterway information	North central Gulf of Mexico

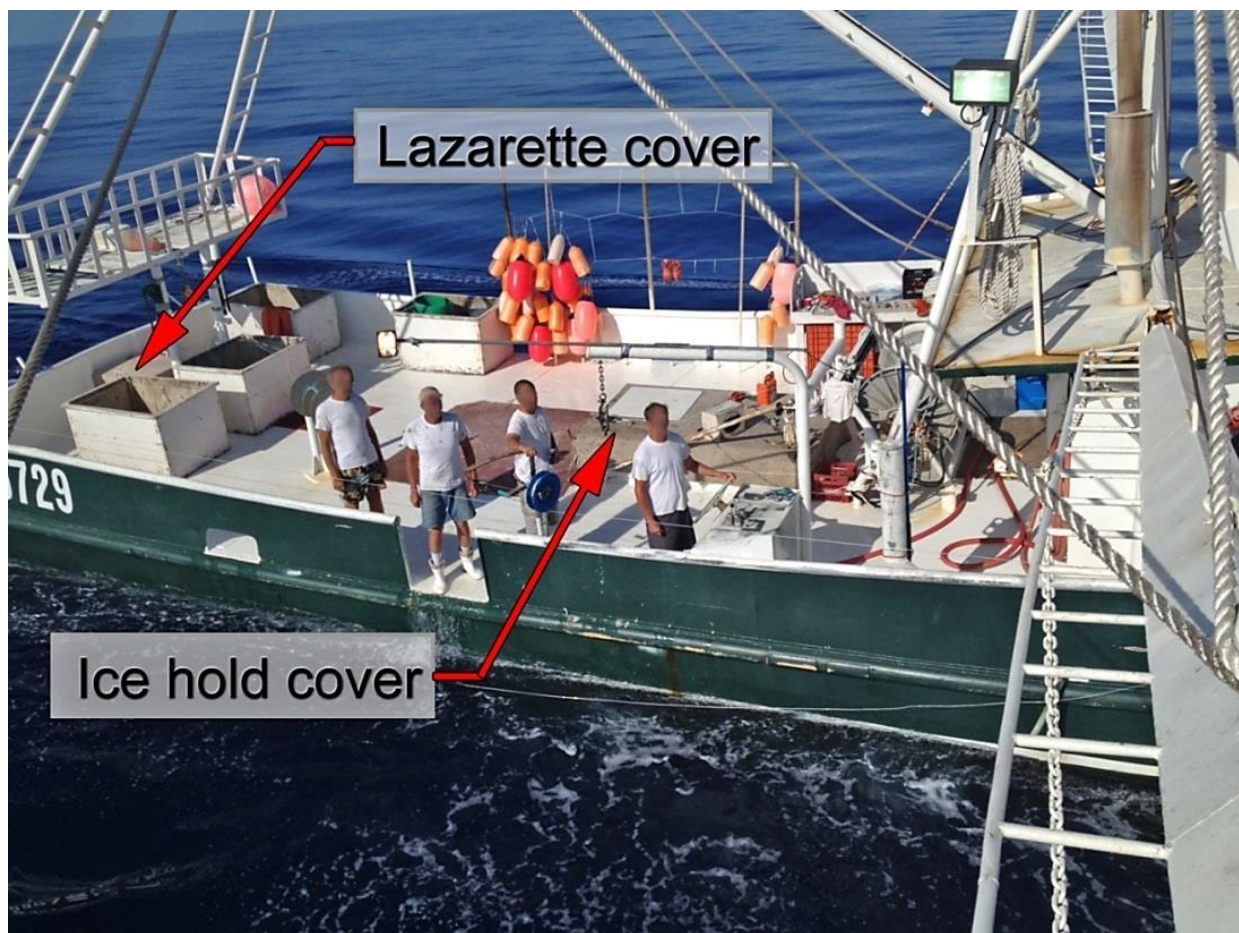
The leak increased in severity, and on the morning of the 13th day of the trip (November 14), about 2 feet of water had accumulated in the lazarette. The crew began to continuously monitor the leak and pump water out of the lazarette as the vessel proceeded to port. The lazarette had a non-watertight cover that had to be removed to position a portable dewatering pump in the compartment. As required by Coast Guard regulations, the compartment was fitted with a high-water-level bilge alarm but it did not require a fixed bilge pump. At the time, the seas were 6 to 8 feet high.

The *Long Shot* under way several months before the accident voyage. The lazarette cover and the ice hold cover on the aft deck of the vessel are indicated. (Photo by W I T Fisheries)

had said 6 to 8 hours away. During the morning, the weather conditions worsened and the *Long Shot* began taking water over the stern and into the lazarette through its cover, which had been left open. Around sunrise, the two captains spoke again and this time clarified that the *Orion* was still 12 to 14 hours away. The captain became concerned for the safety of the vessel and crew, and decided to contact the Coast Guard to request a dewatering pump so that he could pump out the lazarette. The back deck and the lazarette were flooded, but no water had yet entered the ice hold or the deckhouse.
