# National Transportation Safety Board

## Marine Accident Brief

### Capsizing and Sinking of the Fishing Vessel *Advantage*

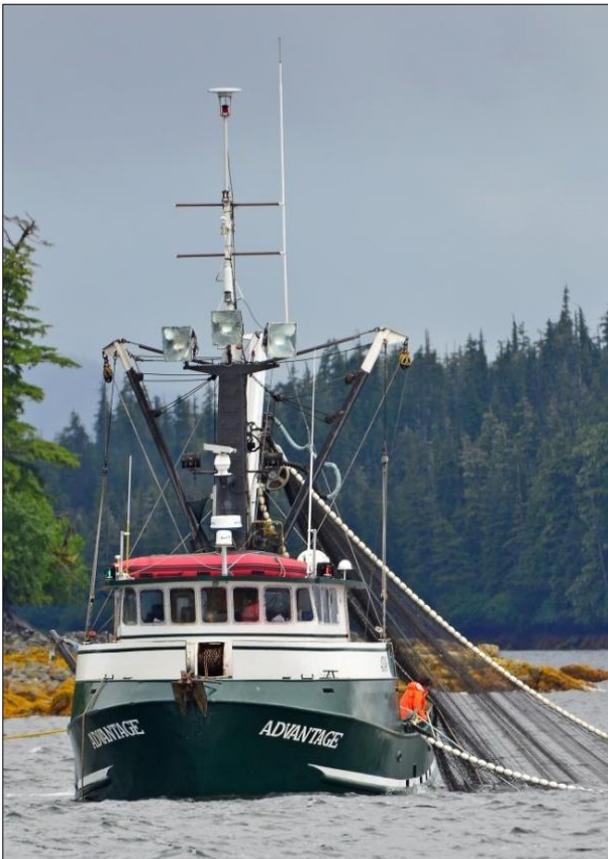
Fishing vessel *Advantage* operating in Prince William Sound, Alaska. (Photo © Charles Scott)
