National Transportation Safety Board

Marine Accident Brief

Fire on Board Towing Vessel *Shanon E. Settoon*

Accident no.	DCA13NM011
Vessel name	<i>Shanon E. Settoon</i> (towing the barge <i>SMI 572</i>)
Accident type	Fire
Location	Bayou Perot, Louisiana 29°38.03 N, 90°10.63 W
Date	March 12, 2013
Time	1745 central daylight time (coordinated universal time – 5 hours)
Injuries	1 fatality
Damage	Total loss of vessel, estimated at more than \$500,000
Environmental damage	Release of high-pressure liquefied petroleum gas from ruptured pipeline, and release of 1,000 gallons of diesel fuel from the vessel. Clean-up and salvage costs estimated at \$166,000.
Weather	Clear; 10-mile visibility; 66°F; north-northwest winds at 8 knots
Waterway information	Bayou Perot Canal in the Intracoastal Waterway, mile marker 20

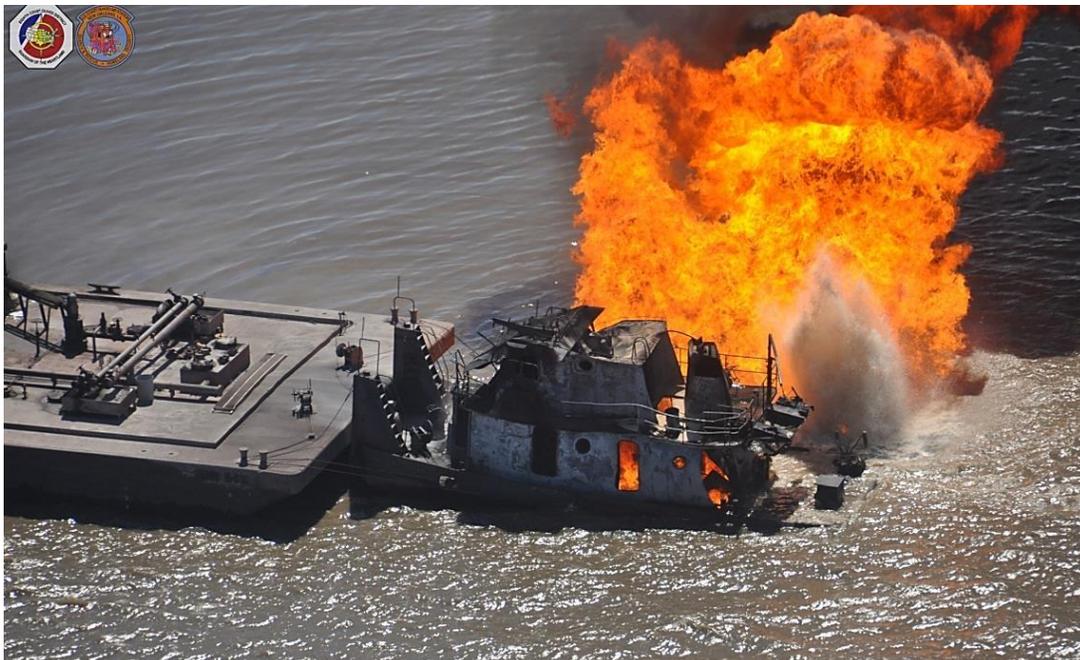
The *Shanon E. Settoon* ablaze after the gas from the ruptured pipeline ignited. Tank barge *SMI 572* is positioned forward of the vessel. (Photo by the United States Coast Guard)

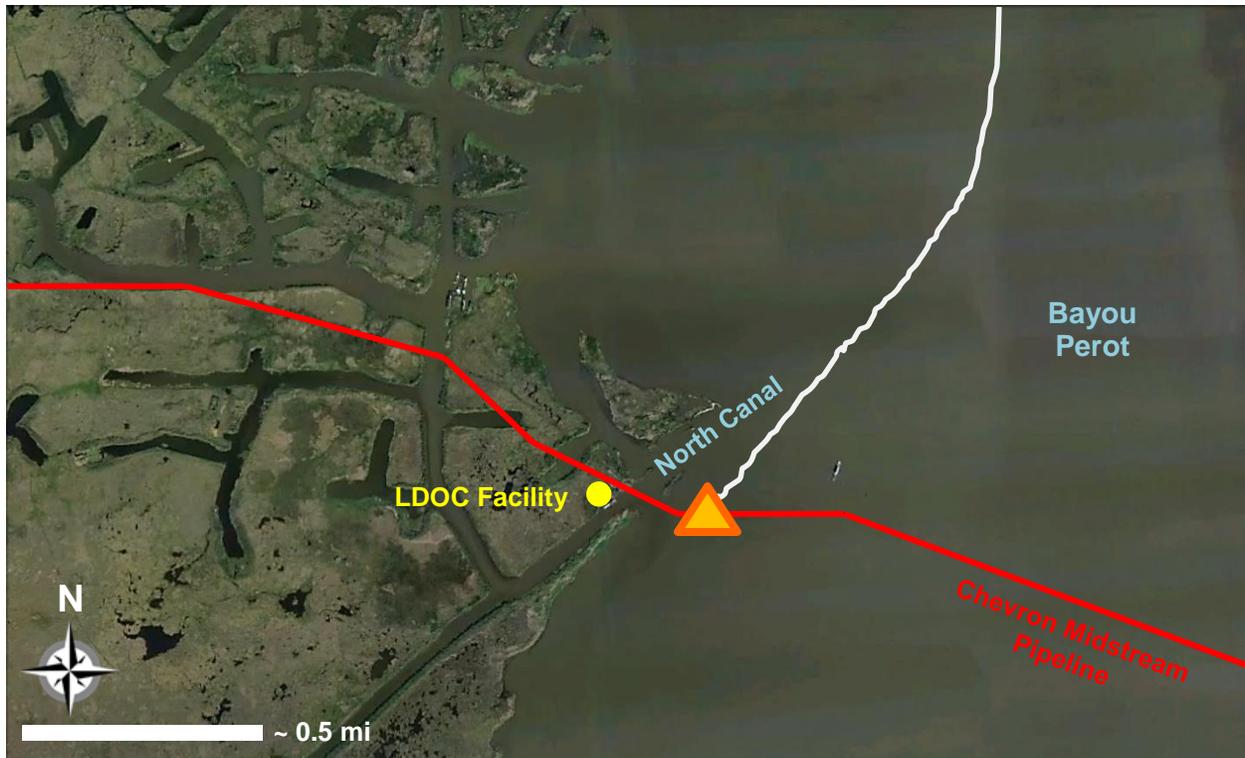
Close-up satellite image of Bayou Perot. The white line represents the vessel's approximate trackline and the approach slightly farther to the southeast that the captain chose. The red line represents the approximate location of the submerged pipeline. (Background by Google Earth)

Numerous active or abandoned oil and gas pipelines traverse this Louisiana region. When installed, the pipelines are surveyed to ensure that they are buried at an appropriate depth. However, over time their coverage can decrease due to storms, shoreline changes, etc., which makes voyage planning challenging and particularly reliant on up-to-date, accurate information. Many pipelines in the region do not appear on standard navigation charts and mariners do not know their exact locations.

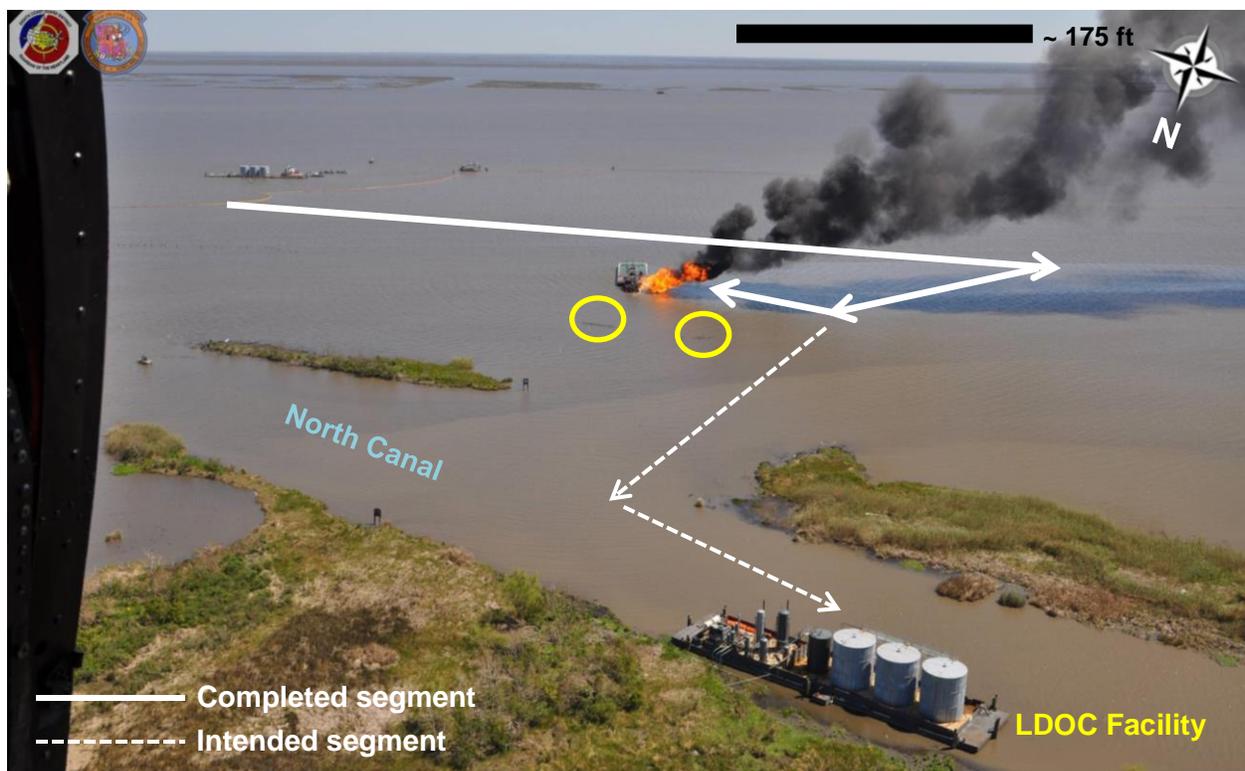
Photo of the area near the LDOC facility to which the tow was headed, looking southeast. Overlaid in solid and dashed white lines are the vessel's completed and intended transit segments (approximate). Overlaid in yellow circles are the obstructions in the water that the captain tried to avoid just before striking the submerged pipeline. (Photo by the United States Coast Guard)

Given the numerous pipelines in the area that present submerged hazards, and given that the locations of oil and gas facilities may be temporary and subject to change, it is essential that vessel companies provide their operators with up-to-date, well-researched information to ensure safe navigation. The *Shanon E. Settoon* captain attempted to avoid a visible hazard, but inadvertently struck a submerged one.

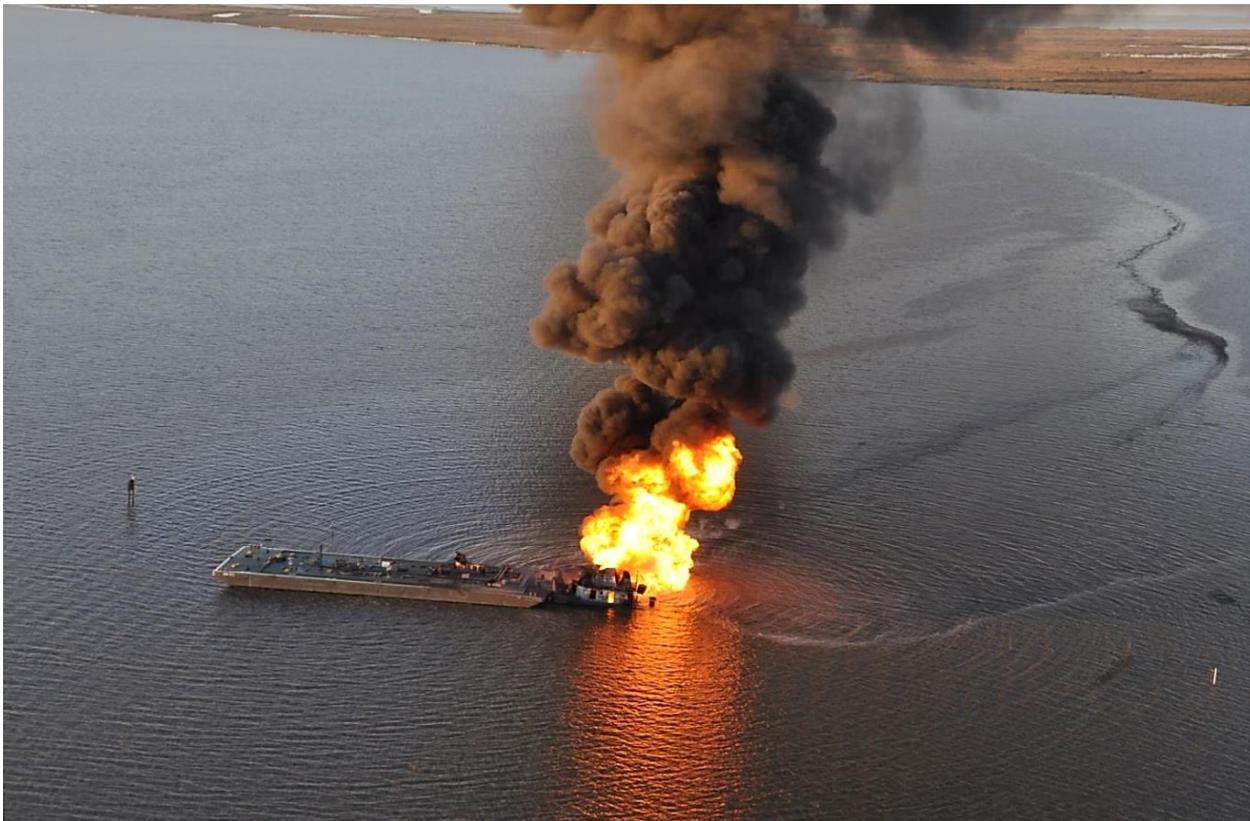
On realizing that the tow had struck an object, the captain notified the LDOC contractor and tried to maneuver away from the obstruction. A crewmember told investigators that, about that time, he twice heard a noise and saw a disturbance in the water that pushed the stern of the vessel upward. He and another crewmember began to head forward on the vessel toward the barge when he heard the captain say that he needed help shutting down the main engines to prevent a spark. The crewmembers began to walk aft when the main engines exploded and fire engulfed the *Shanon E. Settoon*. The captain and the three crewmembers abandoned the vessel. Two of the crewmembers retreated to the barge, while the captain—who was badly burned—and another crewmember ended up in the water and made their way to shore. Chevron shut off the pipeline; however, the remaining gas in the pipeline continued to burn for several days.

The ablaze *Shanon E. Settoon* and the barge *SMI 572*. An oil sheen can be seen on the water extending out from the tow. (Photo by the Coast Guard)

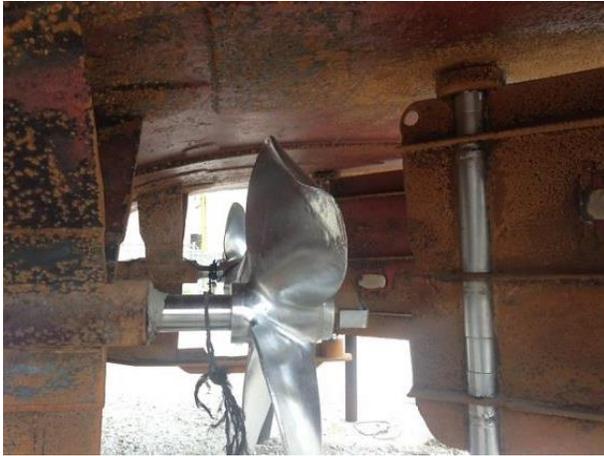
Left, the *Shanon E. Settoon's* damaged propeller blade during postaccident survey; right, the damaged pipeline and its protective casing. (Photos by the Coast Guard)

The *Shanon E. Settoon* was completely burned and declared a total loss. A survey revealed that the vessel's portside propeller had struck and penetrated the pipeline. When the gas reached the surface of the water, it was drawn into the main engines, where it ignited. The explosion caused an intense fire, which was fed by the escaping gas under pressure. The *Shanon E. Settoon* had about 1,000 gallons of diesel fuel on board, which was spilled in the accident.

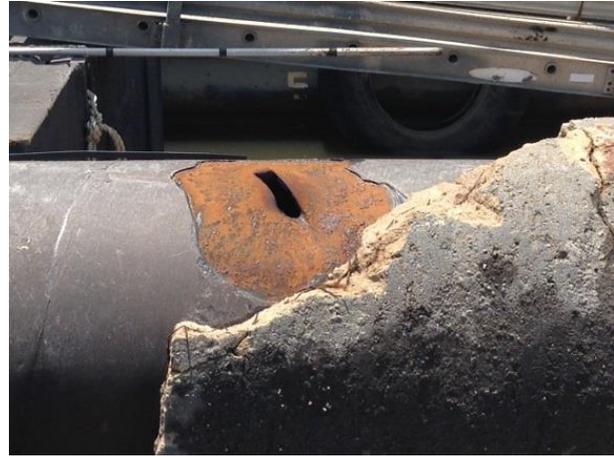
The National Transportation Safety Board determines that the probable cause of the explosion and fire on board the *Shanon E. Settoon* was the introduction of petroleum gas into the main engines after the vessel struck and ruptured a submerged pipeline due to incomplete navigational information provided to the captain by the vessel company.
