# National Transportation Safety Board

## Marine Accident Brief

### Allision of Towing Vessel *Bayou Lady* With Bayou Blue Bridge

<b>Accident no.</b>	DCA14LM004
<b>Vessel</b>	Uninspected towing vessel <i>Bayou Lady</i>
<b>Accident type</b>	Allision
<b>Location</b>	Houma, Louisiana 29°34.5' N, 90°36.2' W
<b>Date, time</b>	December 7, 2013 0630 central standard time (coordinated universal time – 6 hours)
<b>Injuries</b>	None
<b>Damage</b>	Est. \$715,000 (bridge)
<b>Environmental damage</b>	None
<b>Weather</b>	Wind north 13.8 knots, overcast sky, light rain, light fog, temperature 42°F
<b>Waterway information</b>	Gulf Intracoastal Waterway, mile marker 49.5

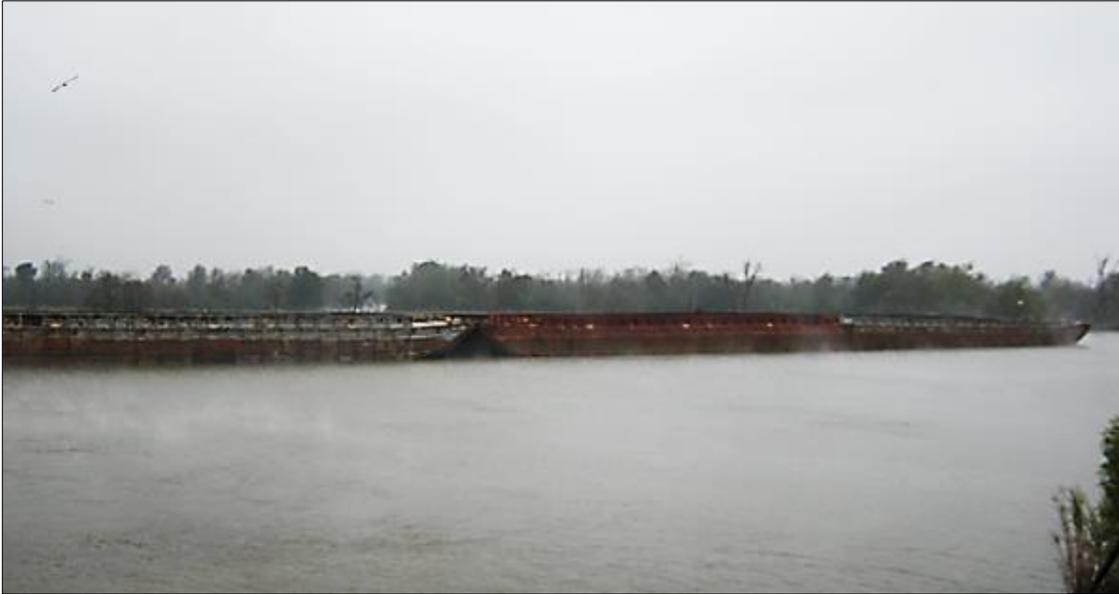
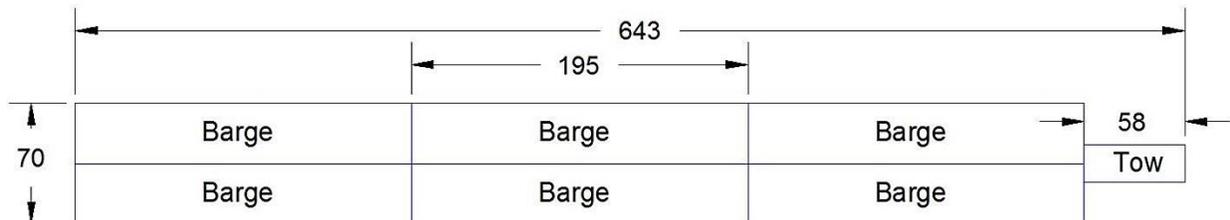
The six hopper barges were ahead of the *Bayou Lady* that morning in a 3x2 configuration: two side by side and three end to end. Each barge was 195 feet long and 35 feet wide; with the towing vessel length of 58 feet, the overall tow configuration was 643 feet in length and 70 feet wide.

**Flotilla of six barges, top, pushed by the *Bayou Lady* at the time of the accident and dimensions (in feet) of *Bayou Lady* tow and barge configuration, bottom. (Photo by Coast Guard)**

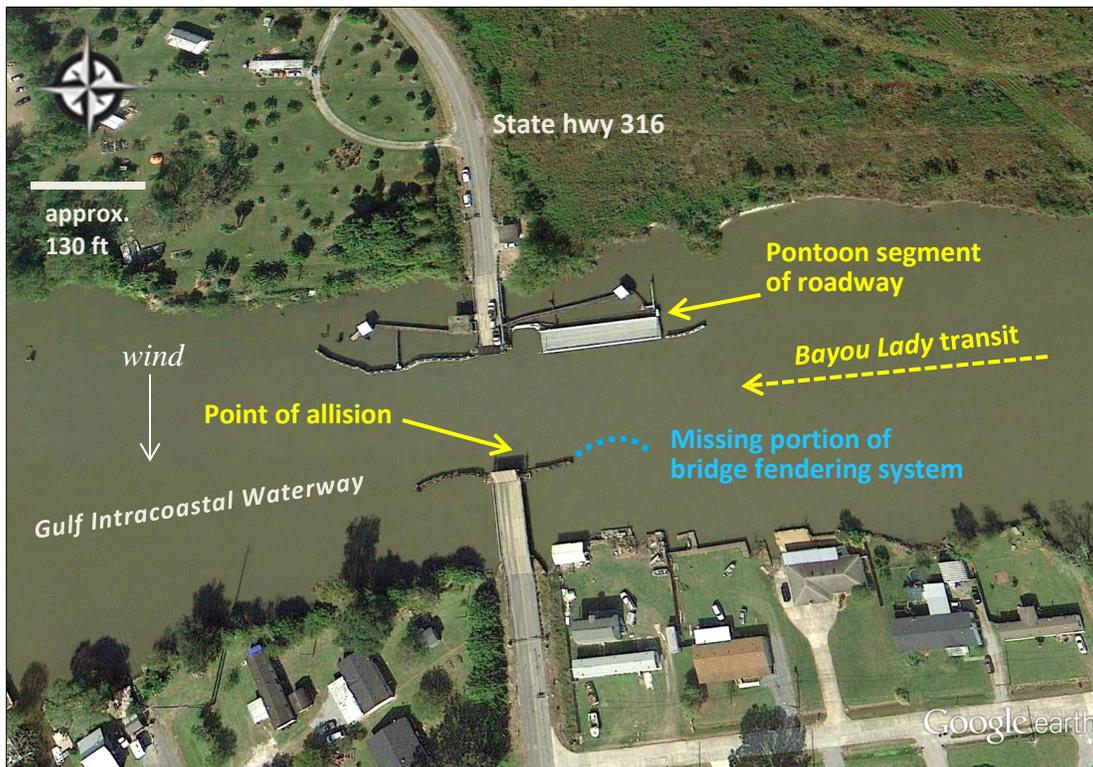
**Aerial view of Bayou Blue Bridge before the accident, in position to allow passage of marine traffic. Pontoon roadway is located to the right of state highway 316 on the north side of the Gulf Intracoastal Waterway. Dashed blue line opposite the pontoon indicates portion of the bridge fendering system missing since a previous accident. (Background by Google Earth)**

A wooden fendering system protects the fixed north and south sections of the bridge, bowing out into the waterway a few feet on either side, which reduces the navigable channel to about 126 feet wide. The *Bayou Lady*'s two-barge-wide configuration with a combined width of 70 feet would leave about 23 feet of clearance on either side of the barges while passing through the constricted area around the bridge.

A portion of the bridge fendering system had previously been damaged and was missing at the time of the accident, indicated in the aerial image above by the curved blue line directly opposite the pontoon. This portion of the fendering system—had it been in place—was designed to lessen or absorb the impact of an allision instead of the steel ramp and bridge structure receiving the majority of the strike.

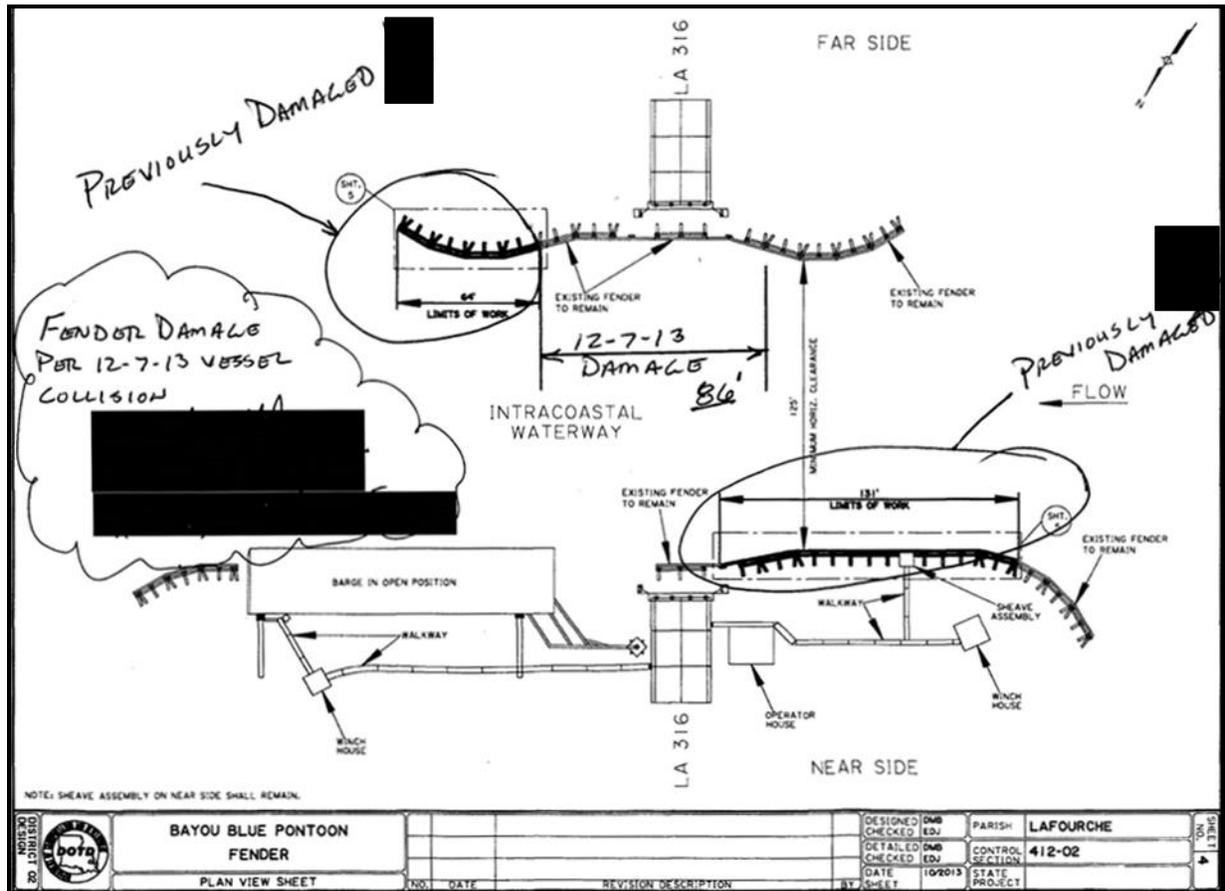
The bridge tender stated that the bridge opened normally for the *Bayou Lady* transit. The on-scene investigation found that wood pilings and much of the "bumper" structure on either side of the vehicle ramps were damaged, apparently due to previous strikes. Comparison with a drawing of the bridge and fendering system as designed indicated that a good portion of the structure had been knocked down before this accident and had not been replaced. Coast Guard records also showed the bridge had been struck on several occasions in the past, including a

Overhead plan view of Bayou Blue Bridge with Coast Guard record of areas damaged in the *Bayou Lady* allision and in previous incidents (image redacted). (Provided by Coast Guard)

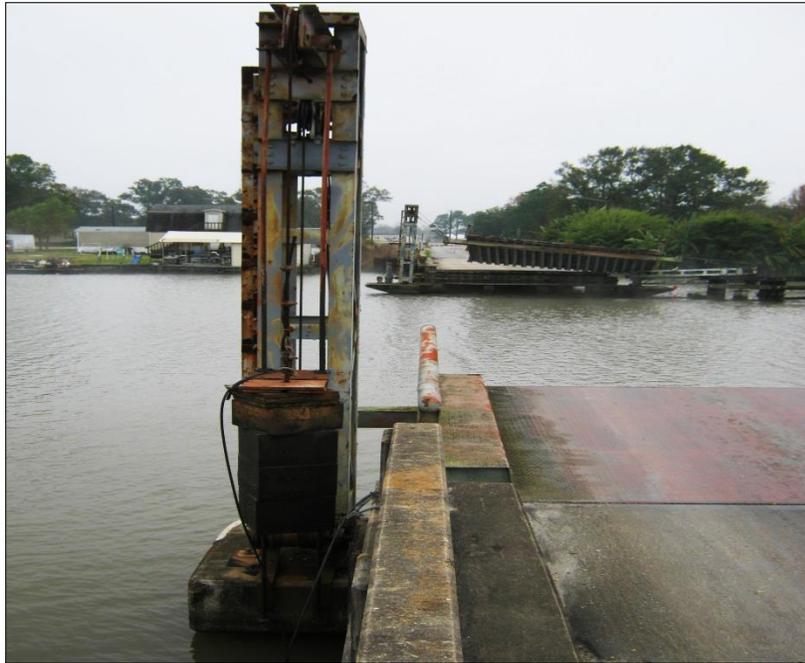
Bayou Blue Bridge after the accident, from north side of bridge ramp looking south at displaced ramp and wire lift tower lying on its side.

The National Transportation Safety Board determines that the probable cause of the allision of the *Bayou Lady* tow with Bayou Blue Bridge was the decision of the captain to transit the bridge opening in windy conditions and the reported temporary loss of steering control after the rudder was fouled by submerged debris.
