# National Transportation Safety Board

## Marine Accident Brief

### Allision and Sinking of Offshore Supply Vessel *Celeste Ann*

| <b>Accident no.</b> | DCA13NM025 |

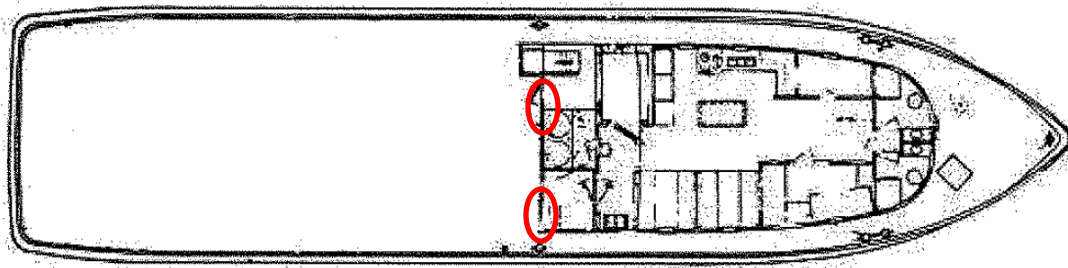
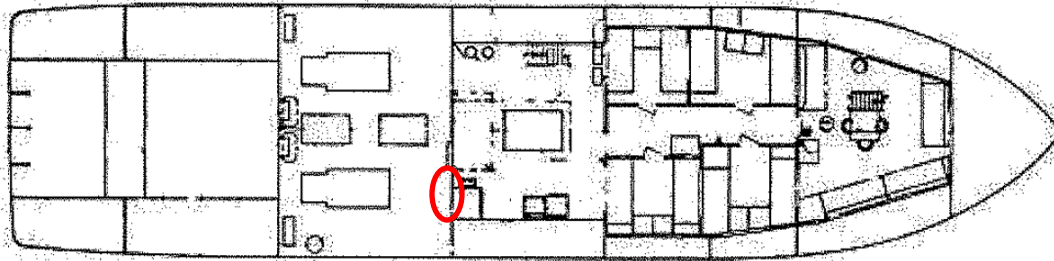
About 0900, another offshore supply vessel, the *Oddysea Endeavor*, pulled alongside the *Celeste Ann* to assist. By 0910, the *Celeste Ann* lost electrical power and, as a result, lost steering capability, and all passengers and crew evacuated to the *Oddysea Endeavor* by 0915. With watertight doors left open, progressive flooding ensued, and the *Celeste Ann* sank about 1000.

Layout of the *Celeste Ann* main deck and below deck. Watertight doors (red ovals), two on the main deck and one on the below deck, separated the engine room from the pump room. All three watertight doors were left open after the junior master checked the engine room following the allision. (Drawing provided by Coast Guard)

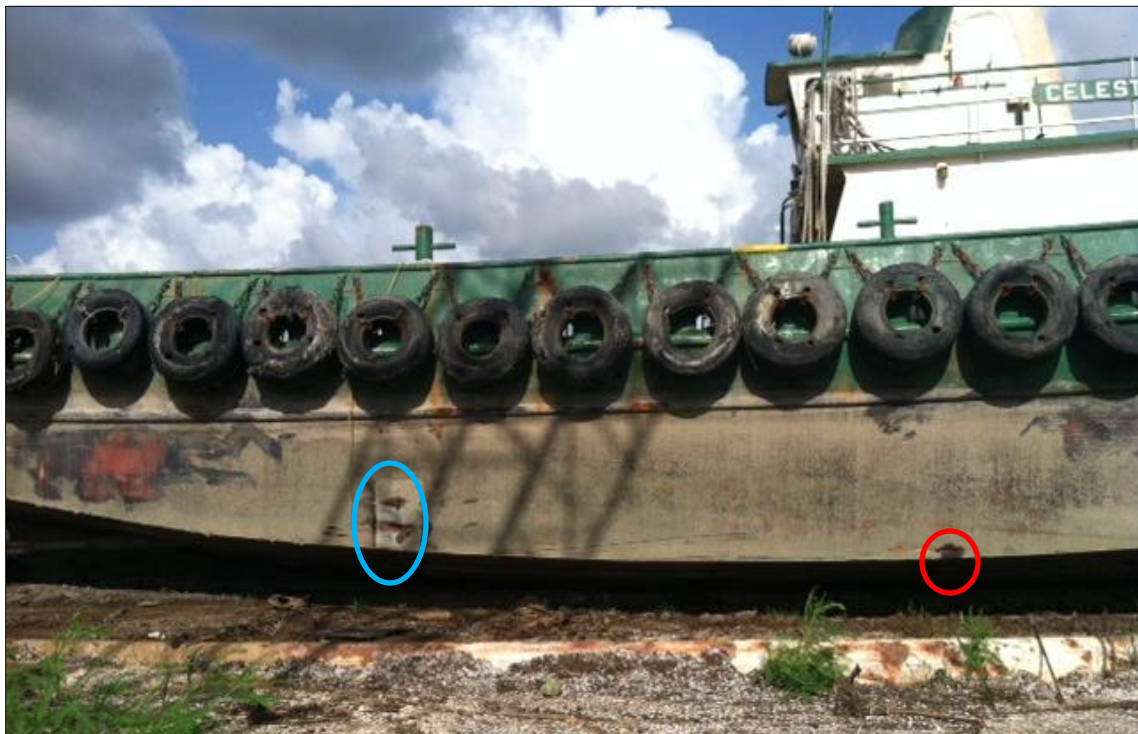
About a month later, the owners of the *Celeste Ann* decided to salvage the vessel, and it was raised and brought to Morgan City, Louisiana, for repairs. A damage survey determined that the initial impact with the landing platform resulted in a 2-inch-wide hole about 7 feet below the waterline near the pump room. The second impact resulted in two holes in the engine room—one about 1 inch in diameter located 6 feet below the waterline and another about 12 inches by 1 inch about a foot below the first. The Coast Guard estimated the total flooding rate to be greater than 1,000 gallons per minute. Estimated costs to salvage and repair the vessel were \$1 million.

Damage to starboard side of the *Celeste Ann*. The first impact punctured the hull along the vessel's chine in the area of the pump room (circled in red at right). The second impact caused two punctures to the hull near the engine room (shown circled in blue at left). (Photo by Coast Guard)

The platform owner conducted an underwater survey of the landing area on the West Delta 73A platform after the accident. The survey noted that a vertical pipe on the platform was arranged with a clamp attaching the vessel landing to the platform. The clamp had two horizontal protrusions that extended off the vertical pipe that likely punctured the hull of the *Celeste Ann*.

The National Transportation Safety Board determines that the probable cause of the allision of the offshore supply vessel *Celeste Ann* with West Delta 73 platform A was the inability of the junior master to compensate for and overcome wind forces that pushed the vessel into the platform. Contributing to the hull breach and subsequent sinking of the *Celeste Ann* were underwater protrusions from the platform and open watertight doors on board the vessel.
