# National Transportation Safety Board

## Marine Accident Brief

### Fire on Board Saturation Diving Support Vessel *Ocean Patriot*

<b>Accident no.</b>	DCA14LM003
<b>Vessel name</b>	<i>Ocean Patriot</i>
<b>Accident type</b>	Fire
<b>Location</b>	Gulf of Mexico, about 50 miles south-southwest of Port Fourchon, Louisiana 28° 13.1' N, 090° 23.4' W
<b>Date, time</b>	November 28, 2013 2215 central standard time (coordinated universal time – 6 hours)
<b>Injuries</b>	None
<b>Damage</b>	\$9.8 million
<b>Environmental damage</b>	None
<b>Weather</b>	Clear, visibility 10 miles, winds 10 knots, seas 1–3 feet
<b>Waterway information</b>	Gulf of Mexico

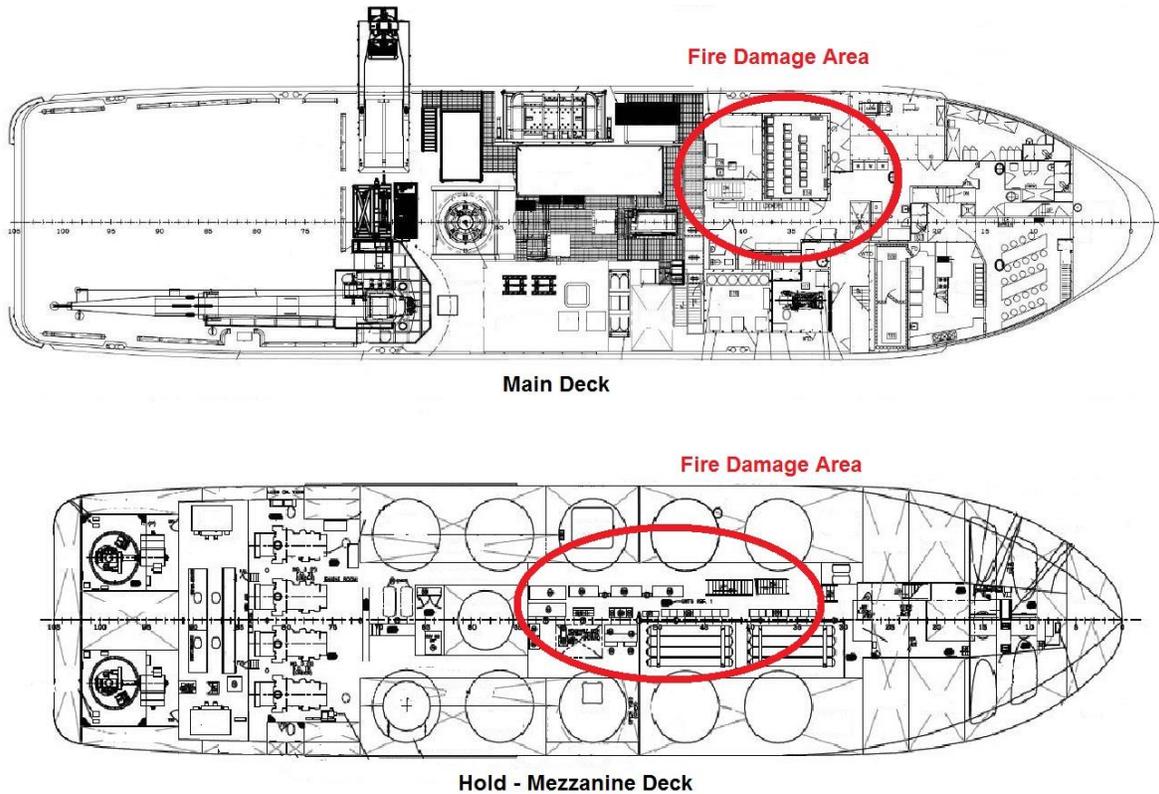
According to the assistant engineer, the fire was located in a cable tray above an electrical motor control center; the area directly underneath the cable tray was used for storing sundry items such as cardboard and air filters. He was first on the scene and attempted to fight the fire with a portable extinguisher, emptied the unit, but was not able to extinguish the fire. He returned to the engine room using an emergency escape hatch to muster with the rest of his department. On the bridge, the chief mate called the captain, rang the general alarm, and made a public address announcement to inform the crew of the situation. When the captain arrived on the bridge, he was briefed by the watch team and then notified the company via satellite phone, sent a distress signal via Global Maritime Distress and Safety System (GMDSS), ordered the ship's heading to be put into the wind, and directed the crew to be mustered. The captain then went below to the scene to assess the situation. Upon return, he ordered mayday to be called over the VHF radio. The crew gathered at their muster location, and all were accounted for. The fire teams assembled at their respective fire gear lockers.

Schematic drawings indicating location of fire damage on the main deck, top, and the mezzanine deck, bottom. (Drawings courtesy Oceaneering International)

About 15 minutes after the FM-200 was released, the chief engineer entered the change room directly above the fire to monitor the temperature of the deck. The deck was smoking and had buckled due to the heat, and the steel deck appeared to be breached. He used a fire axe to break cement above the steel deck to allow cooling water to be applied directly onto the steel; the water was continuously applied to the deck and temperatures began to drop. The crew consulted the FM-200 manual and was advised not to enter the space where the chemical was discharged.

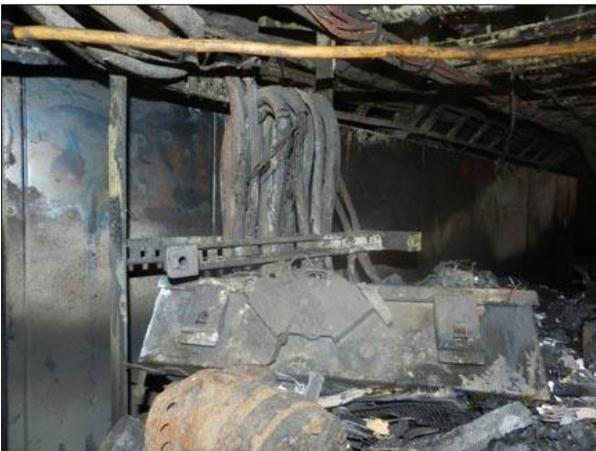
Oceaneering International hired an integrated forensic engineering investigation firm to conduct a survey of the damage to the vessel. The firm determined that the source of ignition was damaged electrical cables located in a cable tray that contained combustible material in storage racks just below. The fire damaged motor control centers and their associated cabling, helium storage bottles, a ventilation trunk, and various piping systems. Considerable smoke and soot damage was found in the machinery space, and the diving deck equipment stored there was also damaged. A main generator and frequency drive sustained water damage, and heat from the fire caused severe buckling to the main deck in the changing area.

Damaged electrical cables and cable tray, left, and motor control center, right.  
(Photos courtesy Oceaneering International)

The National Transportation Safety Board determines that the probable cause of the fire on board the *Ocean Patriot* was damage to electrical cables due to the tightly installed metal securing bands in a cable tray chafing the protective layers of the cables and creating an ignition point. Contributing to the extensive damage was the combustible material stored immediately below the cable tray area, fueling the fire.
