National Transportation Safety Board Marine Accident Brief

Collision of Bulk Carrier *Mesabi Miner* and US Coast Guard Cutter *Hollyhock*

Accident no. DCA14PM005

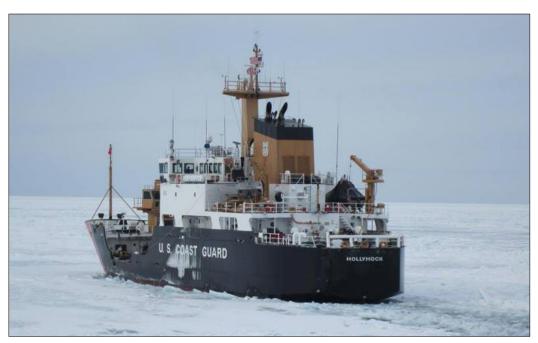
Coast Guard cutter *Hollyhock* returns to St. Ignace, Michigan, following collision with the bulk carrier *Mesabi Miner*. (Photo by Coast Guard)

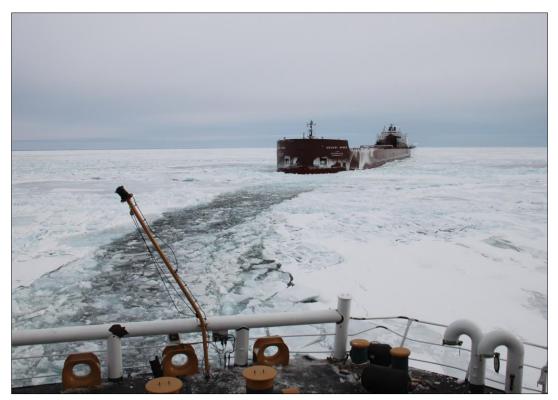
Mesabi Miner seen from the stern of the Hollyhock after the collision. (Photo by Coast Guard)

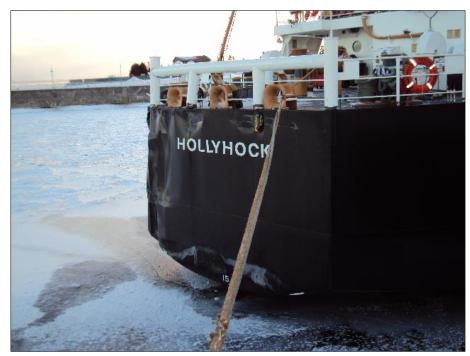
Damage to the *Hollyhock* was estimated at \$244,145, and the cutter was lost to icebreaking duties for a few weeks while repairs were completed. Damage included structural framing at the stern and port quarter in the steering gear room, aft laundry, stern thruster space, fantail, and railing. The hull was punctured in two small areas about 20 feet above the waterline.

Damage to the left side of the cutter *Hollyhock*'s stern, where the steel was inset and displaced by the force of the collision with the bow of the *Mesabi Miner*.
