National Transportation Safety Board

Marine Accident Brief

Allision of Bulk Carrier *Anna Smile* with Louis Dreyfus Grain Elevator

Accident no.	DCA14LM013
Vessel name	<i>Anna Smile</i>
Accident type	Allision
Location	Louis Dreyfus Grain Elevator dock, Woodhouse Terminal, Houston, Texas 29° 43.16' N, 95° 14.22' W
Date, time	July 14, 2014 0504 central daylight time (coordinated universal time – 5 hours)
Injuries	None
Damage	Grain elevator: approx. \$2.5 million <i>Anna Smile</i> : estimate not provided
Environmental damage	None
Weather	Light winds 4 knots, visibility 10 miles, air temperature 79° F
Waterway information	Houston Ship Channel

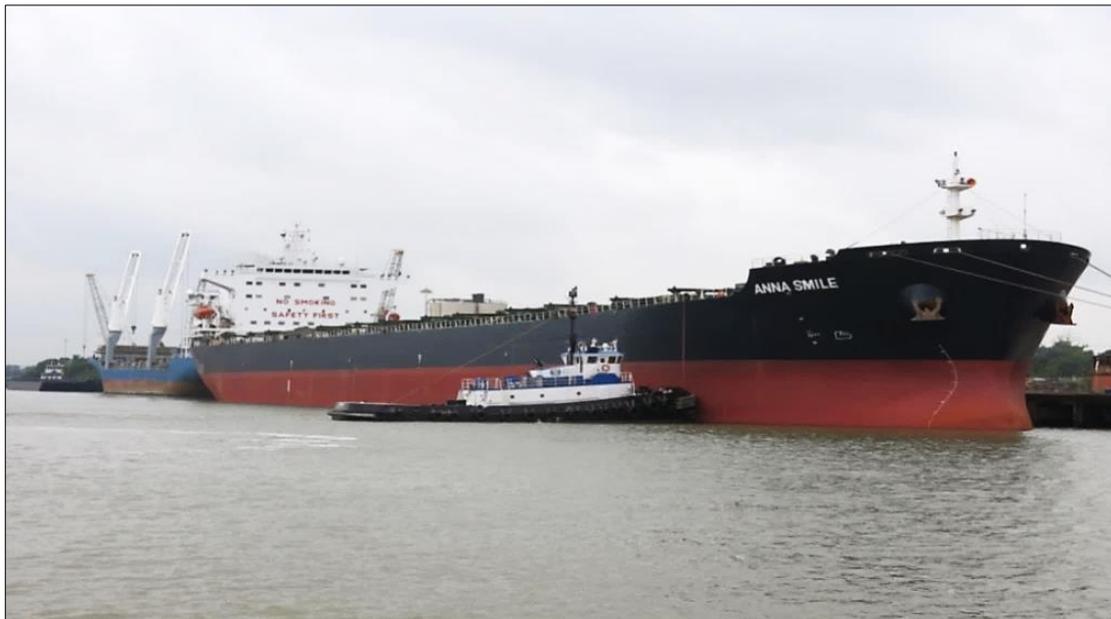
After the accident, the bulk carrier *Anna Smile* was berthed in the Houston Ship Channel upriver from the site of the allision.

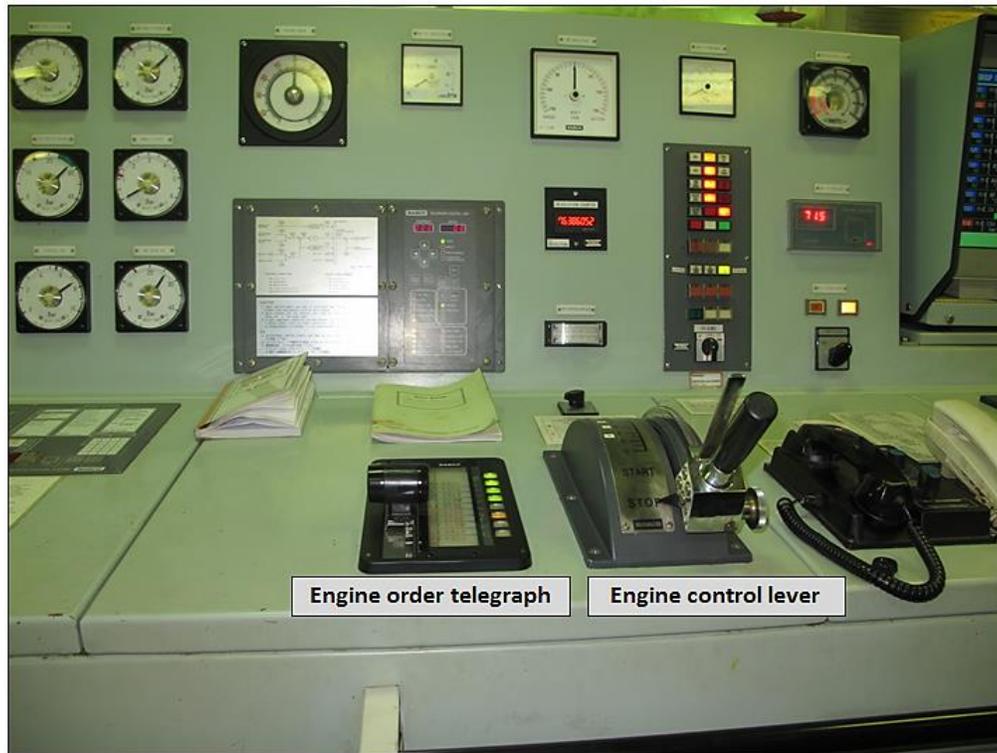
next order was dead slow astern, but when the chief engineer moved the engine control lever, the engine failed to remotely start as expected. Two more astern commands were given from the bridge—slow astern and half-astern—both with no response from the engine, despite the chief engineer's command inputs to the engine control system. The chief engineer did not advise the captain that he was having difficulty starting the engine.

Anna Smile ECR engine order telegraph and main engine control lever.

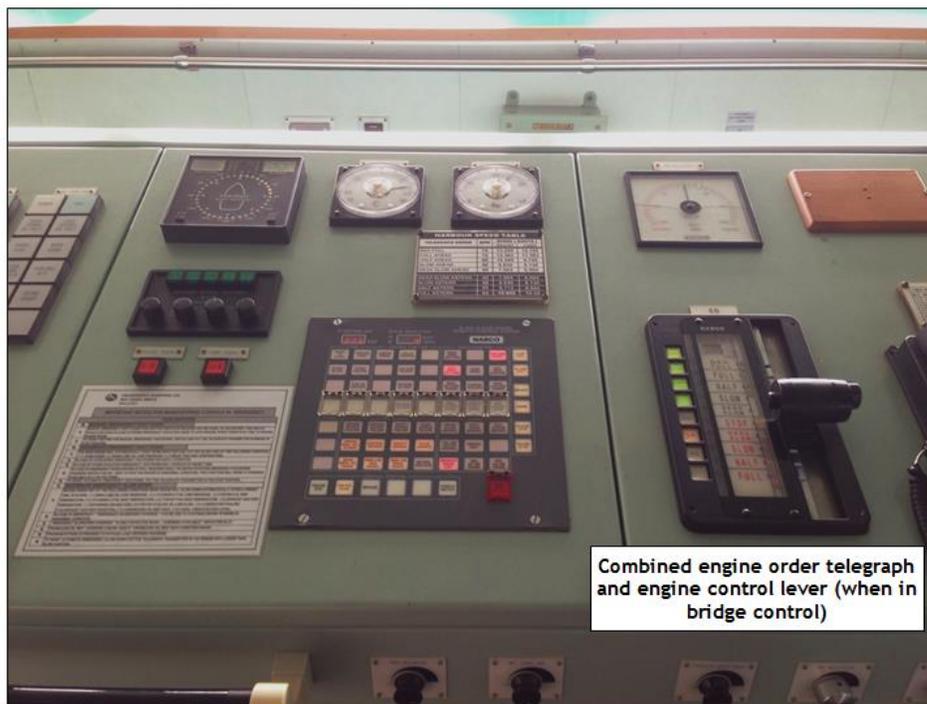
Anna Smile bridge engine control.

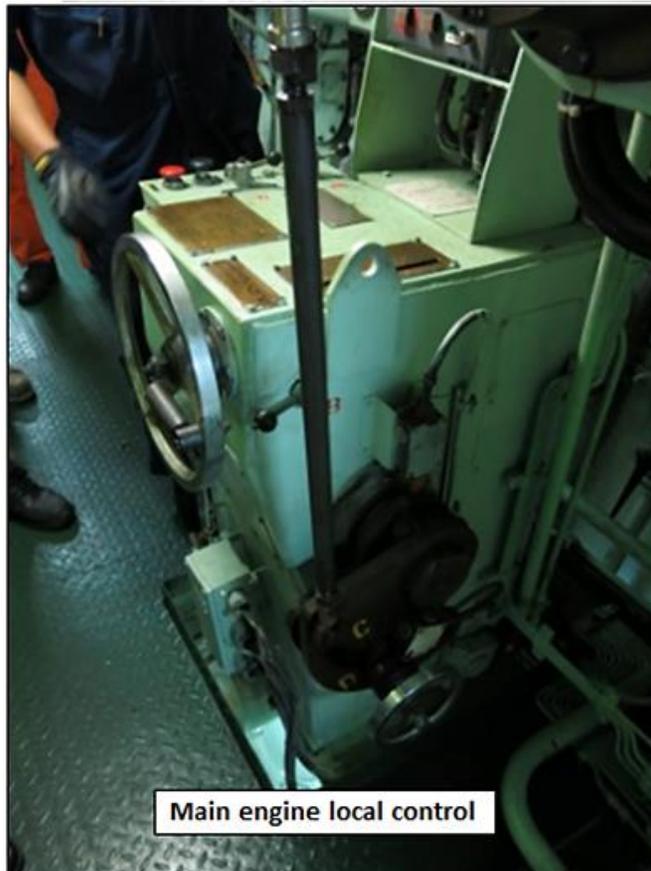
After completing the steps to engage the local control station, the chief engineer started the engine at the dead slow ahead speed of 40 rpm despite the current stop command. Dead slow ahead was the last command that he was aware of before leaving the ECR, but the command had changed from ahead to stop while he was changing the engine control mode. The engine continued to run in the ahead direction for about 1 minute until the chief engineer was told to stop the engine by the second engineer who ran down from the ECR and relayed the stop command he had received from the bridge via the ECR phone. When the chief engineer was asked why he did not use the local phone located directly behind him, he stated that the bridge called the ECR and it was too loud in the machinery space to hear the local phone behind the emergency control station.

Local control station at the side of the main engine.

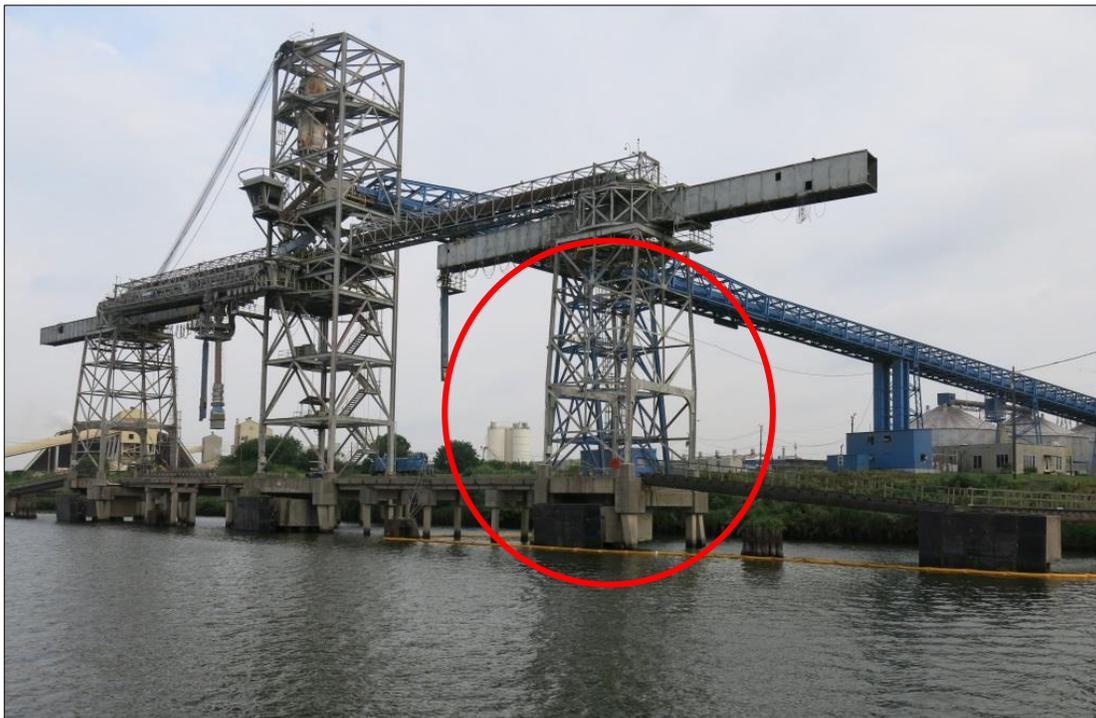
Damage to the grain elevator's east tower was estimated at \$2.5 million. Horizontal and vertical steel structural supports on the grain elevator's structure were damaged, concrete pads were cracked, and a rubber fender was bent from the impact. To repair the elevator tower, contractors were required to remove and replace the entire upper section of the tower from the base, including the conveyor and carousel; fabricate four new legs of the lower structure; repair the bent fender and bent steel in the upper section; and replace the damaged concrete pedestals and dock area.

Louis Dreyfus Grain Elevator east tower, which was damaged in the allision.

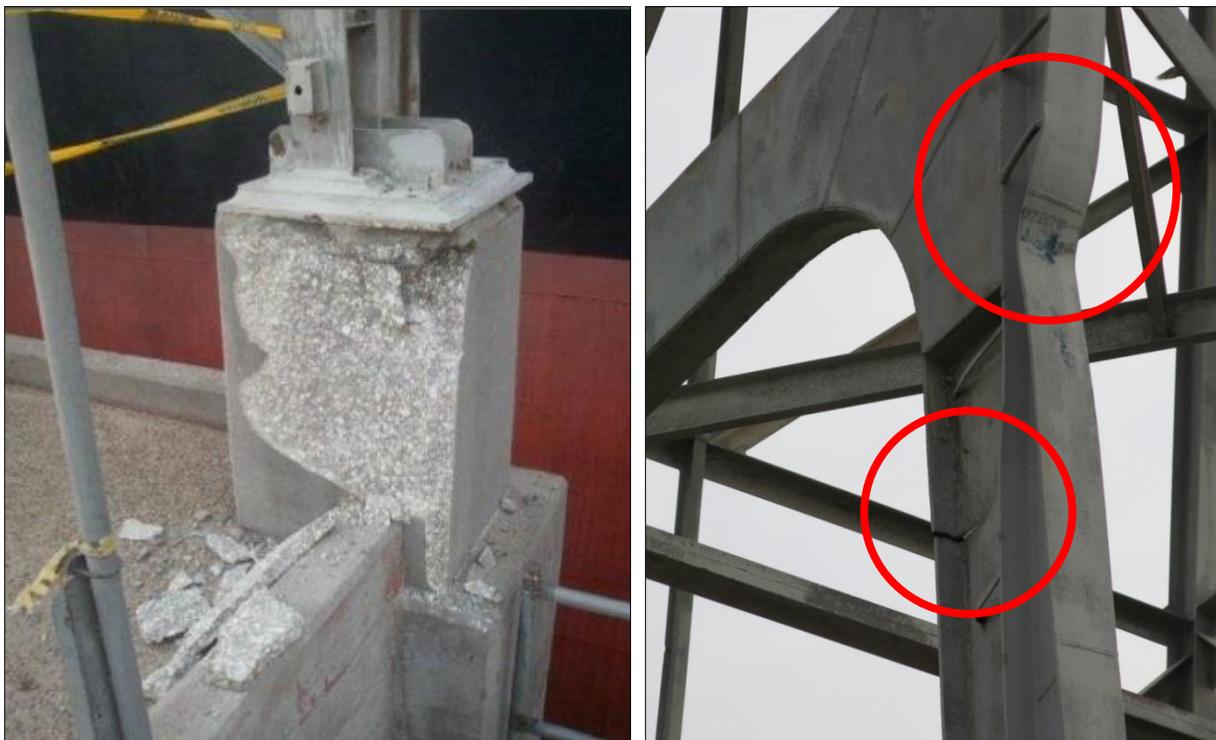
Close-up of a damaged concrete pedestal (left) at the Louis Dreyfus Grain Elevator and a cracked weld and bent I-beam on a vertical support (right). (Left photo by Coast Guard)

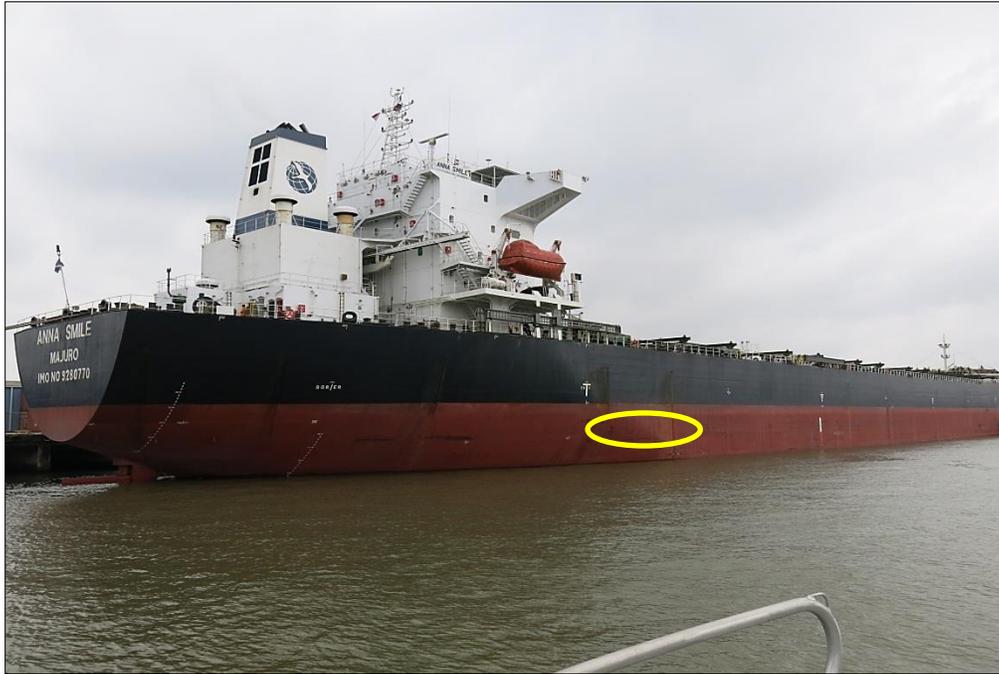
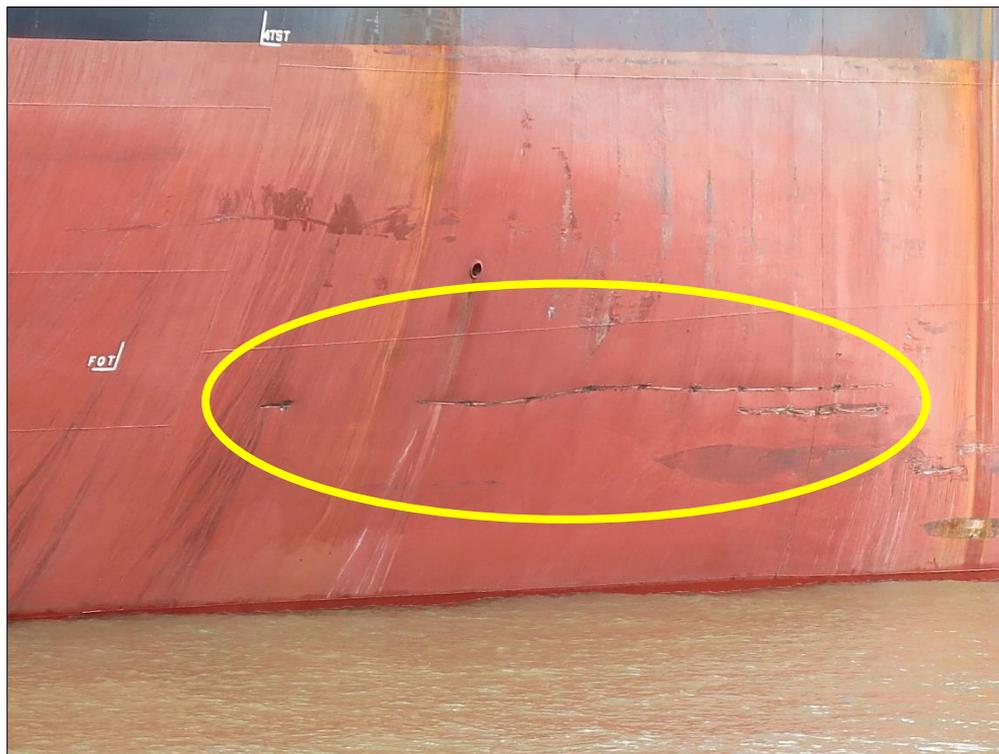
The *Anna Smile* sustained minor scraping and a 2-inch inset of the hull plating for about 11 frames (30 feet) as the ship moved forward while in contact with the grain elevator. The damage estimate for the ship has yet to be determined, but the classification society recommended that the insets be repaired by June 2017, which is the next regularly scheduled dry-dock period.

Damaged area of *Anna Smile* hull (top) and close-up of vessel frames 41–52.
