# National Transportation Safety Board

## Marine Accident Brief

### Sinking of Tank Barge *Nash*, Towed by Towing Vessel *Calvin*

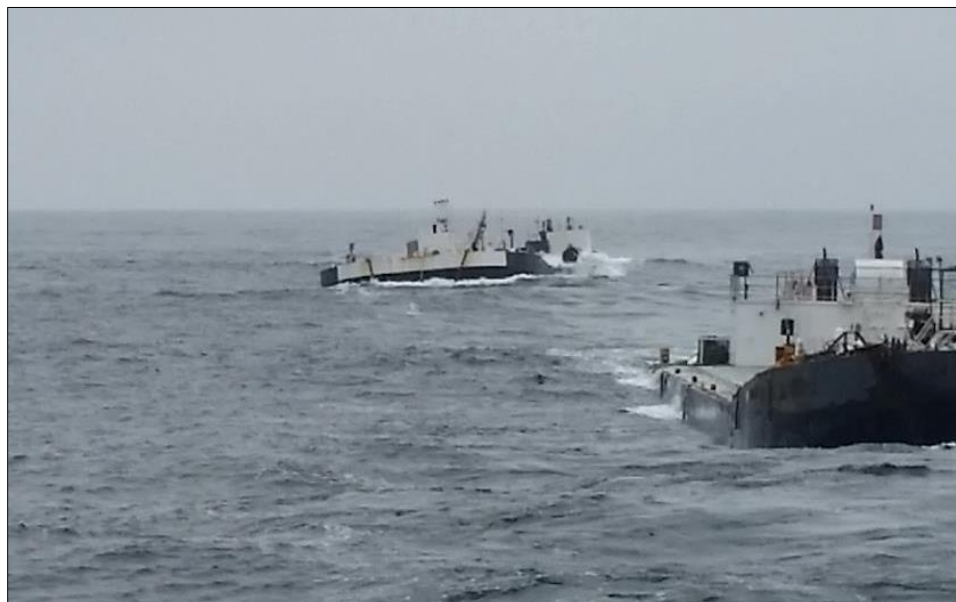
Barges *Nash* (left) and *Kenny* under tow on the afternoon of the accident. The *Nash* is heeled to its starboard side. (Photo by Salmon Bay Barge Line)

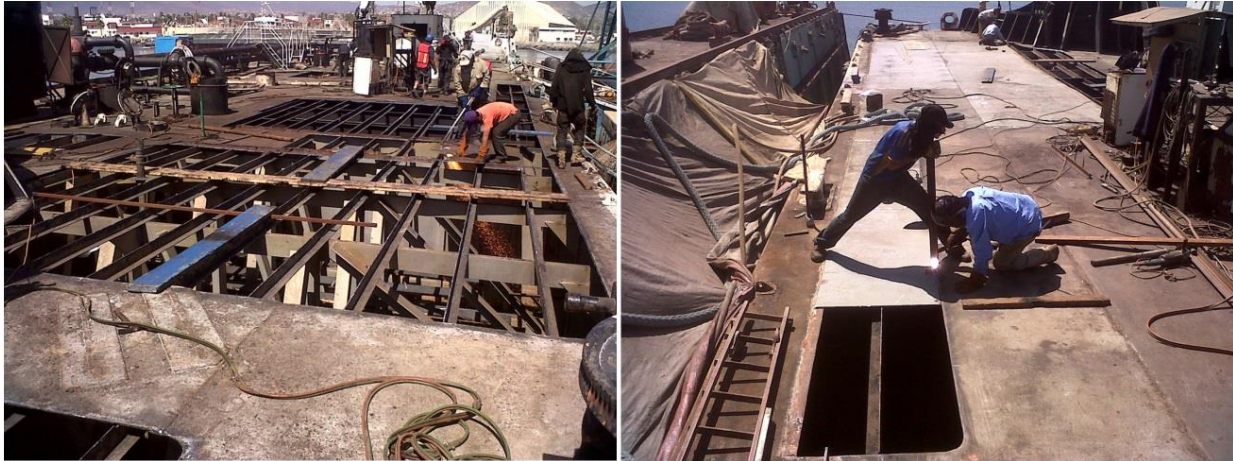
After arriving in Ensenada in late April 2014, a different ABS surveyor ordered additional ultrasonic testing of the barge hull and further repairs were required. The additional visual and ultrasonic testing revealed more areas of pitted and thinned hull and about 280 feet of wasted weld seams at various locations of the bottom plating. The ABS surveyor required that these areas of plating be cropped out and new sections of plate installed. At the aft end of the barge (the transom), several areas of the hull were found to be pitted, and they were repaired by building-up with weld material (clad weld). Also at the stern, the ABS surveyor found that the vent pipe for the aft starboard void tank was holed and that the ball was seized within the gooseneck. (The aft void tanks' vent pipes were of the gooseneck type with the inverted ball checks to prevent the intrusion of water into the void space.) The seized ball was freed, and the affected section of pipe was cropped, renewed, and tested for watertight integrity. A deckhouse fitted at the aft starboard-side end of the barge was permanently removed. Finally, four of six cargo expansion trunks were found to be wasted beyond ABS limits and were renewed.

**Barge *Nash* in the Ensenada shipyard during renewal of main deck plating. (Photos by SBBL)**

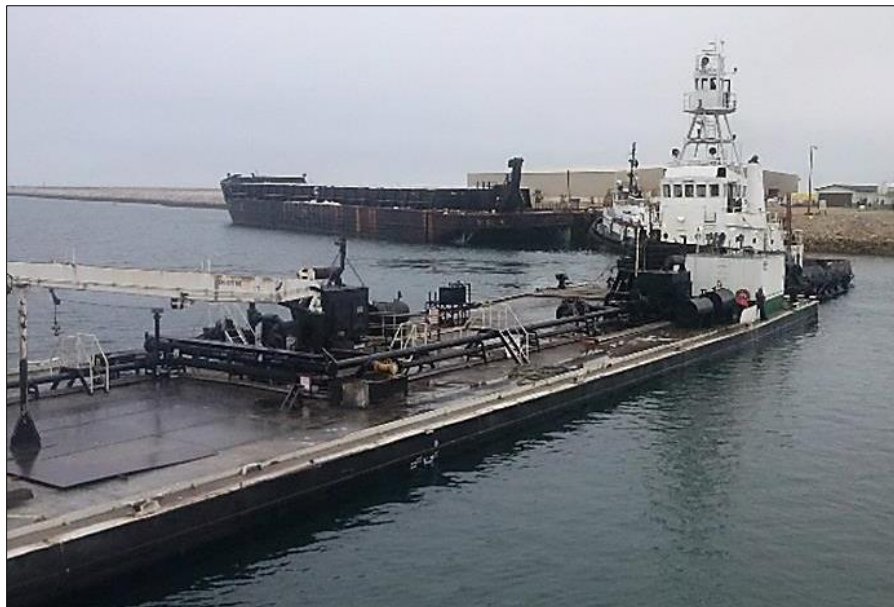
Barge *Nash* after loading at Guerrero Negro, Mexico.  
(Photo by Exportadora de Sal, SA)

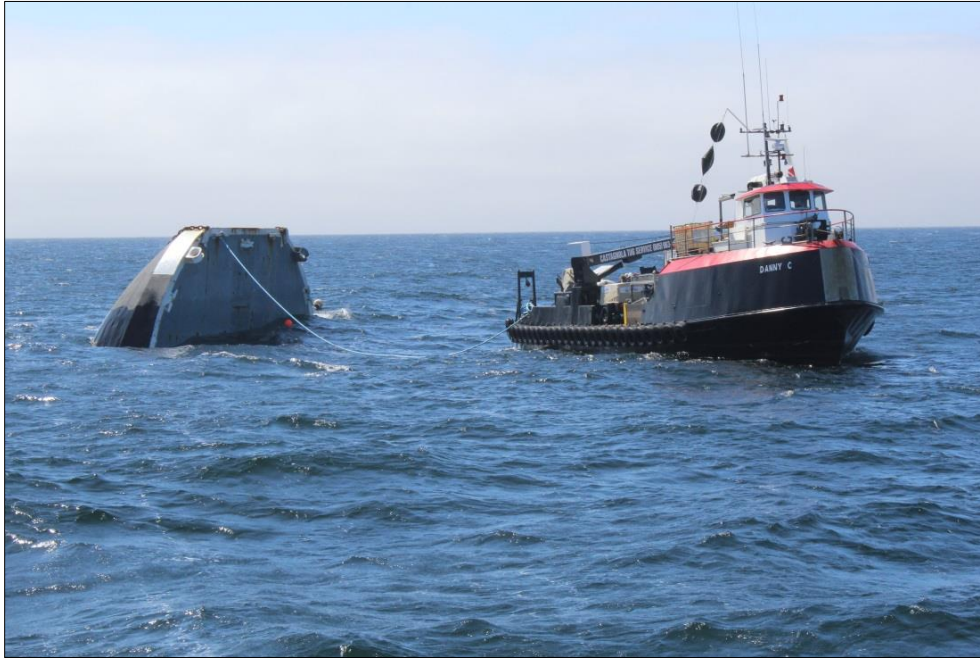
Dive boat *Danny C* (right) engaged in salvage operations of the *Nash* and the bow of the *Nash* (left) protruding vertically about 15 feet above the sea.

Salvage operations to refloat the *Nash* began the day after its sinking. On June 10, the salvage team deployed a remotely operated vehicle (ROV) to assess the condition of the barge. The ROV dive operation first detected the signs of hull damage at a water depth of 117 feet, about 131 feet aft of the bow. The side shell of the hull at the no. 2 port-side cargo tank was observed by remote camera and sonar readings to be significantly deflected inward. Further aft along the hull, at a water depth of 150 to 165 feet, tears in the side shell and a 15-foot-long fracture along the turn of the bilge were observed.

At a 176-foot water depth, the main deck was seen to be compressed downward into the hull about 5 feet, and at a 214-foot water depth, the side shell was completely compressed inward. The extent of the damage to the side shell indicated failure of the transverse bulkheads between port-side cargo tanks nos. 2 and 3, as well as the bulkhead between portside cargo tank no. 3 and the aft port-side void tank.
