# National Transportation Safety Board

## Marine Accident Brief

### Sinking of Towing Vessel *Jim Marko*

<b>Accident no.</b>	DCA14LM011
<b>Vessel name</b>	<i>Jim Marko</i>
<b>Accident type</b>	Sinking
<b>Location</b>	Upper Mississippi River, mile marker 181.6, near St. Louis, Missouri
<b>Date</b>	July 1, 2014
<b>Time</b>	About noon central daylight time (coordinated universal time – 5 hours)
<b>Injuries</b>	None
<b>Damage</b>	Repairs (not attempted) were estimated to exceed the vessel's insured value of \$800,000
<b>Environmental damage</b>	Undetermined amount of diesel and lube oil released into the waterway
<b>Weather</b>	Mostly cloudy, 82°F, visibility 10 miles, west winds at 8 mph
<b>Waterway information</b>	The Mississippi River stage was 24.85 feet on the St. Louis gage of the day of the accident (high water is 20 feet and flood stage is 30 feet). The current was about 7–8 knots.

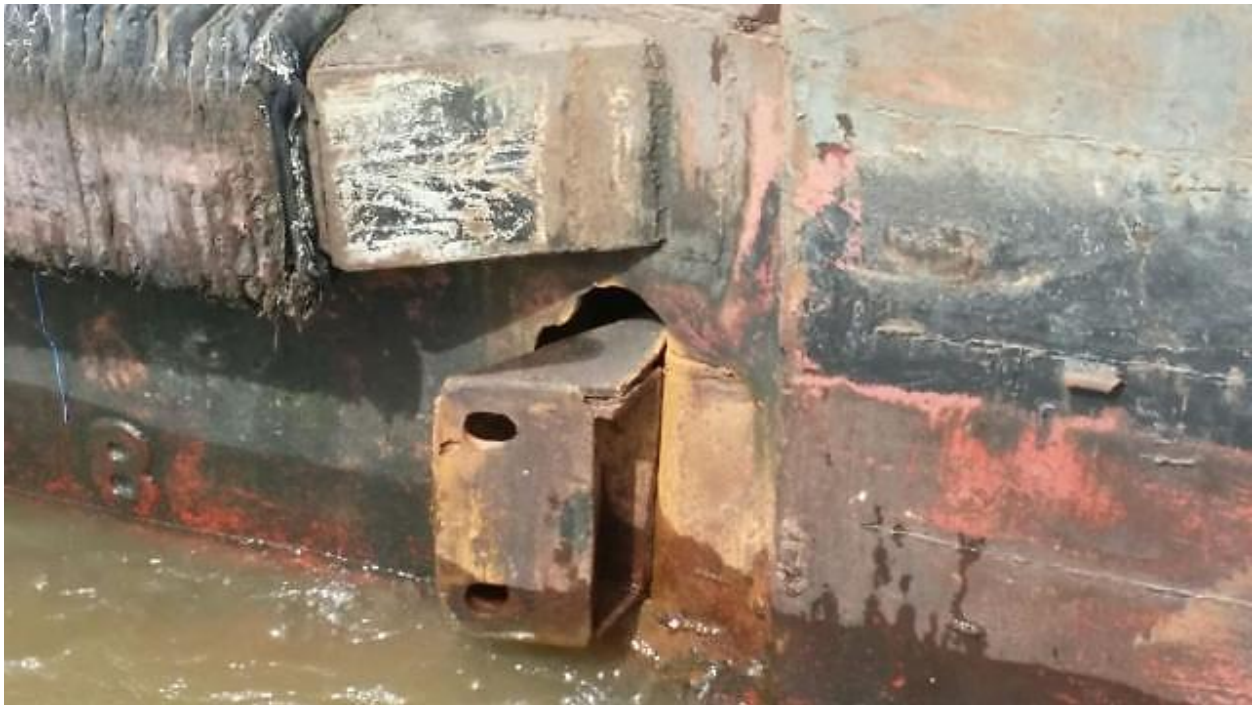
Crewmembers told investigators that, about 1030 at the A&D fleeting area, one of the deckhands noticed a hole on the *Jim Marko*'s starboard side below the rub rail and about 3 feet aft of the turn of the bow. The captain, who was operating the vessel at that time, asked the mate to photograph the hole with his cellphone so that he could see it. The captain looked at the photo, told the mate he would report the hole to the company, and continued operations.

Cellphone photo, taken by one of the *Jim Marko*'s deckhands, showing the hull breach on the vessel's forward starboard side.

The mate told investigators that he checked the bow void and no water was entering from the hole at that time. The vessel then went to the KMI fleeting area at mile marker 178.5 to top (turn) around a barge. After turning the barge, the *Jim Marko* (without any barges, or "light boat") began to travel upriver toward the Venice fleeting area. According to the captain, the vessel developed a slight list to port as it continued toward Venice. About 1115, while still under way, the deckhand began pumping out the stern void to level the vessel out. After the stern void was pumped, the crewmembers noticed that the vessel felt like it was down by the bow. About 1130, they opened the bow hatch to check the bow void and found it quickly filling with water. They attempted to pump the void but were unable to keep up with the flooding. Water was soon coming over the bow and the vessel began listing to starboard.

- **Watertight Integrity:** A hole in the side shell of a vessel, especially a large one near the waterline, poses a serious risk. When a potential hull breach has been identified, operations should be halted until repairs can be made or the crew can determine that the damage does not affect seaworthiness.

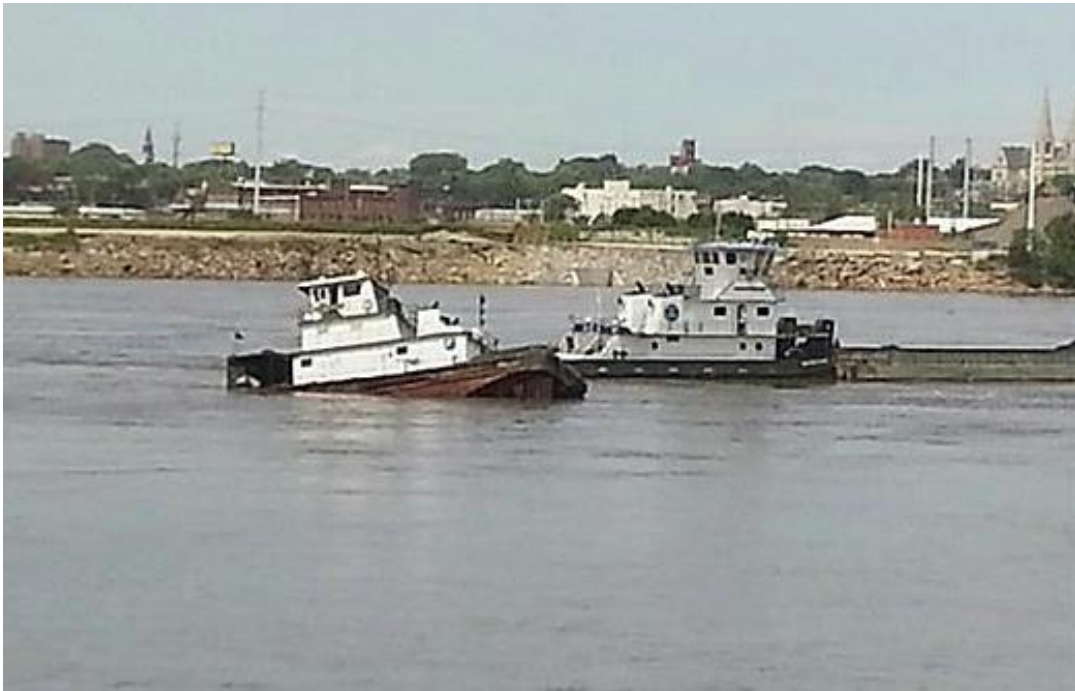
The *Miranda Paige* captain told investigators that he did not keep a line on the *Jim Marko* because it was sinking so quickly and he was afraid it would pull down the *Miranda Paige*'s barge or damage it. Within minutes, the *Jim Marko* sank completely.

Photo of the *Jim Marko* (left) sinking. The *Miranda Paige* and a section of its barge are visible in the background. (Photo by KMOV St. Louis)

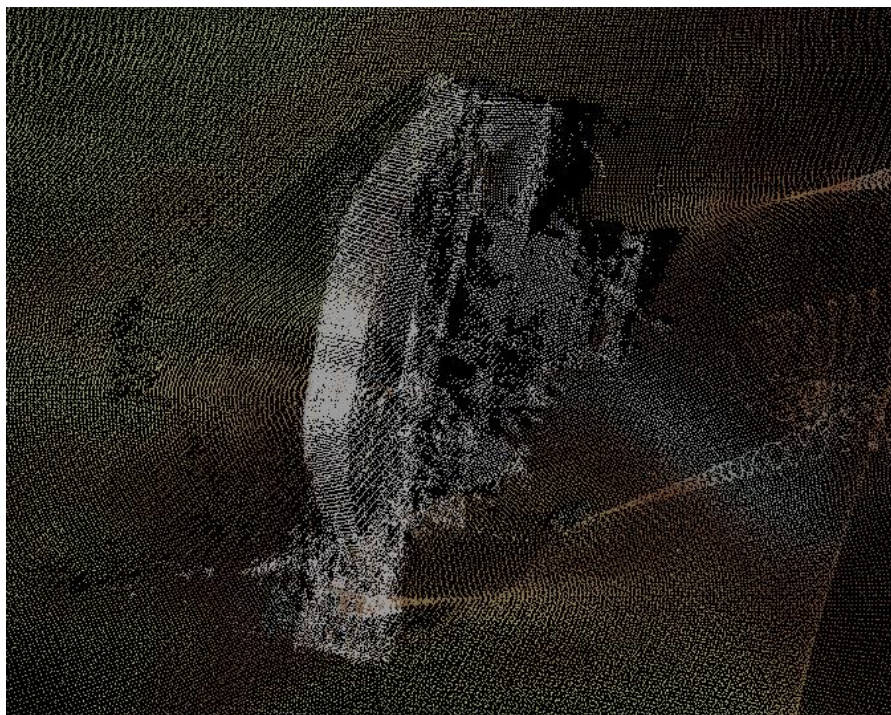
Side scan sonar images taken after the accident showed the towboat resting on its starboard side on the bottom of the river.

Side scan sonar image of the *Jim Marko*. (Photo by the US Army Corps of Engineers)

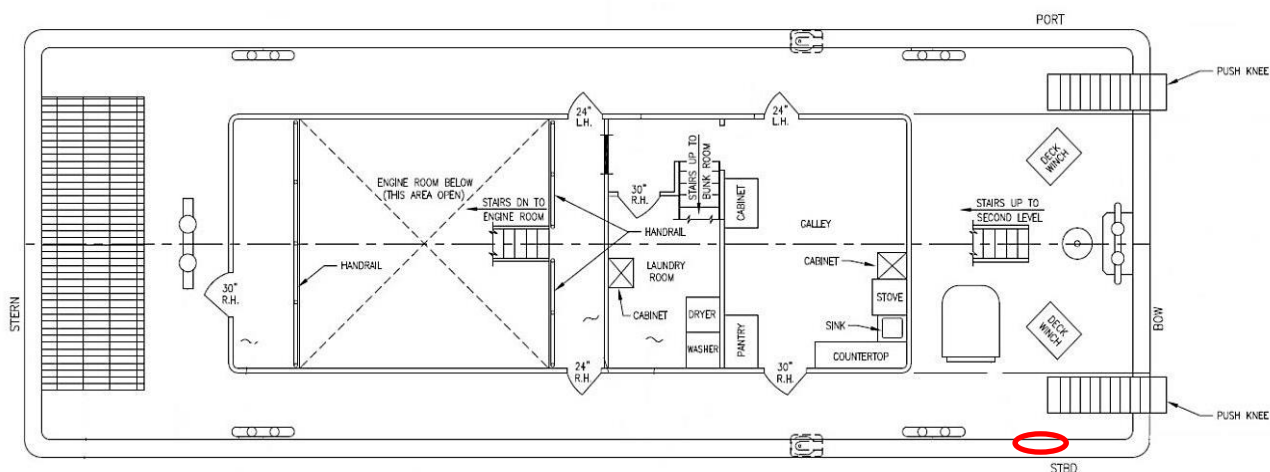
Due to high water conditions in the river producing a fast-moving current, the vessel owners were unable to attempt salvage for over a month. Salvage operations took place August 5–15. The salvage report indicated that “at a point approximately 3 [feet] aft [of] the forward bulkhead of the bow void compartment and 36” below the deck, the starboard side plate in way of a triangular gusset bracket (which would normally be found on the end of a laminated rubber fender) was found to have been ‘swiveled’ and pushed into the compartment to create an 8” x 16” hole.” In addition, the report noted pinhole leaks on the port side of the bow void and a leak where potable water piping penetrated the forward engine room bulkhead.

**Drawing of the main deck layout on board the *Jim Marko*'s sister vessel *John G*. The bow is located on the right side of the image; the stern on the left. A red oval shows the approximate location of the *Jim Marko*'s hull breach. (Image provided by McDonough Marine Services)**

The damage survey also noted that a number of watertight doors were found open, including the starboard and aft galley doors on the main deck. Open watertight doors on the main deck allowed water to travel directly into the engine room once the bow was submerged. The rapid nature of the sinking indicates that water was able to quickly fill the spaces below deck. The president of Osage Marine Services told investigators that company policy required the watertight doors to be closed when the vessel was under way.

- **Watertight Doors:** Water- and weathertight doors should be kept closed when a vessel is under way, unless the crew must pass through them. These doors are critical for preventing ingress of water or stopping its spread if a hull breach and/or flooding occurs.

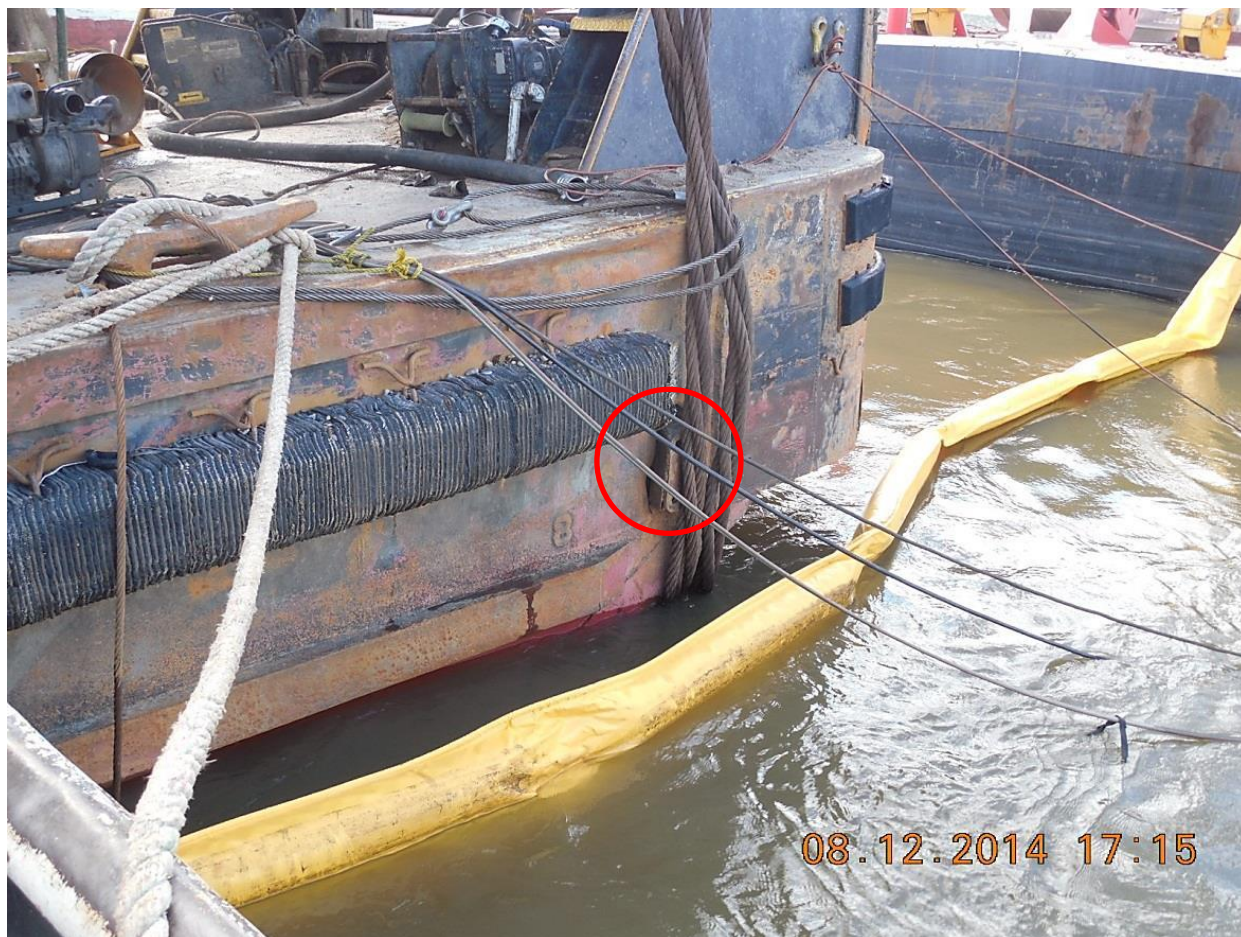
Postsalvage photo of the starboard bow area. The hole created by the gusset bracket is circled in red. (Photo by the Coast Guard)

The National Transportation Safety Board determines that the probable cause of the sinking of towing vessel *Jim Marko* was the captain's decision to continue operations with a known hull breach in the vicinity of the vessel's waterline. Contributing to the rapid sinking was a lack of watertight integrity due to watertight doors on the main deck left open while under way.
