National Transportation Safety Board

Marine Accident Brief

Launch Capsizing of the Yacht *Baaden*

Accident no.	DCA14LM009
Vessel name	Recreational yacht <i>Baaden</i>
Accident type	New build capsizing at launch
Location	Fidalgo Marina ramp, Anacortes, Washington
Date, time	May 18, 2014 2050 Pacific daylight time (universal coordinated time – 7 hours), twilight
Injuries	3 minor injuries
Damage	Total constructive loss, estimated at \$10 million
Environmental damage	None
Weather	Clear, visibility 10 miles, no wind, air temperature 60° F, water temperature 54° F
Waterway information	Fidalgo Marina Harbor, Fidalgo Bay, a sheltered recreational boat harbor; calm surface, minimal flood current, near high tide (about 2158)

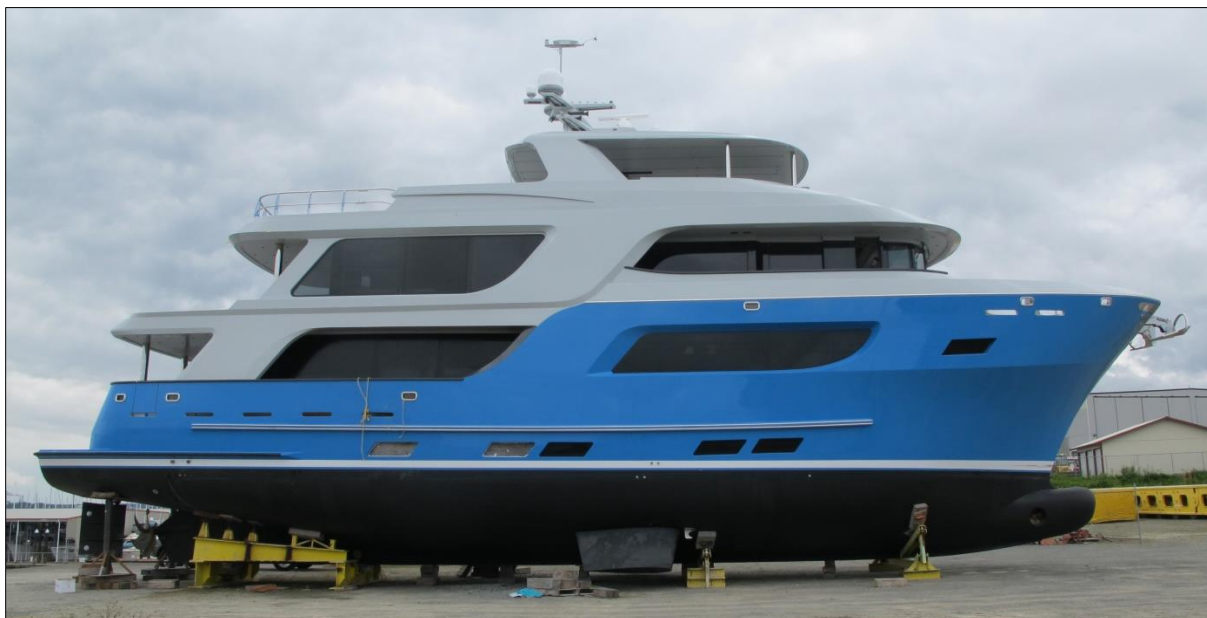
The yacht *Baaden* after the accident and salvaging.

Due to water damage to interior woodwork, machinery, and electrical systems and expenses associated with repairing the vessel, at the time of this report the *Baaden* was considered a total constructive loss with an estimated value of \$10 million.

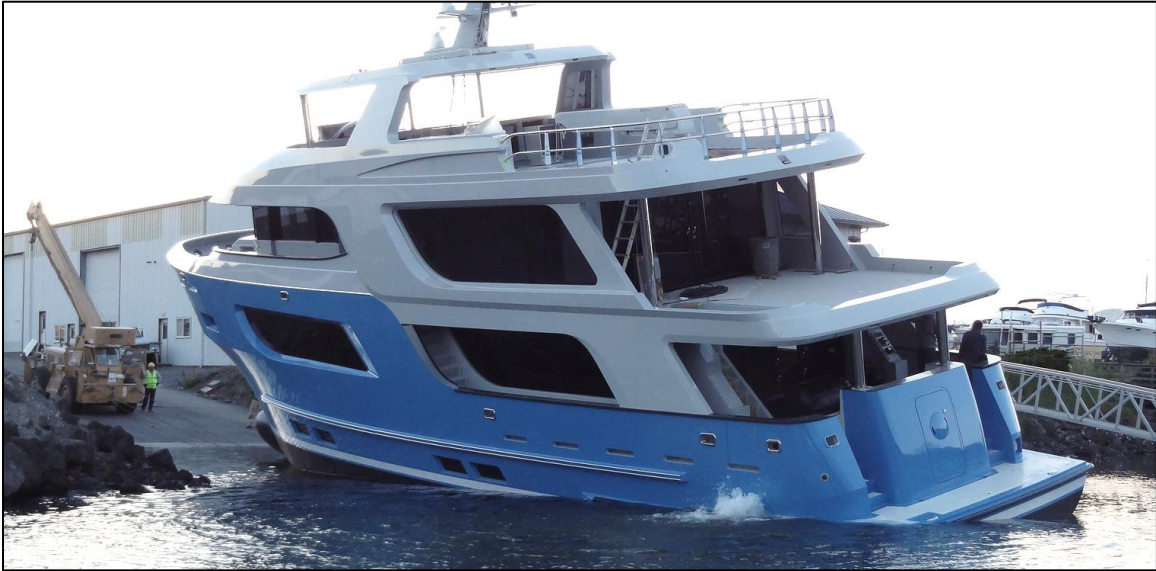
Team members said the launch was not rushed as they were ahead of schedule. Video footage and team members' statements indicate the launch was proceeding according to plan until about 40 seconds after the *Baaden's* front dolly completely submerged. About 2037, with the transom immersed and the swim steps forward of the swim platform beginning to get wet, launch team members said they heard a sudden loud clank and crunching sound from the stern area. Then the boat shifted bodily on the front cradle and lurched to port where it remained heeled to about 12 degrees, according to an NTSB video study.¹ Following this movement, the *Baaden* had slightly less trim by the stern.

The team suspended the launch to assess the condition of the vessel and launch mechanisms. No leaks were found inside the hull, and the launch mechanisms were normal. The team decided to continue the launch, in part because they could not pull the yacht back out of the water and they feared it would roll over when the tide went out. The safety coordinator said the team felt comfortable continuing and did so about 12 minutes later. The launch team believed the boat would right itself from the port list once it floated free from its cradles.

The *Baaden* after its initial roll to port and stable at about 12 degrees with its generators and propulsion engine running. (Photo provided by *Western Mariner*)

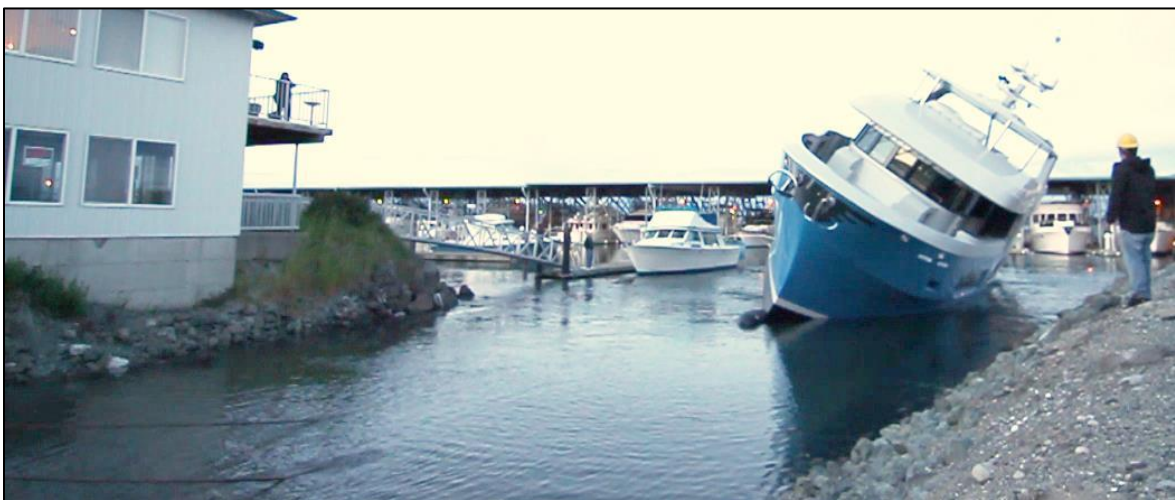
About 2050, when the depth at the end of the upper ramp was about 7.8 feet, the vessel moved to port again and slipped off the front cradle while increasing its list to port. The New World owner, who was acting as launch captain, said he increased reverse throttle to get the vessel off the cradles quickly, and the *Baaden* began accelerating aft and continued to slowly roll. The buyer’s representative heard unsecured items moving inside the boat (lazarette ballast, appliances, and equipment), and a few seconds later the roll rate increased and the boat quickly capsized, drifted into the marina, and began filling with water through its engine air intakes.

The *Baaden* at 25 degrees port heel (determined by NTSB video study) and in the process of rolling completely over to port while backing down. (Screenshot from *YachtVid* video)

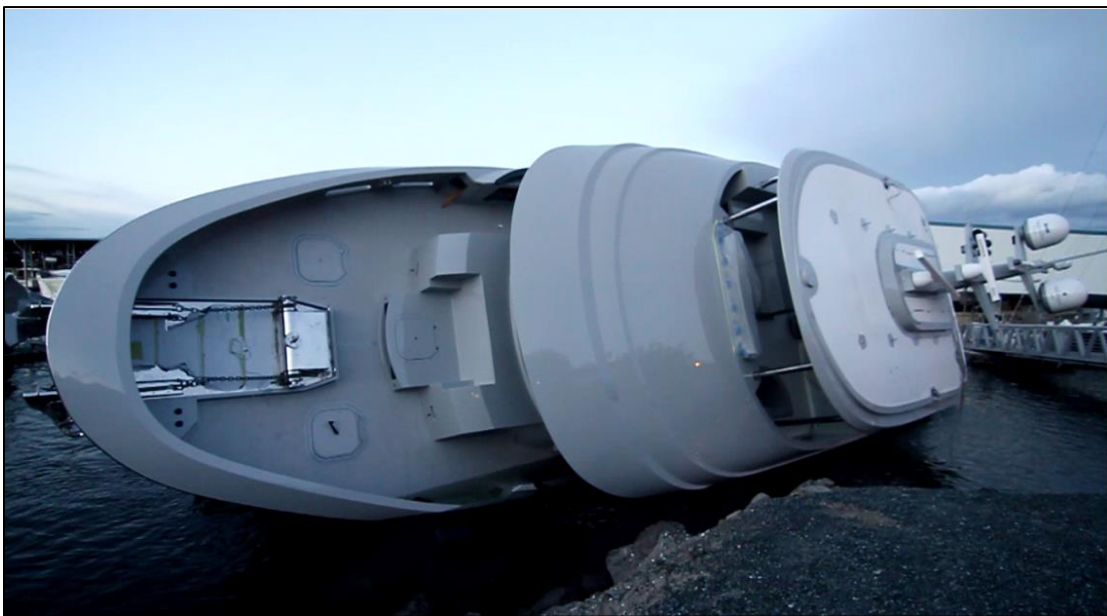
The *Baaden* floating freely about 1 minute after rolling over to about 80 degrees. (Photo from YachtVid video)

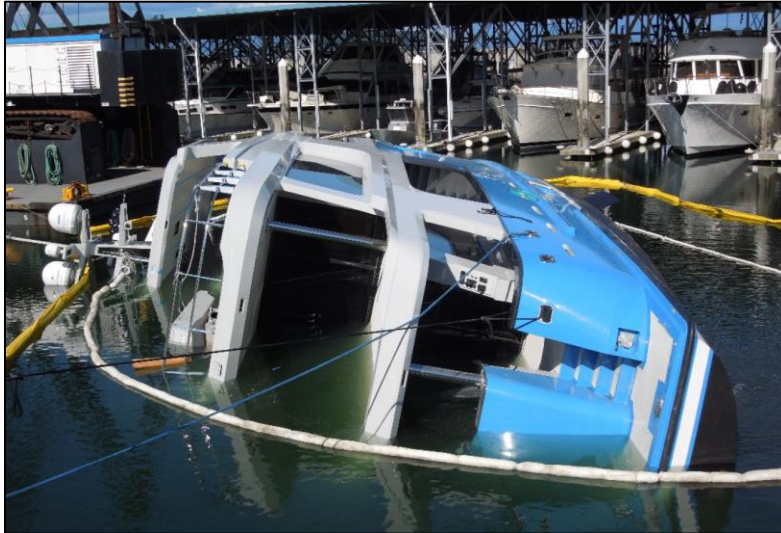
Following the rescue, New World contacted a salvage company which arrived later that night, and the boat was boomed to mitigate potential oil pollution. The vessel sank to the bottom of the marina basin at about a 65 degree port list but did not completely submerge in the shallow water.

The *Baaden* resting on the bottom at about 65 degrees on the day after accident. (Photo from Bowditch Marine)

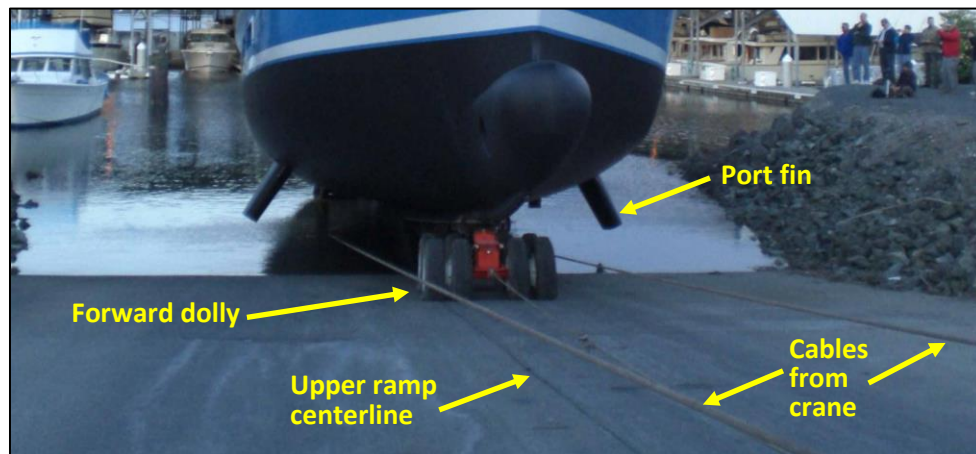
Although several launch team members stated that the *Baaden* appeared centered on the ramp during the launch, postaccident analysis of photographs shows the forward dolly roughly 2 feet to the right of the upper ramp centerline (looking down the ramp) before entering the water. The aft dolly assembly was 16 feet wide and the lower ramp was 24 feet wide; therefore, if the yacht's stern was more than 4 feet off the ramp's centerline, the aft dolly tires would begin leaving the ramp.

The *Baaden* on the upper ramp before its initial roll onto the port fin. The forward dolly is to the right of the upper ramp centerline. (Photo provided by New World)

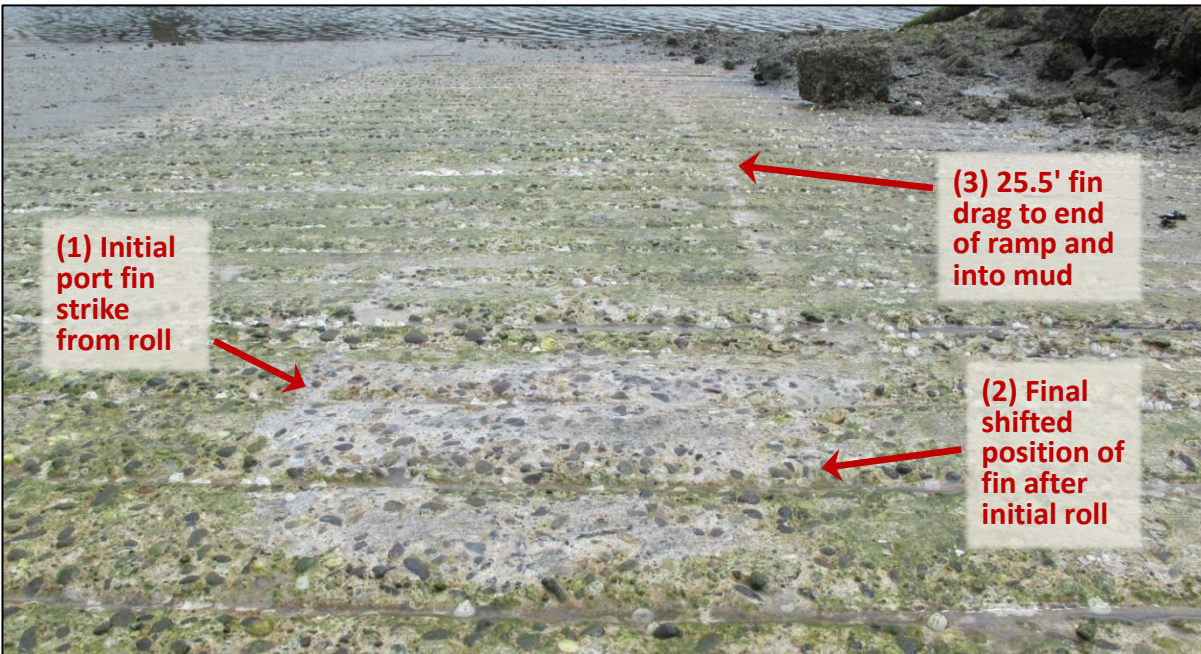
The width of the topmost portion of the fin scrape also indicates that the *Baaden* bodily shifted nearly 2 feet to the right side of the ramp during this roll before settling at a 12 degree port heel. With the vessel still supported primarily by the aft cradle, the roll was likely stopped only by the yacht's port fin contacting the ramp.

Looking down the concrete upper ramp, scrape marks match the size and position of the *Baaden*'s port stabilizer fin at (1) initial strike, (2) final shifted position, and (3) final drag to end of ramp.

The fin gouges and narrow 25.5-foot upper ramp scrape correspond with the resumption of the launch when the *Baaden*'s astern propulsion was needed to help pull the yacht further into the water. The narrow scrape ends at the upper ramp's waterside edge, about 2.5 feet to the right of the lower ramp planks. This indicates that the fin dragged down the ramp as it supported the yacht and then dropped off the ramp edge and into the mud. This sudden loss of support likely initiated the final roll of the vessel.

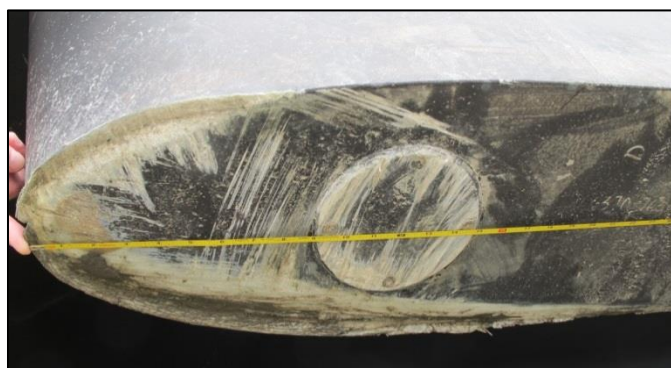
Damage to the underside of the *Baaden*'s port stabilizer fin showed evidence of compression failure as well as transverse and longitudinal gouging. Investigators matched the damage to the fin with scrape marks found on the upper ramp following the accident. A 25.5-foot-long scrape down to the bottom edge of the upper ramp matches the distance from the stabilizer fin to the axle of the forward wheel set of the aft dollies. Additionally, New World

photographed markings on a roughly 10-foot section of the right edge of the lower ramp's concrete planks that indicated the axle between tire sets contacted it. This evidence suggests that the aft dolly tires rolled off the right side of the upper ramp into the mud; this dropped the stern cradle to port and jostled the partially buoyant vessel, causing the *Baaden*'s initial roll to port.

Underside of port stabilizer fin showing compressive damage and both transverse and longitudinal scraping.

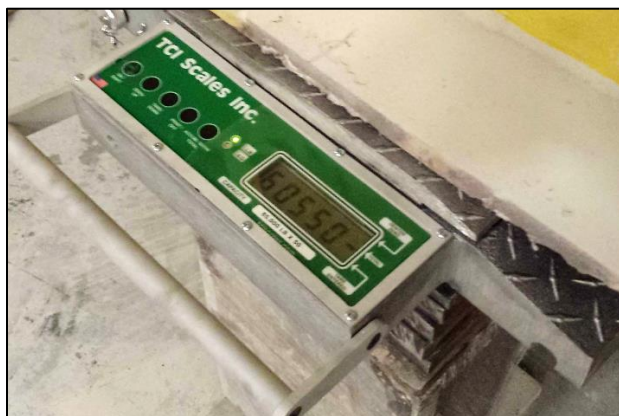
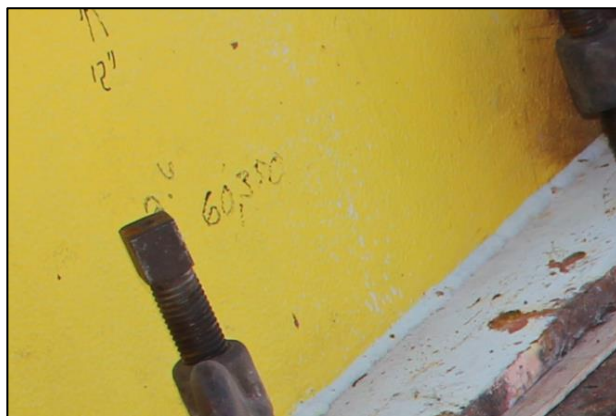
Investigators reviewed photographs of the load cells from the second weight test. The photograph of the aft starboard load cell showed a value of 60,550 pounds. Additionally, the investigation determined the load cell values were written in grease pencil on the cradle above the cell from which they were taken. An aft starboard pencil value of 60,350, nearly similar to the value shown in the cell photograph, was found written on the cradle. However, the investigation determined that New World supplied the stability naval architect a value of 68,500 pounds for this cell—indicating a transcription error at New World—and the naval architect used this incorrect weight in his spreadsheet to determine total vessel weight and estimate launch stability. As the aft port load cell reading was 68,700 pounds, an actual aft starboard side reading of 60,550 was more than 8,000 pounds less than the aft port side. The stability naval architect said this 8,000-pound difference indicated a transverse weight differential and would produce a heeling moment to the heavier port side. This meant the vessel's center of gravity was further to port than had been estimated.

Left, aft starboard load cell reading of 60,550 pounds taken in March 2015. (Photo by New World)
Right, aft starboard cradle grease pencil marks indicating 60,350 pounds 2 days after the accident. (Photo by Coast Guard)

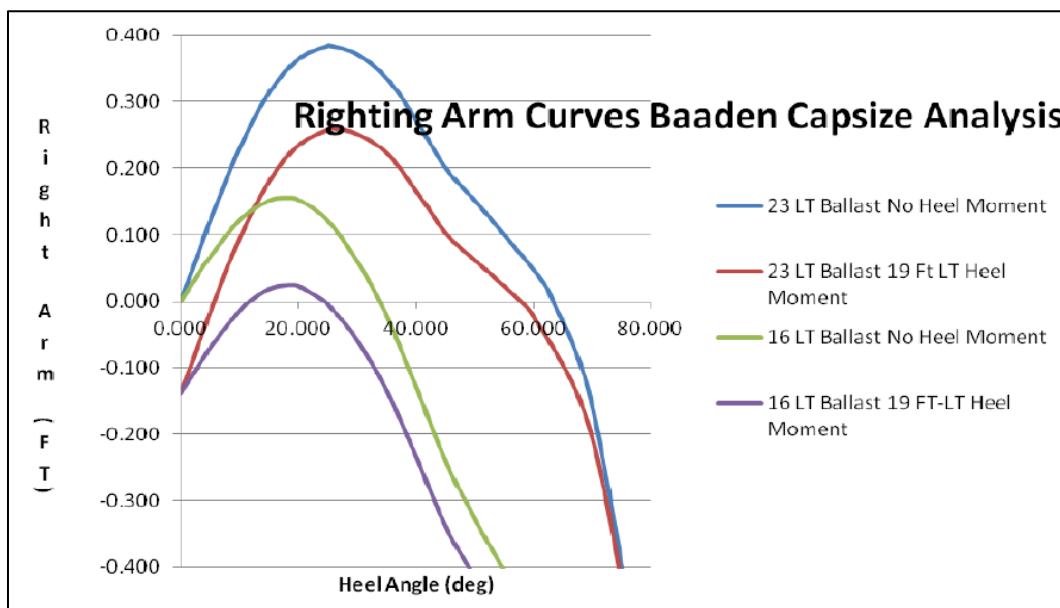
The *Baaden's* stability naval architect performed a postaccident stability analysis of four different launch conditions—for both the 16.61 and 23 LT ballast scenarios, with and without the port heeling moment created by the 8,000-pound transverse weight differential—all with zero trim (even keel) in calm water. The report calculated the port heeling moment to be 19 LT and concluded that when this moment is applied to the 16 LT ballast condition (as seen during the actual launching and indicated by the purple curve below), “there is very little righting available” to return the vessel to an upright position over a range of heel angles and “if the righting arm is negative, the vessel is unstable.”

Postaccident analysis of the *Baaden's* launch stability under differing ballast conditions. The 16 LT ballast curve shown in purple indicates the estimated stability of the yacht during the launch. (Graphic by Roddan Engineering Ltd.)

The National Transportation Safety Board determines that the probable cause of the capsizing of the yacht *Baaden* during its initial launch was the vessel's low margin of stability due to the combined effects of a recording error during the final vessel weigh, which resulted in an incorrect assessment of the vessel's center of gravity, and an overestimation of the weight of installed ballast.
