National Transportation Safety Board

Marine Accident Brief

Collision of Offshore Supply Vessel *Gloria May* and Fishing Vessel *Capt Le*

| Accident no. | DCA14LM017 |

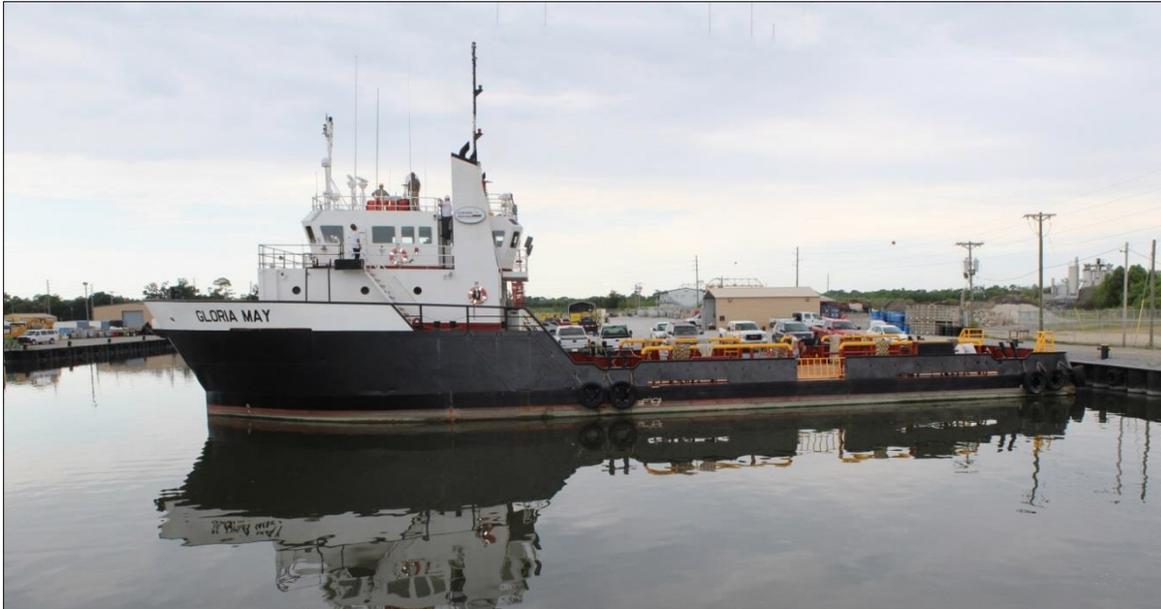
Offshore supply vessel *Gloria May* in port after the collision.

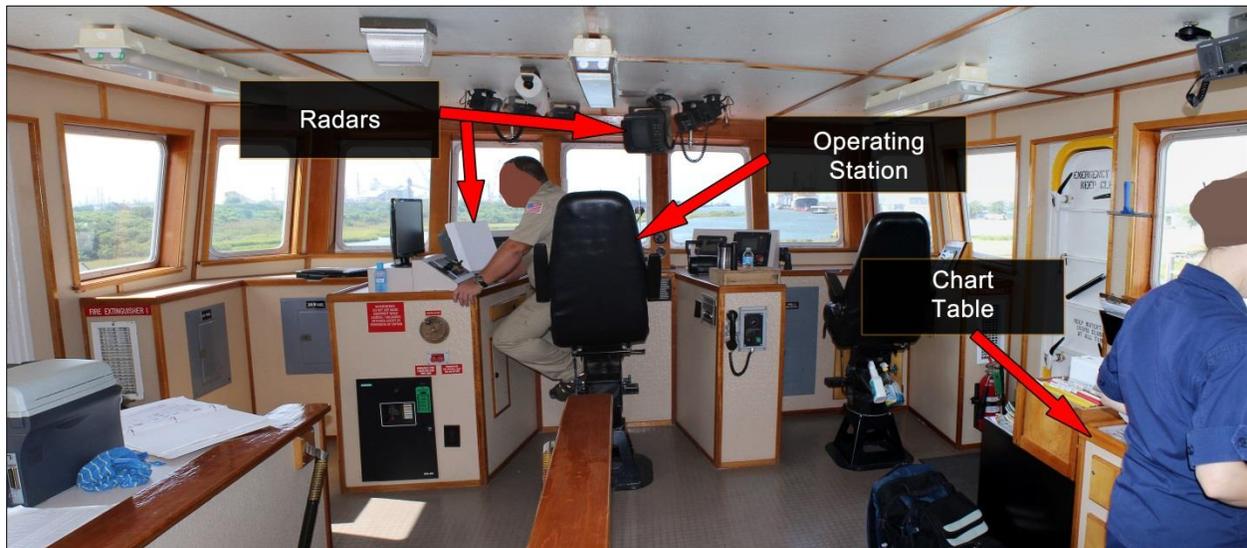
12.5 knots and engaged the autopilot on a course of 357 degrees to the first GPS waypoint. He then checked the operation of all bridge systems, including the two radars and VHF radios, and found everything was functioning properly. At this time he did not detect any contacts ahead, either by radar or by sight. About 5 minutes later, the second captain moved from the front of the bridge to the chart table, which was on the starboard aft side of the control station, and began filling out paperwork required for the voyage back to the MOVK Base. The second captain was alone on the bridge and diverted his attention from his primary duty to maintain a proper lookout.

Wheelhouse of the *Gloria May*, looking from aft to forward at centerline. The operating station is at the forward area of the wheelhouse, and the chart table is at the starboard side.

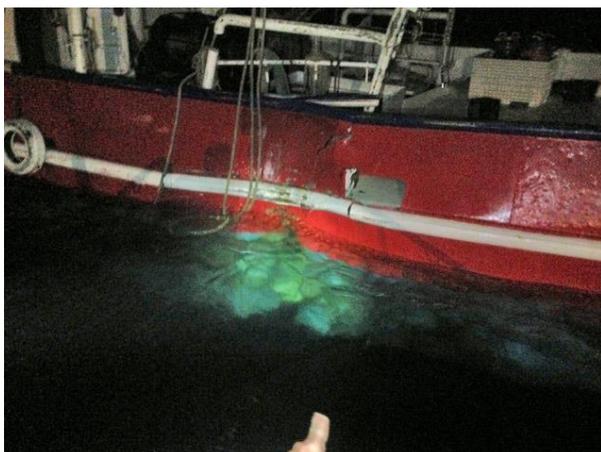
As a result of the collision, the port side of the *Capt Le*'s hull in the area of the bulkhead between the engine room and the fish hold was split open over a length of about 10 feet starting from 3 feet below the gunwale and extending downward toward the vessel's keel. The width of the split in the hull was about 2 to 3 feet, and the hull in the area of the split was inset about 1.5 feet.

Damage to port side of *Capt Le* (left) and the *Capt Le* after the collision with stern protruding above the sea (right). (Photos by Coast Guard)

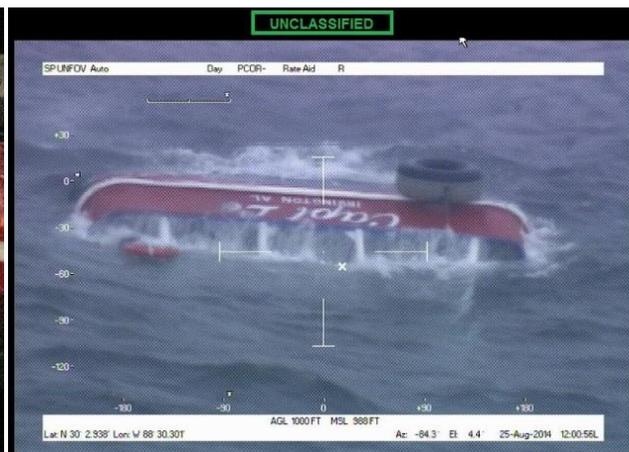
Coast Guard Sector Mobile received VHF radio notification of the collision from the *Gloria May* at 2240 and soon after requested that Coast Guard Station Pascagoula launch a boat to respond to the collision. A 45-foot medium response boat from Station Pascagoula got under way at 2302 and arrived on scene about 2355. The Coast Guard responders found the *Capt Le* was still afloat but listing to its starboard side with damage to the port side of its hull. The Coast Guard took the *Capt Le* crewmembers aboard their boat and transported them to Station Pascagoula, arriving there about 0130. Later that night, the fishing vessel sank in about 70 feet of water with its bow down and its stern projecting about 2 feet above the sea surface.

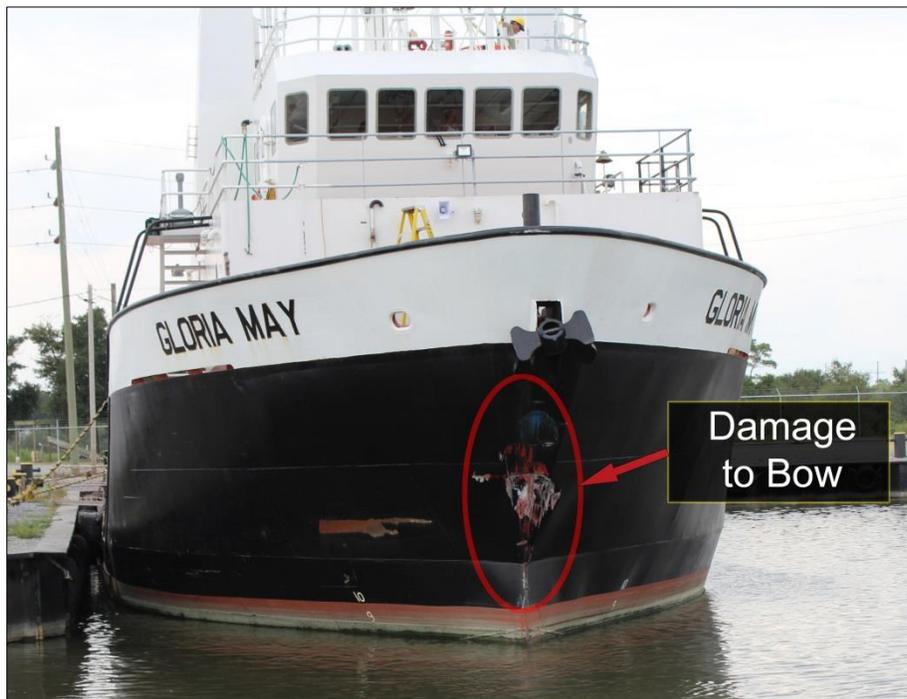
Damage to the *Gloria May* consisted of denting and scraping of the bow on either side of the stem above the waterline where the bow contacted the port side of the *Capt Le*. Additional damage was found to the hand rails at the walkway forward of the wheelhouse, the aft mast atop the aft end of the wheelhouse, a communication antenna and a radar antenna on the top of the wheelhouse, and other areas that apparently contacted the fishing vessel's port outrigger.

Scraping and denting damage to the bow of the *Gloria May*.
