# National Transportation Safety Board

## Marine Accident Brief

### Sinking of Towing Vessel *Nalani*

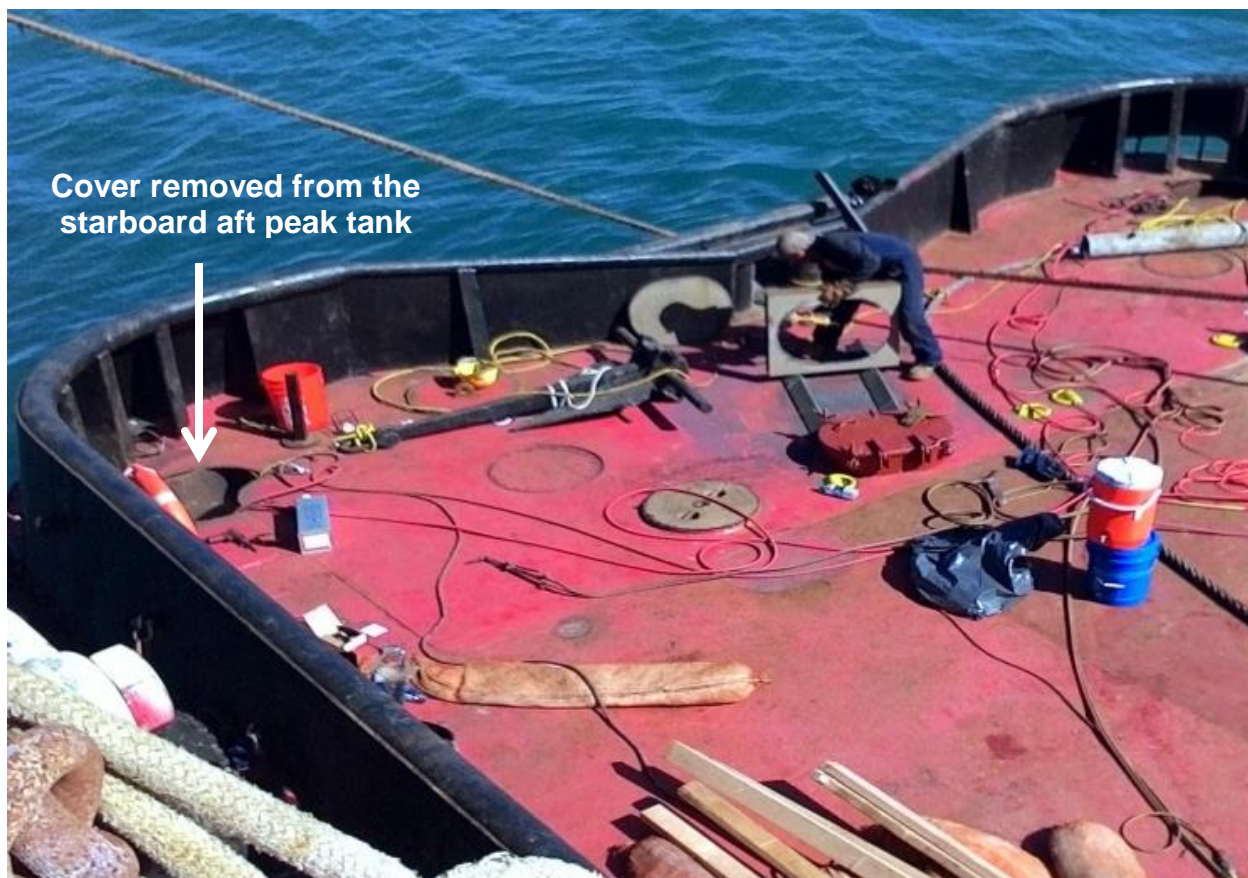
**Stern of the *Nalani* with its starboard aft peak cover removed. (Photo by *Nalani* crewmember)**

After the steel plate was cut and removed, the shipyard worker went ashore to drill the new cover, but when he returned about 1435, the *Nalani* had already departed for the sea trial. The crew on board the vessel temporarily placed a piece of gasket material over the 20-inch hole

in place of the steel cover. This remedy, however, left the starboard aft peak tank vulnerable to water intrusion and progressive downflooding. The captain told investigators that he was aware of the unsecured opening but decided to get under way for the sea trial anyway.

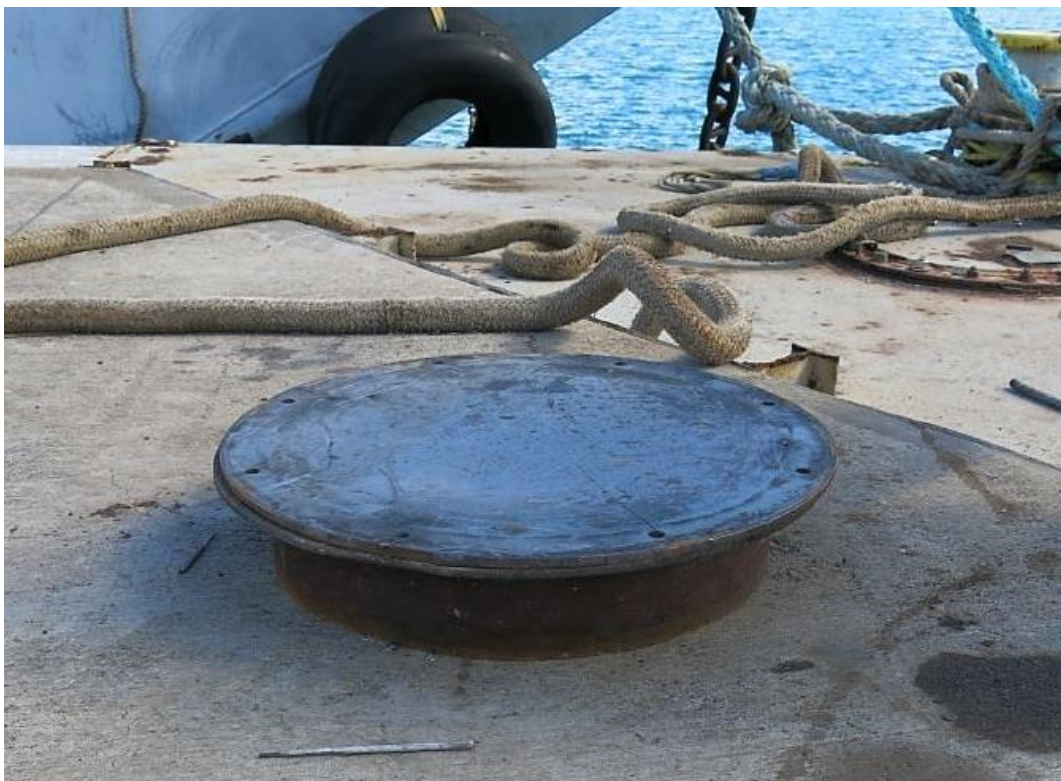
A 30-minute sea trial of the autopilot system was scheduled for 1500 on January 22, 2015, the day before departure. A Hawaii state pilot was requested to join the sea trial, and he arrived about 1415. Earlier that same morning, an owner’s representative directed a shipyard worker to cut out a 20-inch-diameter welded steel plate cover from the starboard side of the stern deck above the starboard aft peak tank. (Steel plates had been welded in place of bolted hatch covers during the previous year due to water leakage into the aft peak tanks.) The shipyard worker was told to replace the 20-inch plate with a raised-combing hatch cover, which had threaded bolts for securing.

**The replacement cover that was to be installed on the starboard aft peak tank.**

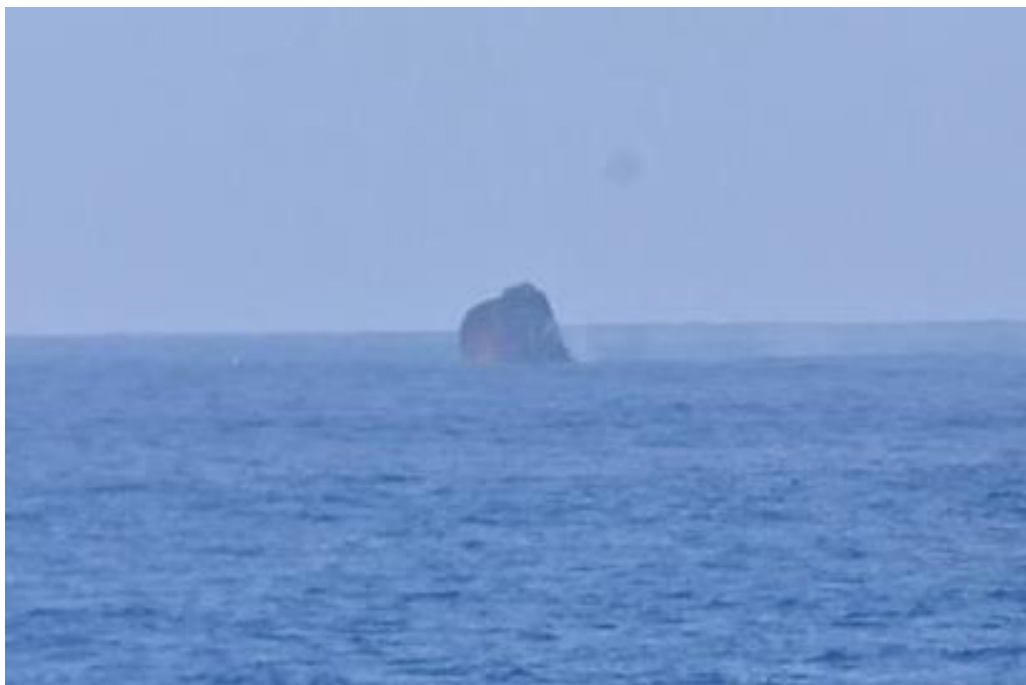
Less than 1 minute later, the *Nalani* suddenly began listing heavily to port, and the captain sounded the general alarm. The pilot ordered the engines to be stopped, the crew to move to the high side of the vessel, and then to abandon ship. All 11 persons entered the water; the pilot counted everyone and notified the Coast Guard via handheld radio that all persons were off the vessel. Some of them were able to board the inflatable auxiliary boat and a liferaft that released from the vessel. About 1531, the *Nalani* listed 45 degrees to port and, about 2 minutes later, 90 degrees to port. About 1533, the stern sank beneath the waves, the bow pointed toward the sky, and the vessel slid beneath the surface and sank at a water depth of about 2,200 feet.

The skyward-pointing bow of the *Nalani* just before the vessel sank. (Photo by *Clean Islands* crewmember)
