National Transportation Safety Board

Marine Accident Brief

Grounding of Commercial Fishing Vessel *Savannah Ray*

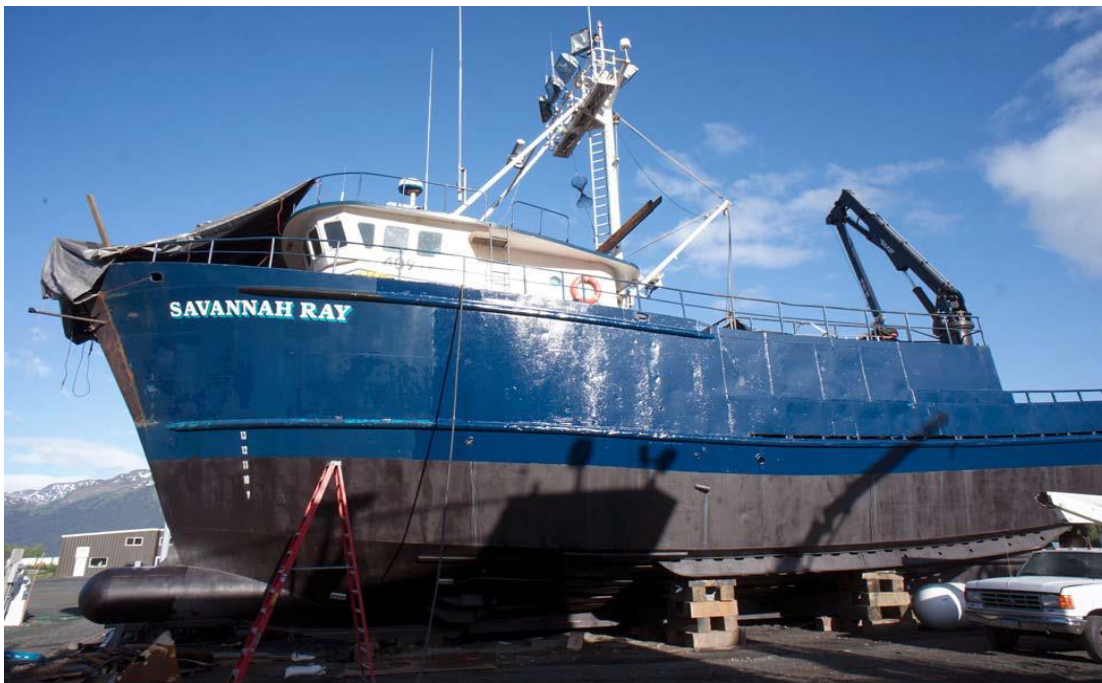
The *Savannah Ray* at its spring 2014 survey. (Photo by Resurrection Technologies)

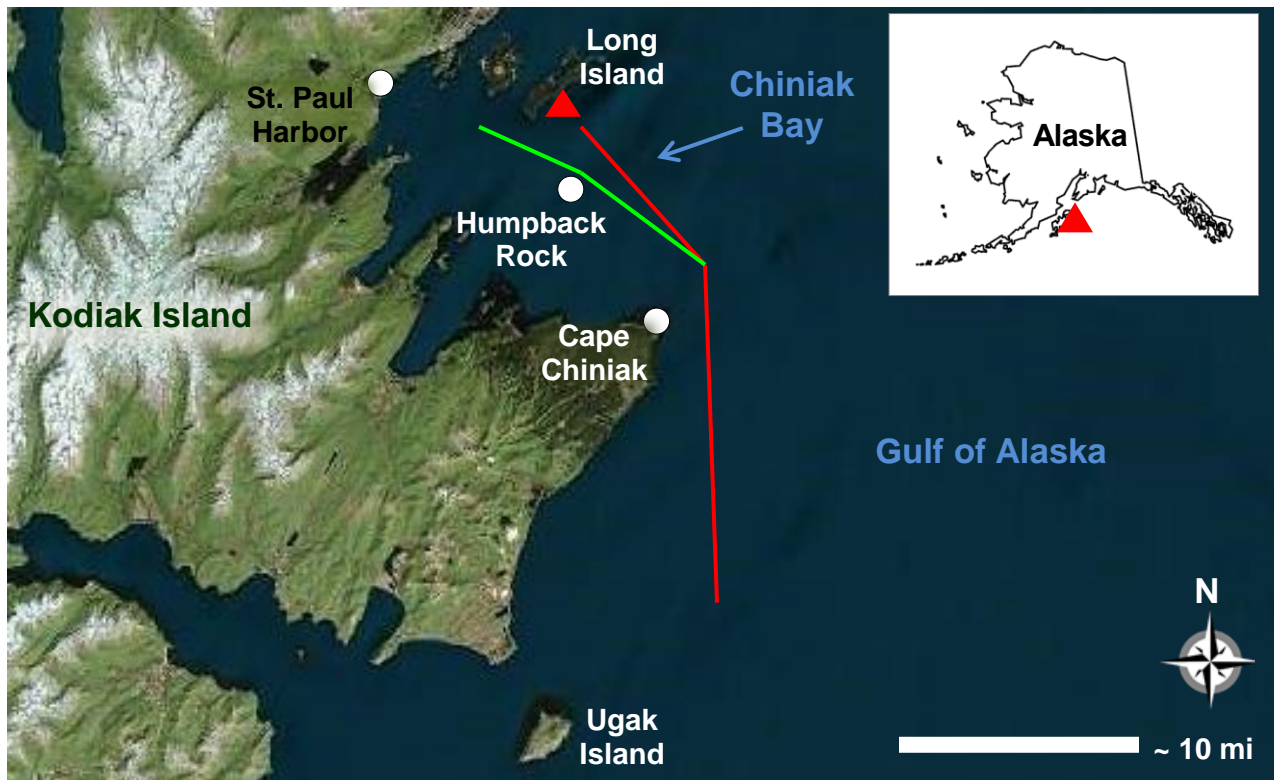
Satellite image of the accident area, with the *Savannah Ray*'s actual trackline overlaid by a red line and intended trackline overlaid by a green line. The grounding site on Long Island is marked by a red triangle. (Image based on information from the Coast Guard; background by Google Earth)

With no one minding the helm, the vessel continued past the waypoint off Humpback Rock and, according to AIS data, grounded at 0048 in the shallow water off the southeast coast of Long Island. Minutes later, strong seas shattered the aft wheelhouse window, allowing water ingress, and the vessel took a 45-degree list and lost power. With no power or lights, the crew donned immersion suits, and the captain broadcast a mayday call on the vessel's hand-held very high frequency (VHF) radio, which he used because the batteries to the fixed

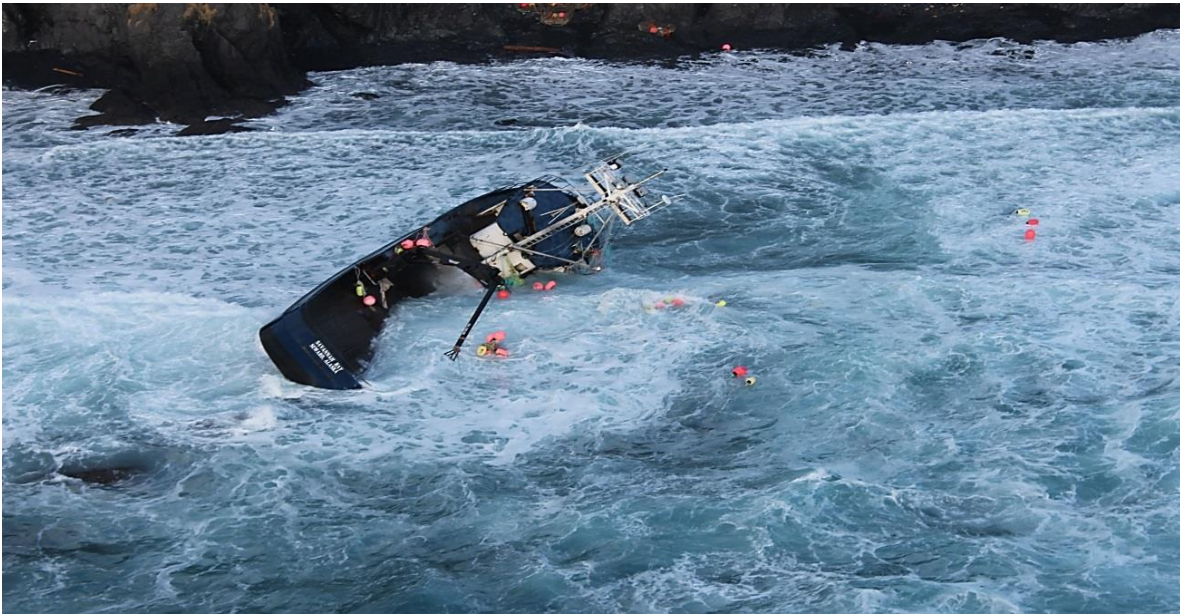
The *Savannah Ray* aground off Long Island, Alaska. (Photo by the Coast Guard)

The National Transportation Safety Board determines that the probable cause of the grounding of the *Savannah Ray* was the vessel straying off course and entering shallow water because the captain fell asleep while navigating due to fatigue. Contributing to the grounding was the captain's failure to use all of the vessel's available alerting and navigation alarms.

- **Crew knowledge of alerting and navigation alarms:** The vessel was equipped with a watch alarm that, if used properly, would likely have prevented this accident. Best practices for commercial fishing operations include vessel owners/operators ensuring that their crews have sufficient knowledge of all onboard alerting and navigation alarms.
- **Written procedures for alerting and navigation alarms:** The owner/operator of the vessel did not have any written guidance that required the crew to use all available onboard alerting and navigation alarms. Owners/operators can promote the proper use of alerting and navigation alarms by providing their crews with written procedures for this equipment.
