National Transportation Safety Board

Marine Accident Brief

Collision between Tanker *Chembulk Houston* and Container Ship *Monte Alegre*

Issued: February 23, 2016

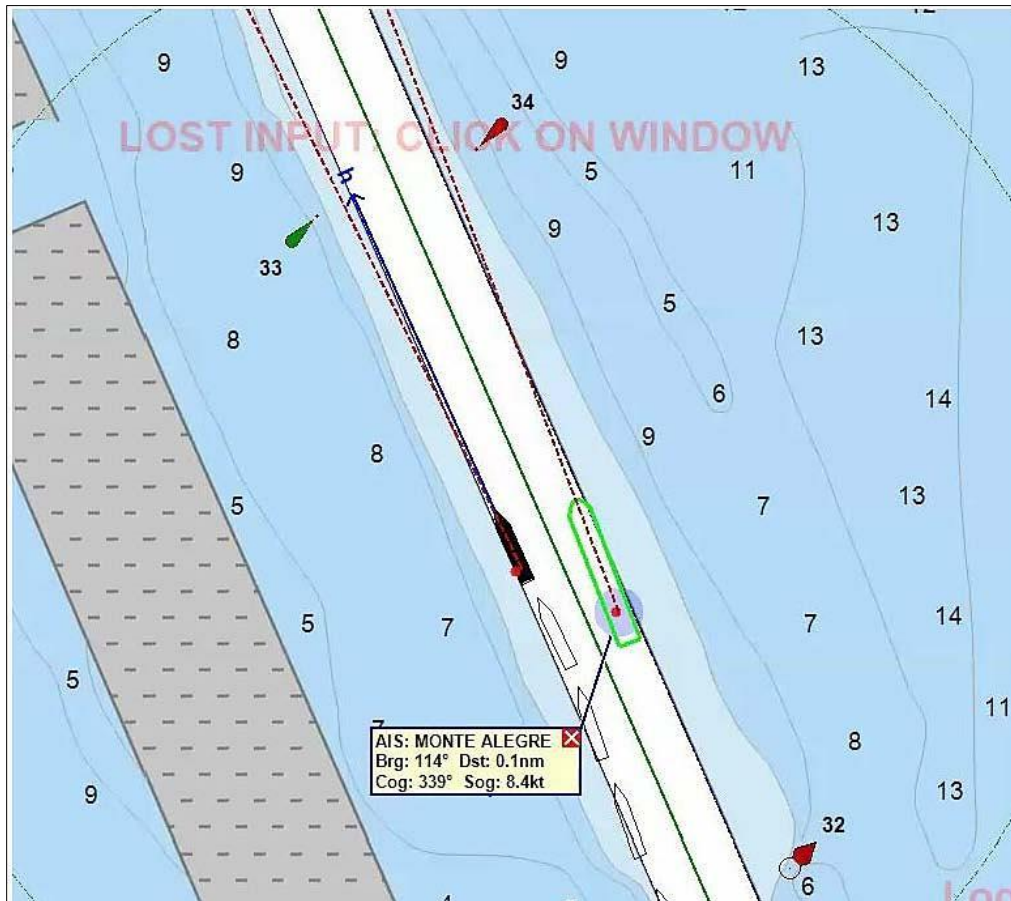
About 1320, the deputy pilot on the *Chembulk Houston* contacted the pilot on the *Monte Alegre* and said, “I’m losing even more [referring to his vessel’s speed]. Do you want me to drop back?” The pilot on the *Monte Alegre* replied, “Yeah, probably the best thing.” The deputy pilot stated that he would begin easing off the throttle so that he could drop back into a position behind the *Monte Alegre*. The pilot on the *Monte Alegre* replied that he would increase the container ship’s speed to assist in repositioning the vessels. According to the two pilots’ portable pilot units (PPUs), at 1320, the speed of the *Monte Alegre* was about 8.4 knots and the speed of the *Chembulk Houston* was 8.3 knots. During the next 2 minutes, the pilot on the *Monte Alegre* issued a series of commands intended to increase the speed, bringing the engine throttle from dead slow ahead to full ahead. On board the *Chembulk Houston*, from about 1320 to 1326, the deputy pilot issued a series of commands intended to slow the vessel, bringing the engine throttle from full ahead to slow ahead. Nevertheless, the *Chembulk Houston*’s speed actually increased. At 1326, according to the PPUs, the speed of the *Chembulk Houston* had increased to 11.2 knots. The speed of the *Monte Alegre* was 10 knots.

Still image extracted from the PPU used on board the *Chembulk Houston*, showing the approximate position of the two vessels at 1320 when the overtaking situation was aborted. (Image provided by the Houston Pilots Association)

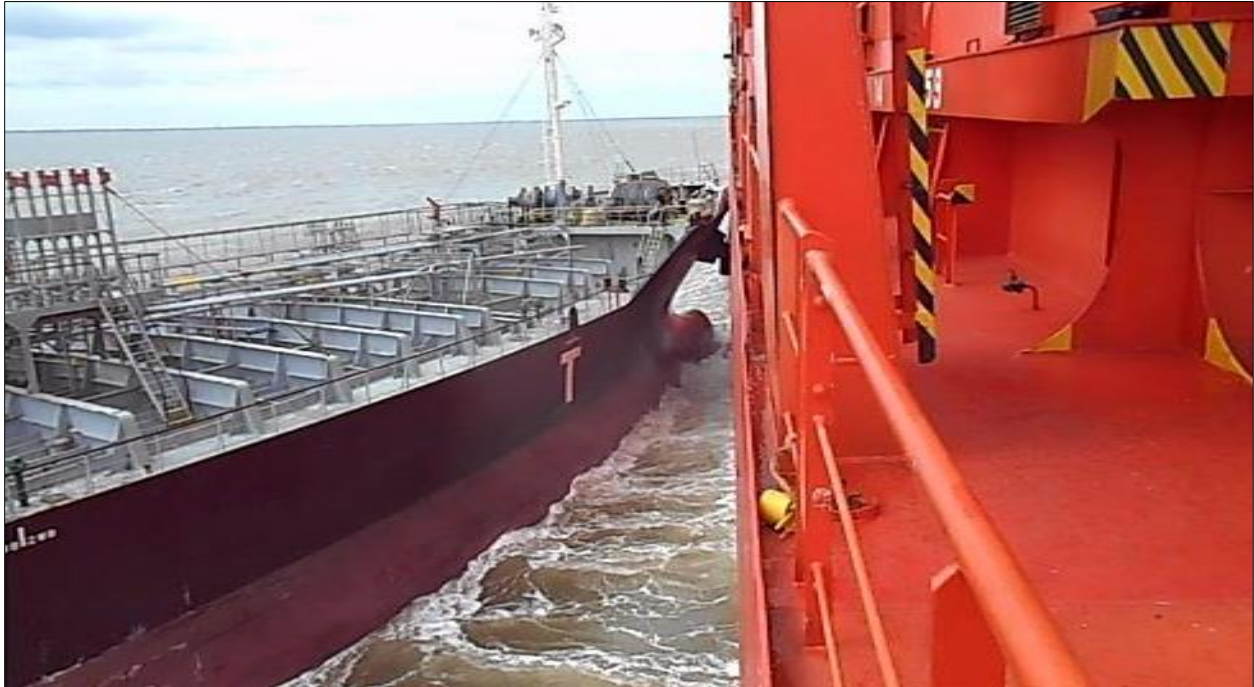
During the next 4 minutes, the deputy pilot on the *Chembulk Houston* issued several helm and throttle commands, ranging from hard port to hard starboard and from dead slow ahead to full ahead, that were intended to prevent the tanker from making contact with the *Monte Alegre*. Despite these efforts, at 1334, the starboard-side bow and anchor of the *Chembulk Houston* collided with the *Monte Alegre*’s aft portside hull, and the ships remained in contact as the tanker progressed forward. At the time of the collision, the speed of the *Chembulk Houston* was 9.2 knots and the speed of the *Monte Alegre* was 9.6 knots. Both vessels veered to port and grounded on the soft bottom of the Houston Ship Channel near light no. 39.

Still image extracted from video on board the *Monte Alegre*, showing the *Chembulk Houston*'s starboard-side bow and anchor in contact with the *Monte Alegre*'s port side. The initial contact occurred farther aft on the *Monte Alegre*.

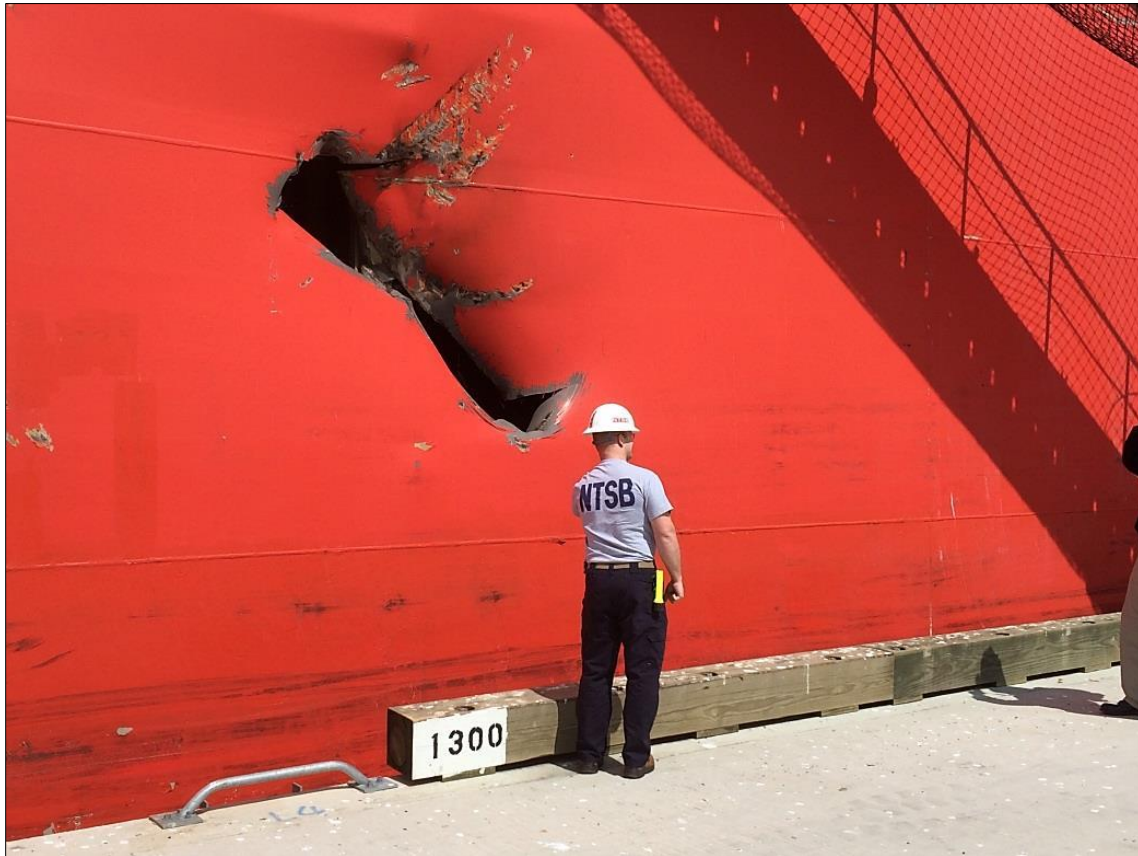
Damage to the *Monte Alegre* totaled about \$997,700 and included distorted internal structural framing and hull inset along a distance of about 660 feet on the port side between frames 40 and 110, about 53 to 65 feet above the waterline. The hull was punctured in several places along this 660-foot-long damage section.

Photo showing the first point of contact on the *Monte Alegre*, where the starboard-side anchor of the *Chembulk Houston* punctured the hull.
