# National Transportation Safety Board

## Marine Accident Brief

### Collision between Passenger Vessel *Diamond Edge* and Liftboat *B.W. Haley*

<b>Accident no.</b>	DCA15LM015
<b>Vessel names</b>	<i>Diamond Edge</i> and <i>B.W. Haley</i>
<b>Accident type</b>	Collision, with subsequent partial sinking of the <i>Diamond Edge</i>
<b>Location</b>	Freshwater Bayou Safety Fairway, Gulf of Mexico (29°27.84'N, 092°18.76'W)
<b>Date</b>	March 2, 2015
<b>Time</b>	1027 central standard time (coordinated universal time – 6 hours)
<b>Injuries</b>	None
<b>Damage</b>	Est. \$1.75 million
<b>Environmental damage</b>	None reported
<b>Weather</b>	Dense fog, visibility less than 0.1 mile; air temperature 65°F; winds easterly at 8 knots
<b>Waterway information</b>	Open waters of the Gulf of Mexico about 55 miles south-southwest of Lafayette, Louisiana

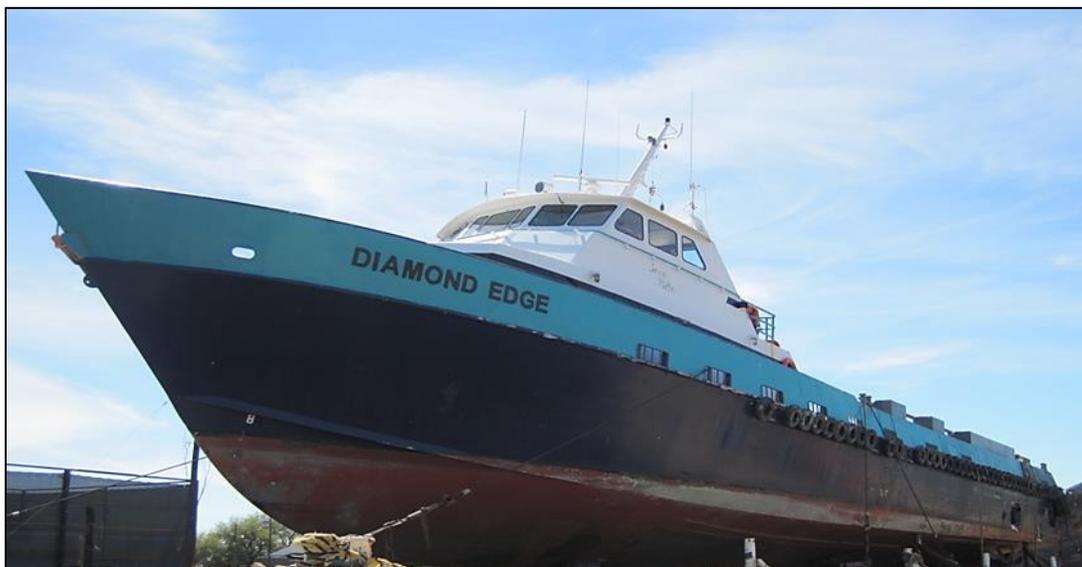
Passenger vessel *Diamond Edge* on a transport barge after it was salvaged.

The force of the collision spun the *B.W. Haley* around and caused over \$117,000 damage to the vessel, but it remained afloat. However, the *Diamond Edge* rapidly took on water from two holes in its aft port side and lost power. A little before 1100, the *B.W. Haley* came alongside the *Diamond Edge* and rescued the four *Diamond Edge* crewmembers. The *B.W. Haley* then returned to port under its own power. The stern of the *Diamond Edge* eventually sank, with its bow remaining above the surface. A few days after the collision, the *Diamond Edge* was lifted onto a barge for transport to a shipyard. Damage was estimated to be at least \$1.75 million.

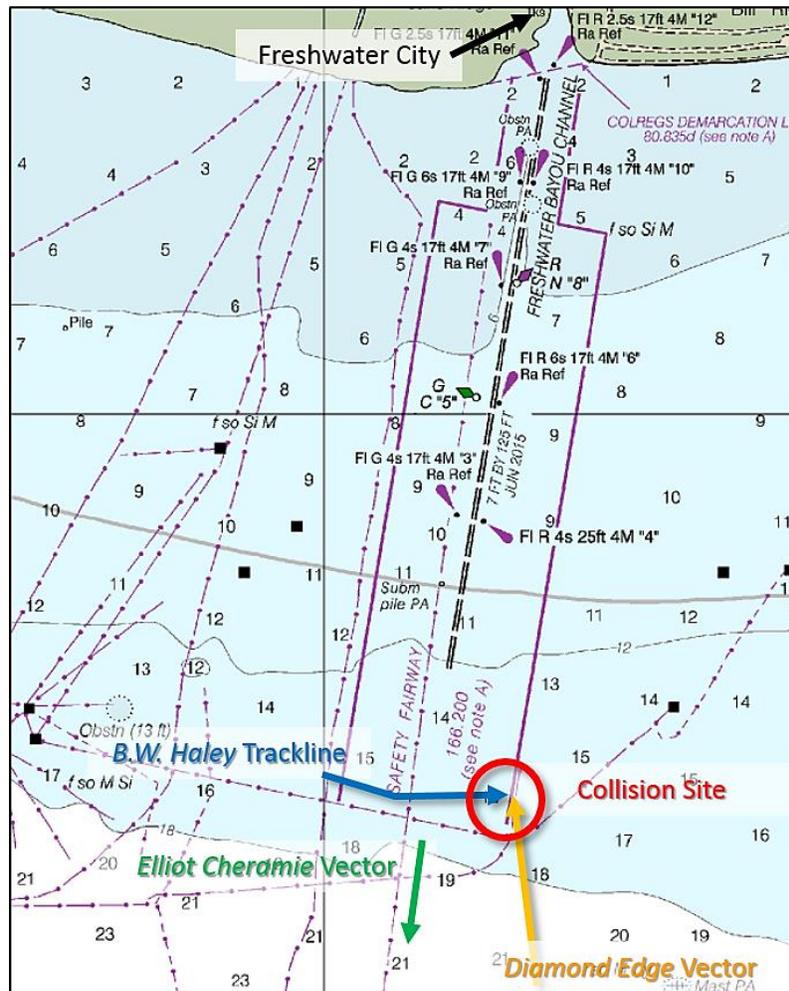
The *Diamond Edge* captain told investigators that, about 1030, he visually saw *B.W. Haley* coming out of the fog at a distance of 60 feet on a collision course with his port bow. The captain said he could not immediately go into reverse because it would have stalled the engines. Therefore, he sped up and turned his vessel to port—toward the *B.W. Haley*—to kick his stern away from the liftboat (information recovered from the *Diamond Edge*'s navigation computer indicates that the vessel initially turned to starboard before turning to port). The captain's maneuvers, however, did not clear the *B.W. Haley* and, according to AIS, the aft port side of the *Diamond Edge* impacted the liftboat's starboard bow and leg mat about 1027.

Chart depicting *Elliot Cheramie* and *Diamond Edge* AIS vectors, *B.W. Haley* GPS trackline, and the collision site. (Background NOAA chart 11349; overlay by NTSB using data compiled from *Diamond Edge's* navigation computer)

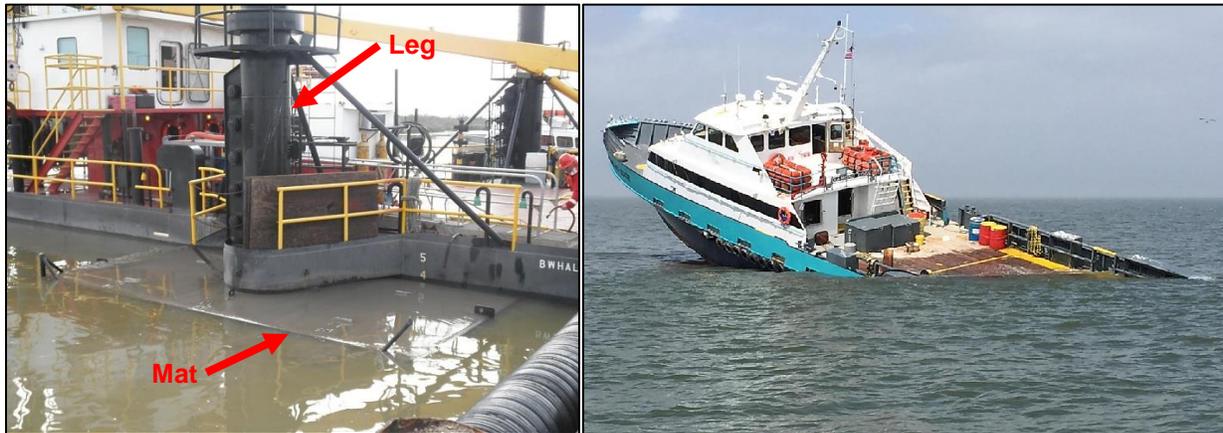
Left picture shows *B.W. Haley* with close-up of starboard leg and mat where the collision occurred. Right picture shows the partially submerged *Diamond Edge*. (Photos by US Coast Guard)

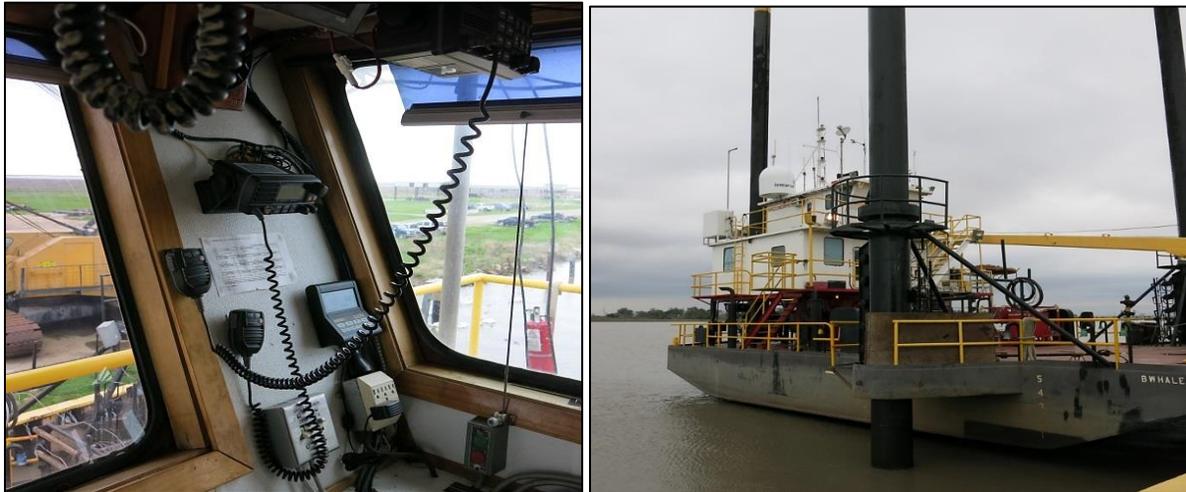
The *B.W. Haley* captain stated that he steered the liftboat; operated the whistle, radar, and VHF radio; navigated the vessel; and was the visual lookout. As lookout, the captain's field of vision was blocked by the wide forward corner column of the wheelhouse and by the position of the raised starboard lifting leg (see next photo). Both the deckhand/relief captain and vessel assistant stated it was hard to see the *Diamond Edge* visually because it was hidden by the leg.

Left picture shows view towards the starboard bow of *B.W. Haley* as seen from captain's wheelhouse conning position. Right picture shows radar shadow area to wheelhouse of *B.W. Haley*.

Since radar transmissions are basically line-of-sight, the lifting legs that visually impaired the captain also obstructed the radar mounted directly above the bridge. The lifting legs created radar shadow areas that could have masked contacts within these zones. Given that the *Diamond Edge* collided with the starboard leg mat and starboard bow of the *B.W. Haley*, it is possible that the *Diamond Edge* was in a shadow area at some point prior to impact. Long-range radar scanning would have mitigated this risk, but the captain told investigators that he did not use this practice.
