National Transportation Safety Board Marine Accident Brief

Collision of Articulated Tug and Barge *Lucia/Caribbean*, Assisted by Tugboat *William S*, with Multiple Barges

NTSB/MAB-16/11

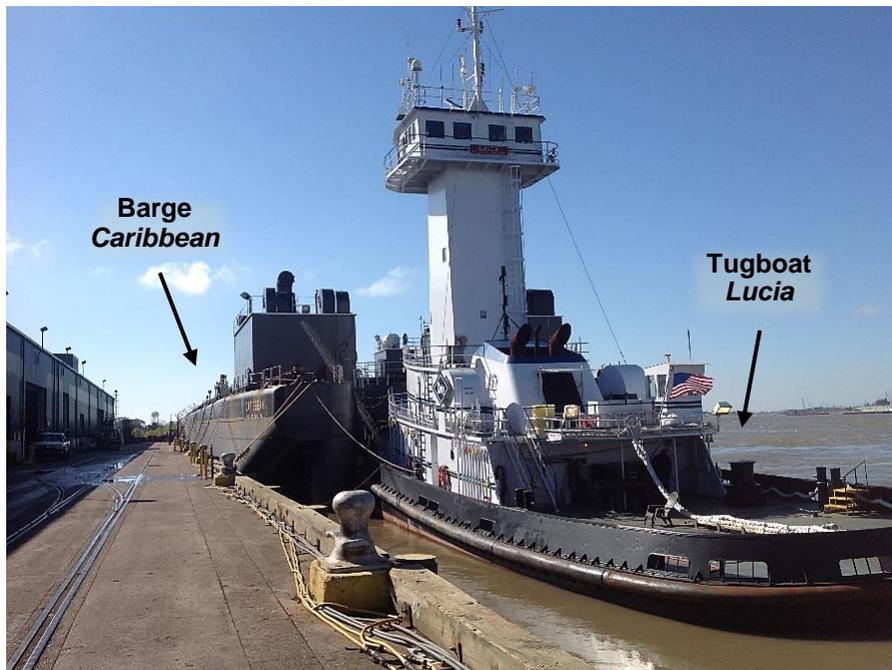
ATB *Lucia/Caribbean* moored portside-to at the Port of New Orleans, Perry Street Wharf, after the accident.

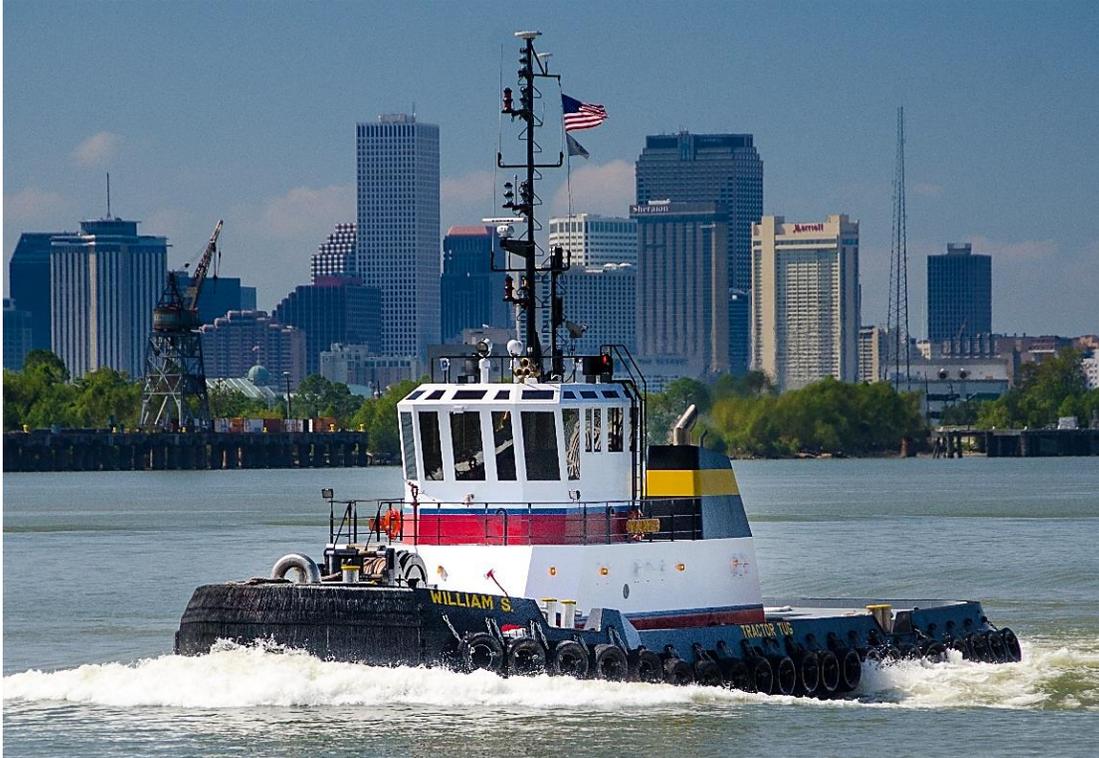
***William S* under way on the Mississippi River near New Orleans, Louisiana. Its permanently installed bow-fendering appears just forward of the vessel's name. (Photo by Bisso)**

When investigators asked the mate on the *William S* why he did not push at full-ahead throttle to initiate the turn to port, he explained that, when he initially applied full throttle, the tugboat's bow rose up on the hull of the *Caribbean*. He said that he did not want any steel-to-steel contact between his vessel and the barge, which could cause damage. He further stated that he normally took directions and followed orders, except when they put his vessel and crew in danger.

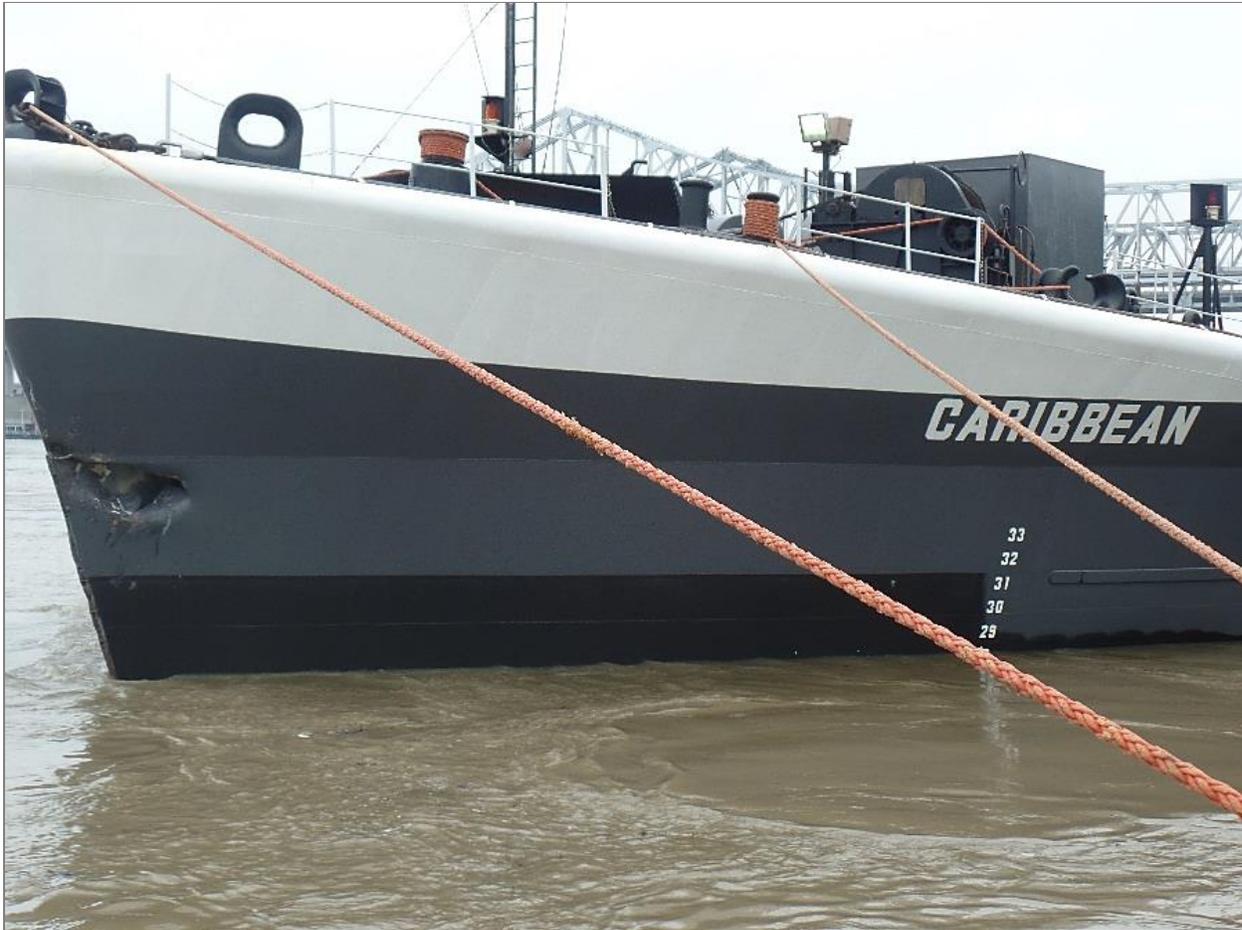
Damaged forward portside bow of tank barge *Caribbean* after the collision. (Photo by Coast Guard)

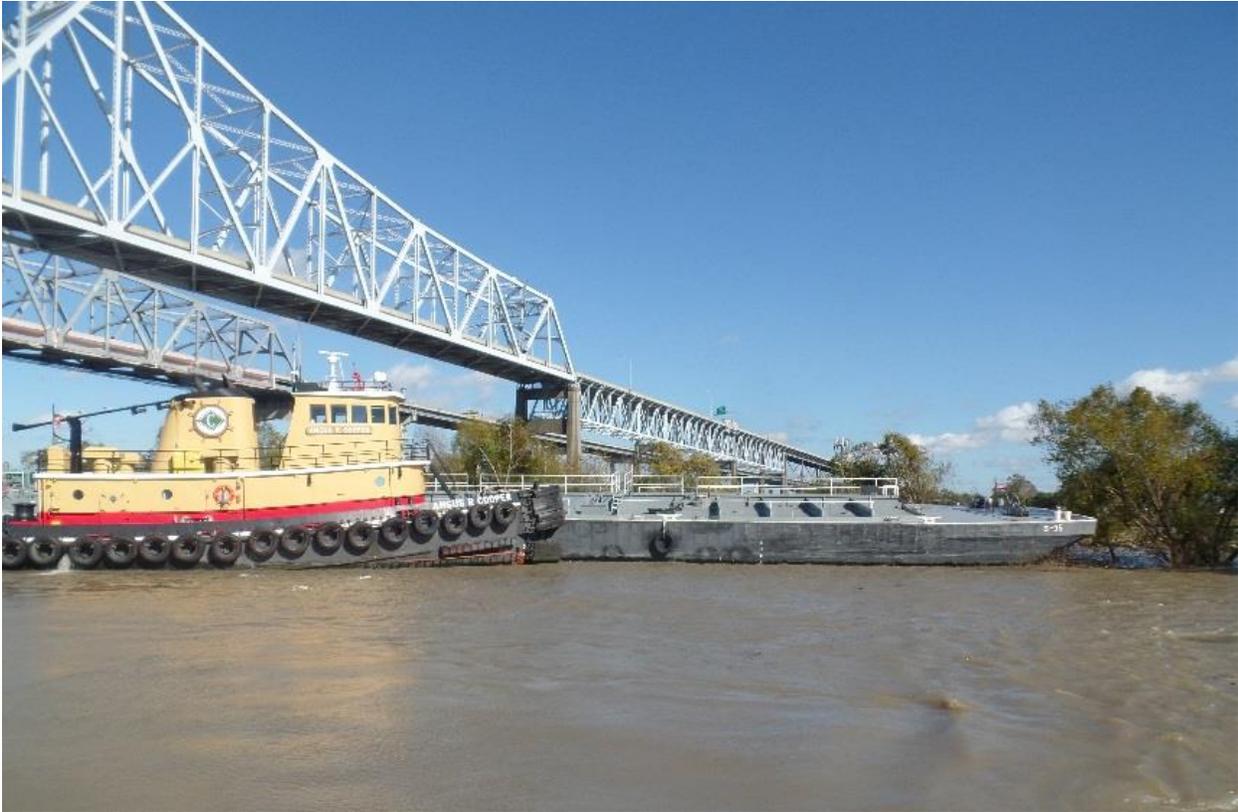
Tank barge *S-35* grounded on the river's right descending bank and was held in place by the *Angus R Cooper*. Before the other vessels assisting with the recovery effort could collect the adrift barges, one of the barges struck and damaged the starboard side of the passenger ferry *Col. Frank X. Armiger*, which was shut down for the evening and moored at the Algiers Ferry Landing at mile marker 94.8.

Towing vessel *Angus R Cooper*, holding damaged tank barge *S-35* against the right descending bank of the Mississippi River. The Crescent City Connection bridge is visible in the background. (Photo by Coast Guard)
