National Transportation Safety Board

Marine Accident Brief

Collision between Towing Vessel *William E Strait* and *Margaret Ann* Tow

Accident no.	DCA16FM010
Vessel names	<i>William E Strait</i> and <i>Margaret Ann</i> tow
Accident type	Collision
Location	Lower Mississippi River (LMR), mile marker 727.4
Date	December 14, 2015
Time	1122 central standard time (coordinated universal time – 6 hours)
Injuries	None
Property damage	Estimated \$2 million
Environmental damage	Approximately 700 gallons of oil and diesel released
Weather	Clear, visibility 10 miles, winds 13 mph with gusts to 23 mph from the southwest, air temperature 45°F
Waterway information	LMR near Memphis, Tennessee; river stage 17.7 feet and falling, current running between 1.5 and 2 knots

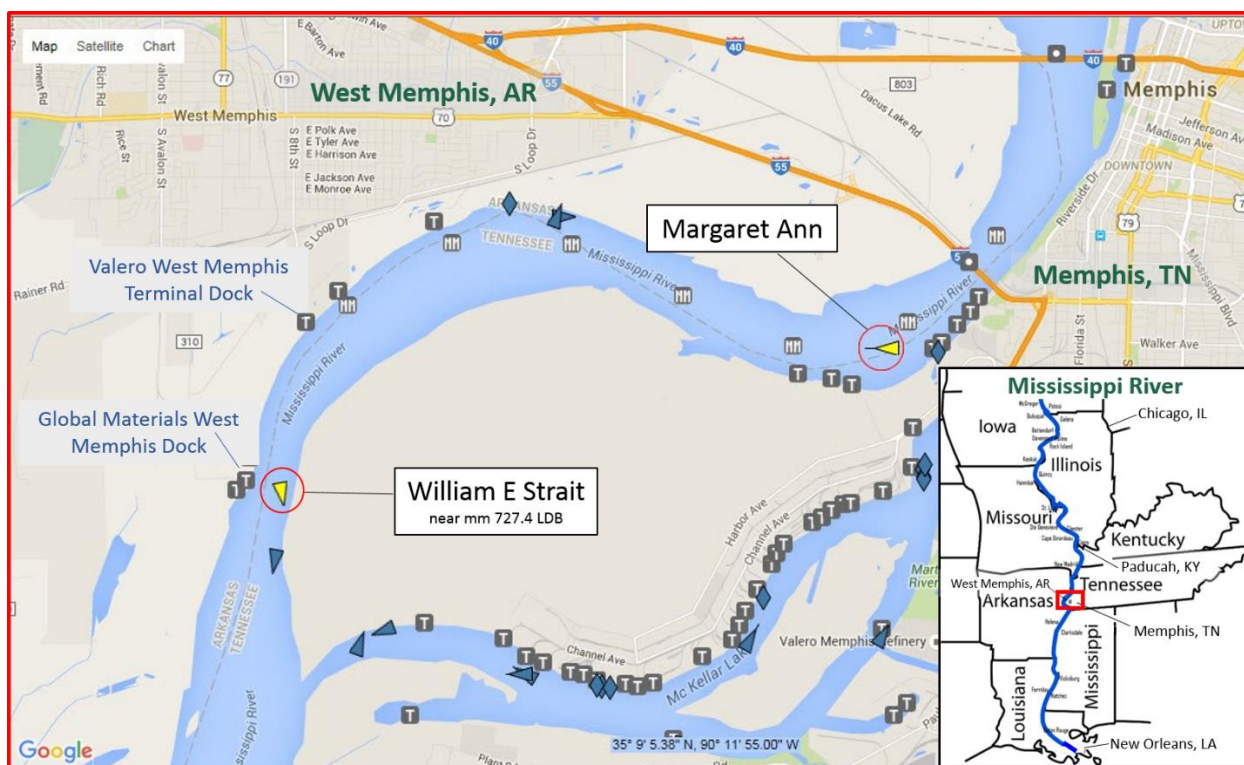
PortVision AIS data playback image showing the river contour and the positions of the downbound *Margaret Ann* and *William E Strait* at 1045 on the morning of the accident.

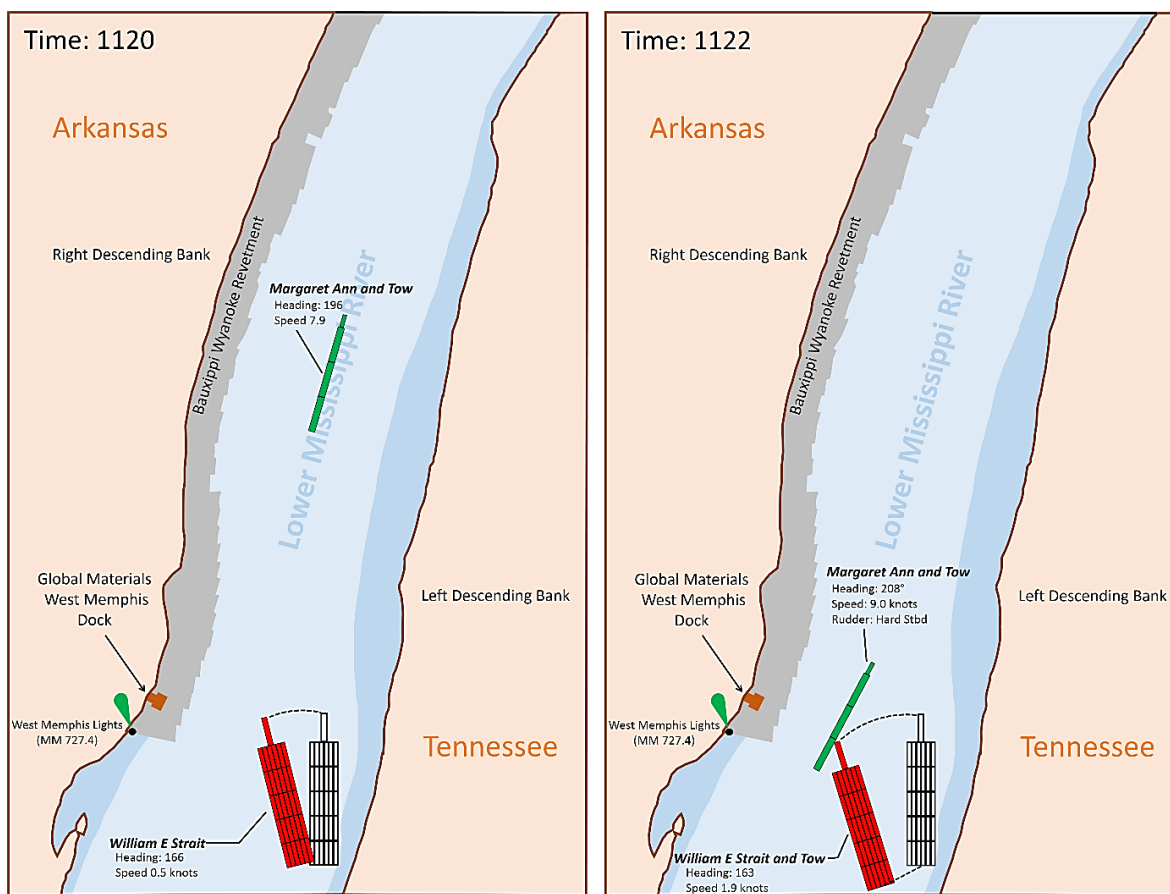
The pilot on the *Margaret Ann* told investigators that, shortly after the communication, the stern of the *William E Strait* continued to swing toward the center of the channel with increased speed. The *Margaret Ann* took evasive maneuvers, which included application of hard-starboard rudder with full-ahead throttle, in an attempt to keep the raked bow of the lead barge, *MM-66*, from impacting the stern of the *William E Strait* and subsequently riding up onto the vessel. The *Margaret Ann* pilot used the internal communication system to alert the crew of the imminent collision. On the *William E Strait*, the captain, who had returned to the wheelhouse, sounded the vessel's horn to alert his crew of the emergency. The aft port side of barge *MM-66* and the port bow of barge *MM-41B* struck the aft starboard corner of the *William E Strait* hull. At 1122, just prior to the collision, the *Margaret Ann* speed was 9 knots.

The *William E Strait* and *Margaret Ann* tows in the moments leading up to the collision. Scale approximate based on vessel dimensions and AIS data.

The pilot of the *William E Strait* did not hold the vessel and tow's position along the left bank as he had agreed to do when arrangements were made with the pilot on the *Margaret Ann*. Additionally, his attempt to apply forward propulsion and starboard rudder in an effort to swing the stern of the *William E Strait* back toward the bank was neither timely nor effective.

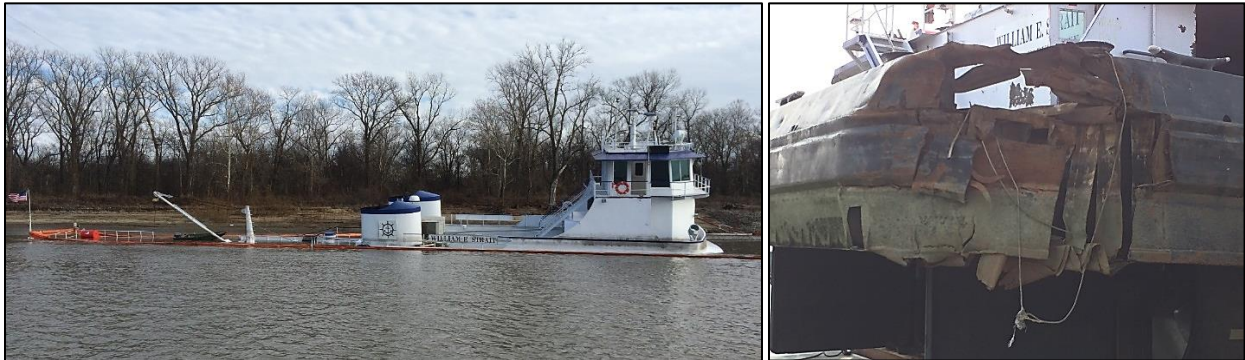
As a result of the collision, barge *MM-66* sustained a hull penetration to its stern void and broke free from the tow string of the *Margaret Ann*, while barge *MM-41B* received damage to its bow and forward deck area. Both barges had significant structural damage as well. The *William E Strait* sustained a 6-foot by 5-foot opening in its hull at the point of impact, which allowed rapid flooding of the engine room. Additionally, the force of the collision pushed the port bow of the *William E Strait* into barge *MTC 6401*, which was in the last row of its tow flotilla, holing the barge's stern void.

The pilot on the *William E Strait* managed to maneuver the vessel and its flotilla back to the left bank with the assistance of the uninspected towing vessel *Paige L Strait*. The crew then boarded the aftermost barge in the flotilla before the *William E Strait* partially sank and came to rest on the river bottom with the uppermost structure of the vessel still above the water's surface. The *Margaret Ann*, with the assistance of the uninspected towing vessel *Lee Leavell*, recovered the *MM-66* and proceeded to McKellar Lake, just off of the Mississippi River near the accident site. There it began pumping out the water in the stern void of the *MM-66* while awaiting the arrival of Coast Guard personnel.

Left image is of the partially submerged *William E Strait* taken shortly after the collision. The wheelhouse, exhaust stacks, davit system, and aft flag staff are seen above the surface of the river. Right image, taken after the vessel was salvaged, is of the damaged hull near the starboard stern.

In October 2014, the Coast Guard performed a towing vessel examination on the *William E Strait* and the examiner identified several watertight integrity concerns on the vessel. The discrepancies, including watertight hatches in need of gaskets and improper penetrations of a watertight bulkhead, were both in the area of the engine room known as shaft alley. The report also stated the need to ensure all watertight hatch securing devices were functioning correctly, but did not specify exact locations. In a post-accident drydock survey, there was no evidence found by investigators that indicated these items in engine room had been corrected, which possibly accounts for the rapid down flooding after the collision.
