National Transportation Safety Board

Marine Accident Brief

Allision of Barge *Gayle Force*, Under Tow by Tugboat *Simone*, with Norfolk Southern Bridge #7

Accident no.	DCA15LM021
Vessel names	<i>Gayle Force</i> , <i>Simone</i>
Accident type	Allision
Location	Chesapeake, Virginia, 36°46.5' N, 076°17.7' W
Date	April 26, 2015
Time	0720 eastern daylight time (coordinated universal time – 4 hours)
Injuries	None
Damage	Estimated \$1.8 million damage to the bridge
Environmental damage	None
Weather	Overcast, visibility 6 miles*, winds 5 knots from the north, air temperature 50°F
Waterway information	Southern Branch of the Elizabeth River, calm with 0.5 knot ebb current

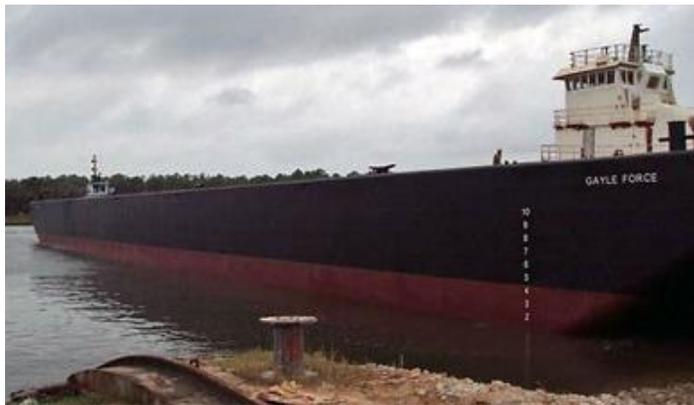
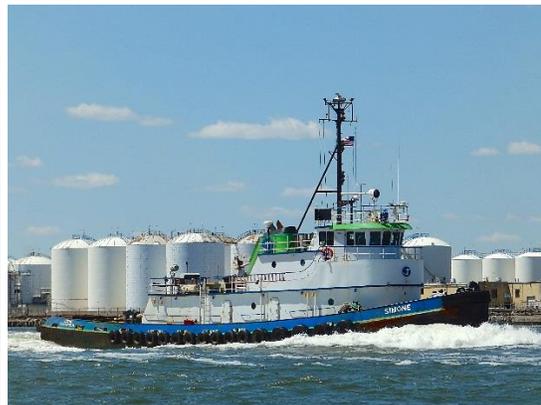
Photo left is barge *Gayle Force*, unloaded. Photo right is tugboat *Simone* under way. (Photos courtesy of Coastal Precast Systems and Will Van Dorp, tugster.wordpress.com)

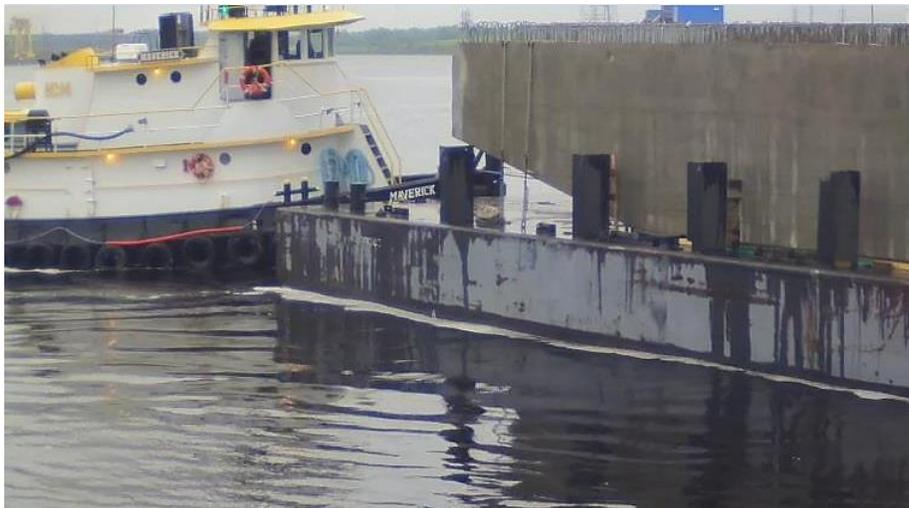
Starboard quarter of *Gayle Force* with pre-cast cement structures on deck and tugboat *Maverick* in background. (Video frame capture courtesy of Norfolk Southern Corporation)

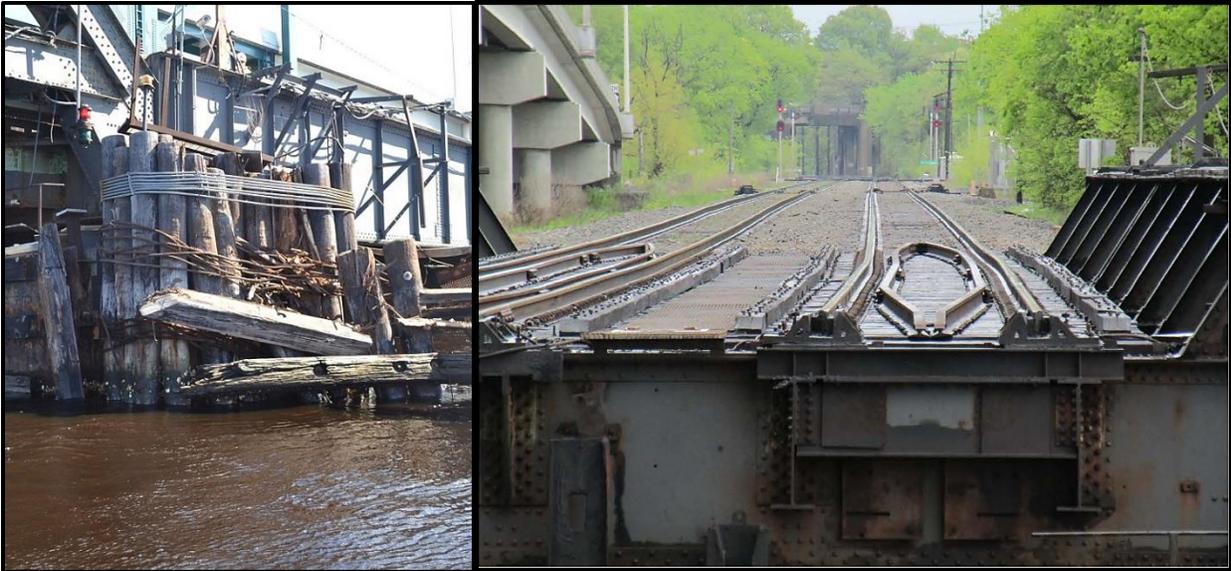
At 0720, the starboard bow of the *Gayle Force* struck the southeast fendering dolphin and concrete piers supporting the NS#7 bridge span. According to automatic identification system (AIS) data, the barge was making a speed of 4.4 knots when it struck the bridge. The timber dolphin was crushed and deformed, and the piers shifted laterally 15 inches toward the north. The rail alignment between the lift span and stationary track was misaligned by 11 inches, shutting down railroad traffic for 36 hours.

Photo left shows damage to NS#7's timber fendering dolphin. Photo right shows misaligned rails caused by the shifting of concrete piers.

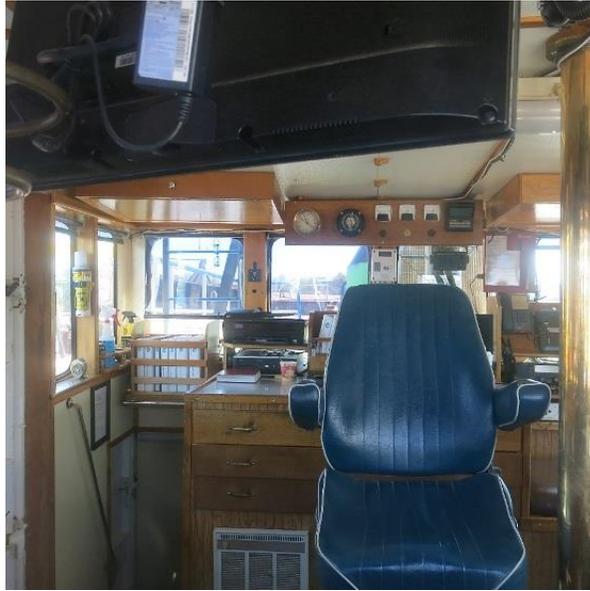
The *Simone* captain did not plan for the bridge transit in accordance with his company's policies and procedures. He did not have a clear view astern, so he relied on the mate to assist him in properly aligning the tow for the passage. But he gave no instruction to the mate. The tugboat *Maverick* was provided to assist the tow for the bridge transits of the Elizabeth River, yet the captain of *Simone* did not use the assist tugboat or ask for the *Maverick* captain's advice despite the latter's extensive experience in these waters. The *Maverick* captain was not given any directions, and the assist tugboat was placed in a location where his view was obstructed.

View from *Simone*'s starboard conning station looking aft through wheelhouse windows.
