National Transportation Safety Board

Marine Accident Brief

Towing by Coast Guard Cutter *Kiska* of Recreational Vessel *Kolina*, Resulting in Loss of Life, Alenuihaha Channel South of Maui, Hawaii, November 5, 2015

Accident no.	DCA16PM005
Vessel names	<i>Kiska</i> and <i>Kolina</i>
Accident type	Tow evolving into search-and-rescue/person-in-the-water mission
Location	26 nautical miles south of Maui, Hawaii, 20°08'35.0"N, 156°20'05.8"W
Date	November 5, 2015
Time	About 2305 Hawaii-Aleutian standard time (coordinated universal time – 10 hours)
Injuries	One fatality
Property damage	Total loss of the <i>Kolina</i> , estimated at \$25,000
Environmental damage	None reported
Weather	Scattered showers, east-northeast winds gusting up to 34 knots, seas at 8–10 ft, water temperature 81°F, air temperature 82°F
Waterway information	Alenuihaha Channel separates the islands of Hawaii and Maui, is 26 miles wide at its narrowest point, and about 6,800 feet deep

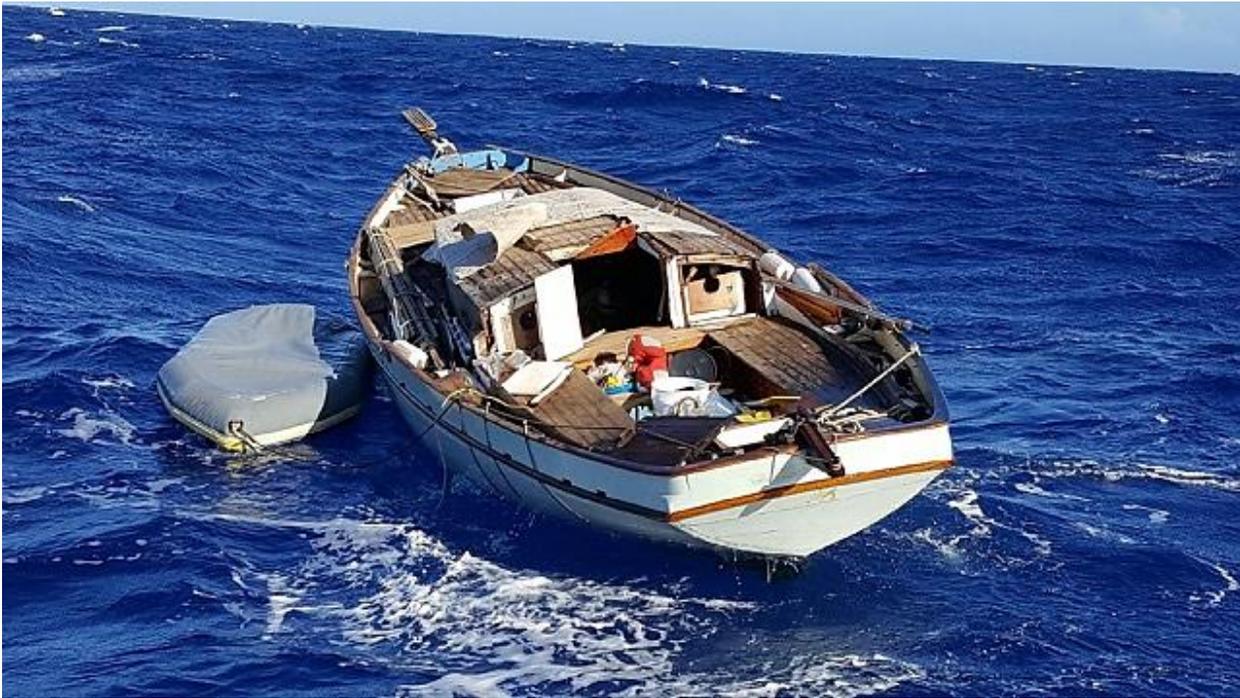
mizzenmast was not supported to compensate for this size disparity; nothing was preventing the mizzenmast from moving laterally inside the collar. Furthermore, the mizzenmast was inadequately equipped with only polypropylene line instead of customary wire-rope standing rigging. In addition, the bridle should have been secured to several strong points over the length of the vessel; however, because of the *Kolina*'s lack of deck fittings, forward cleats, and a bullnose chock at the bow, the captain attached the bridle only to the unsupported mizzenmast base. The bridle, if properly secured, also would have reduced yawing (or twisting/oscillation) of the *Kolina* during the tow; however, because the bridle was attached only to the single focal point of the mizzenmast, yawing was not as controlled.

⁹ The mizzenmast had snapped near its base, unable to withstand the point-loading that the captain configured for the tow.

***Kolina* on the morning after the accident. Not visible in this photo is the broken mizzenmast and rigging in the water off the starboard bow. (Photo by Coast Guard)**

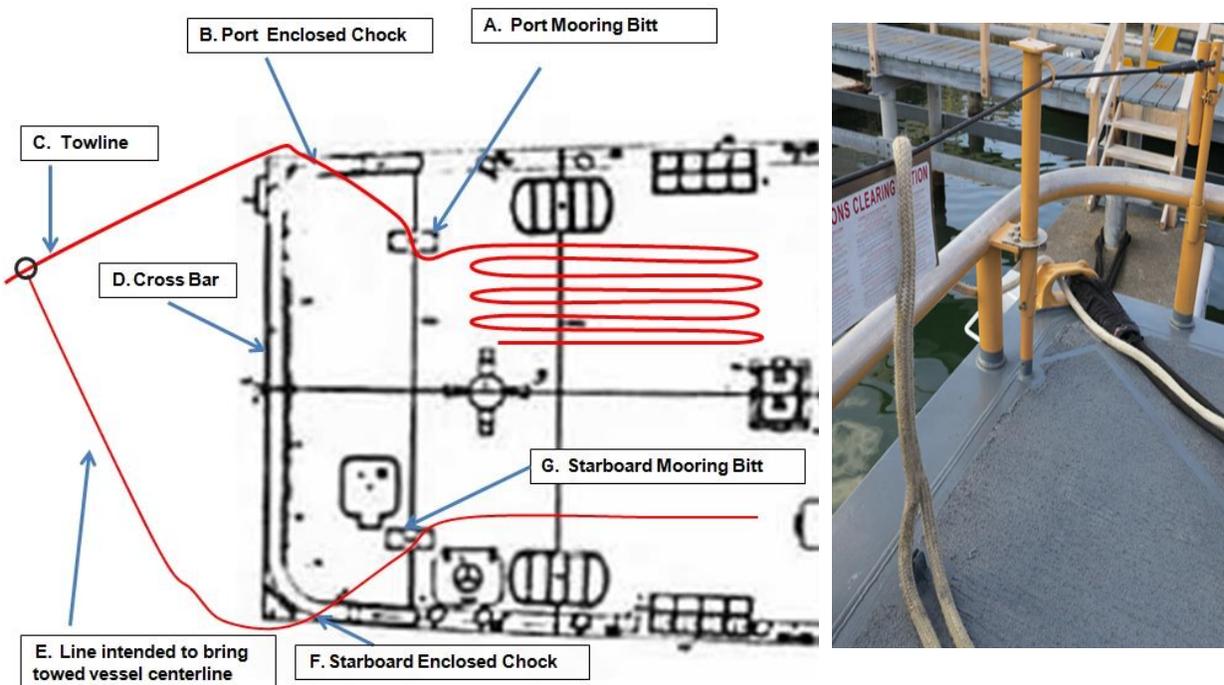
The standard towing configuration for the cutter was not used during the tow because, on October 27 when the *Kiska* was moored in Hilo, the starboard horn of the tow bitt sheared during heavy surging. While en route to the *Kolina*, crewmembers noted that the *Kiska*'s aft starboard bitt, typically used for mooring lines, had a small surface crack. Although the *Kiska* crew did not believe the crack to be structural, the damaged towing bitt required the crew to use an alternative configuration to mitigate risk. Because the *Kolina* was a relatively small and lightweight vessel, the *Kiska* crew concluded that using a towing bitt was unnecessary and that the towline could be attached to the *Kiska*'s aft portside mooring bitts. Accordingly, the crew ran the towline off the port side through an enclosed chock (see next image).

Left, image of *Kiska*'s towing configuration, depicted by a Coast Guard party representative. Right, photo of a section of *Kiska*'s stern, where the tow was configured.

configured. Investigators found no evidence that the Coast Guard's towing configuration played a role in the accident.

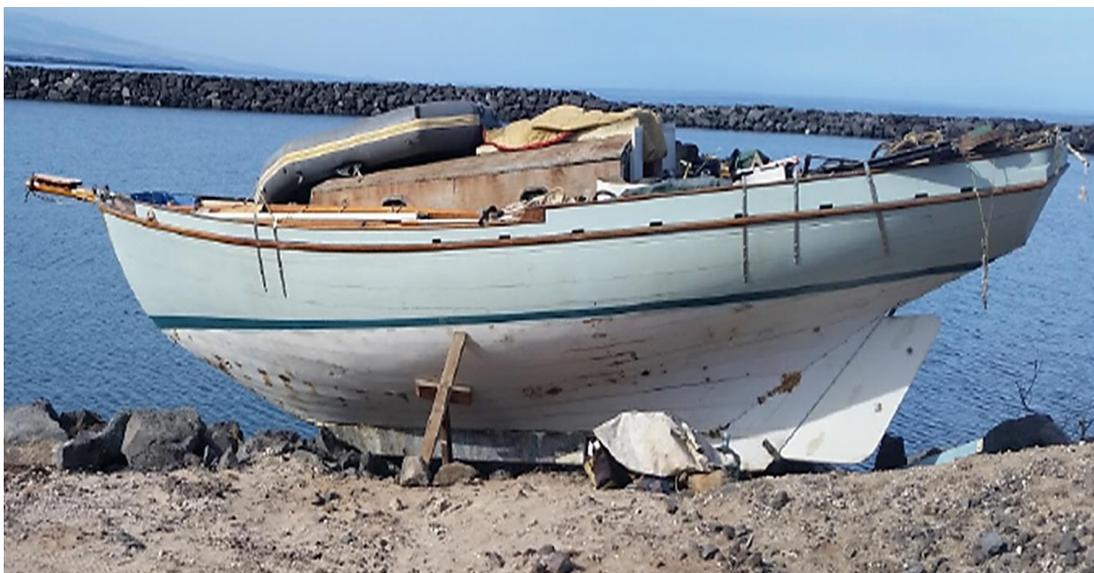
At the South Small Boat Harbor, Apana Crane Service made several attempts to place the *Kolina* in the water. However, seawater was entering through the *Kolina*'s wooden hull planking, and the leaks did not subside even after the wooden planks swelled in the water. Because the flooding exceeded the *Kolina*'s bilge pump discharge capacity, the crane operator finally placed the vessel on the harbor's revetment wall.

Photo of *Kolina* on the revetment wall at South Small Boat Harbor, Kawaihae, Hawaii. (Photo by DLNR)

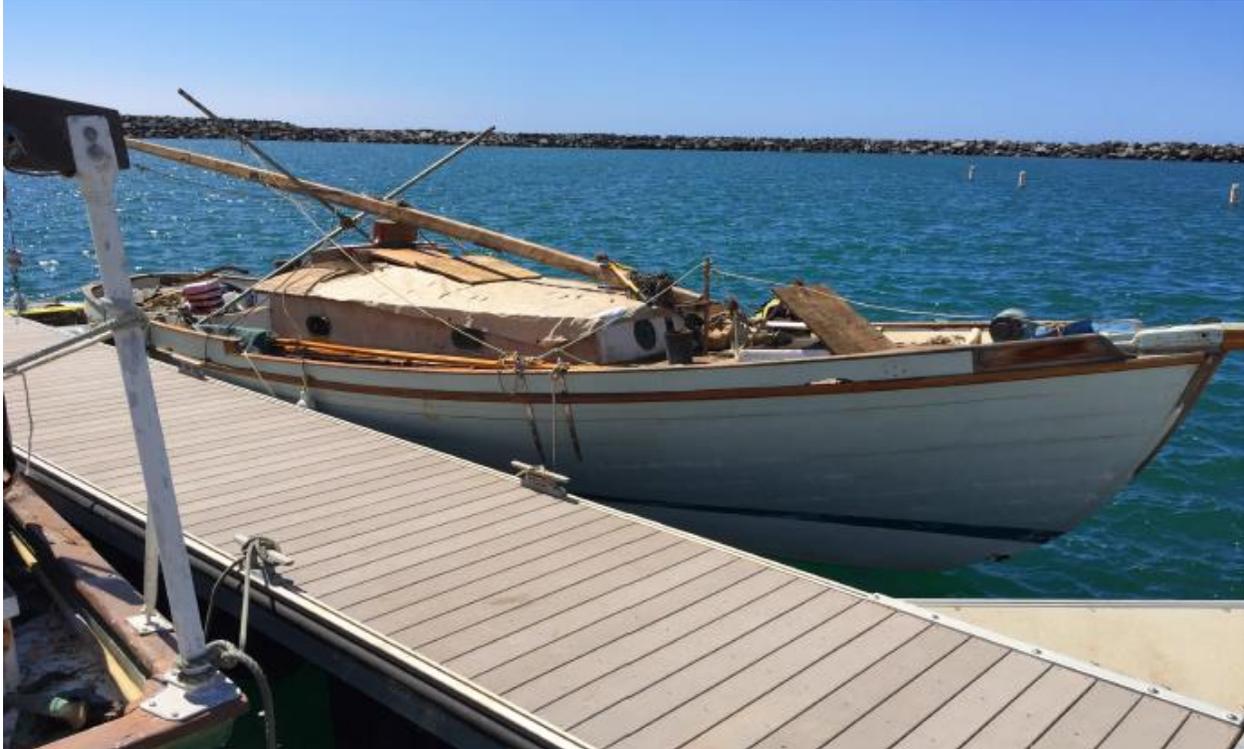
Kolina at South Small Boat Harbor, Kawaihae, Hawaii. (Photo by DLNR)
