# National Transportation Safety Board

## Marine Accident Brief

### Fire Aboard Freighter *Alpena*

<b>Accident no.</b>	DCA16FM012
<b>Vessel name</b>	<i>Alpena</i>
<b>Accident type</b>	Fire
<b>Location</b>	Fincantieri Bay Shipbuilding, Sturgeon Bay, Wisconsin Approx. 44°50'28"N, 87°22'55"W
<b>Date</b>	December 11, 2015
<b>Time</b>	1730 central standard time (coordinated universal time – 6 hours)
<b>Injuries</b>	None
<b>Property damage</b>	Estimated at \$4 million
<b>Environmental damage</b>	None
<b>Weather</b>	Clear visibility, calm winds, air temperature 45°F
<b>Waterway information</b>	Graving dock in Sturgeon Bay, Wisconsin

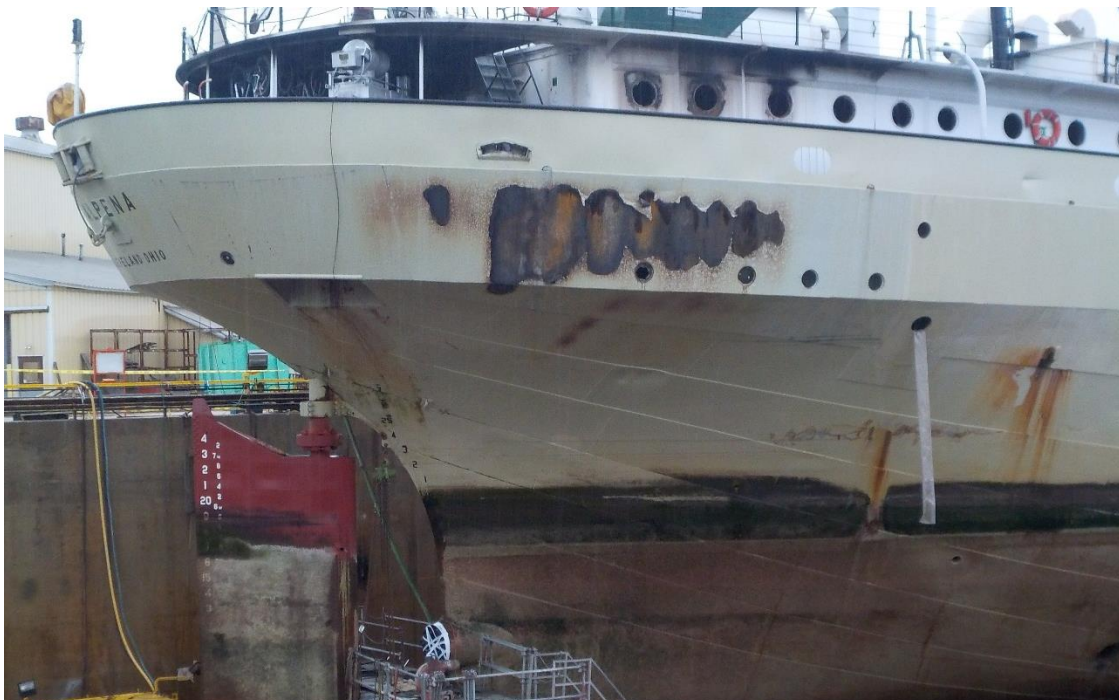
***Alpena* with fire damage to the hull paint on the starboard quarter and burned-out portholes on the superstructure. (Photo by Coast Guard)**

On December 16, 2015, the fire chief led investigators through the various fire affected spaces. A subsequent survey report stated that the ongoing welding activities showed “no evidence of being connected to the fire.” Rather, the fire appeared to have started in the electrical control room and subsequently spread to the steering gear flat and paint locker located in the aft section of the engine room. The fire also spread to the dining room, galley, and several staterooms located on the main deck.

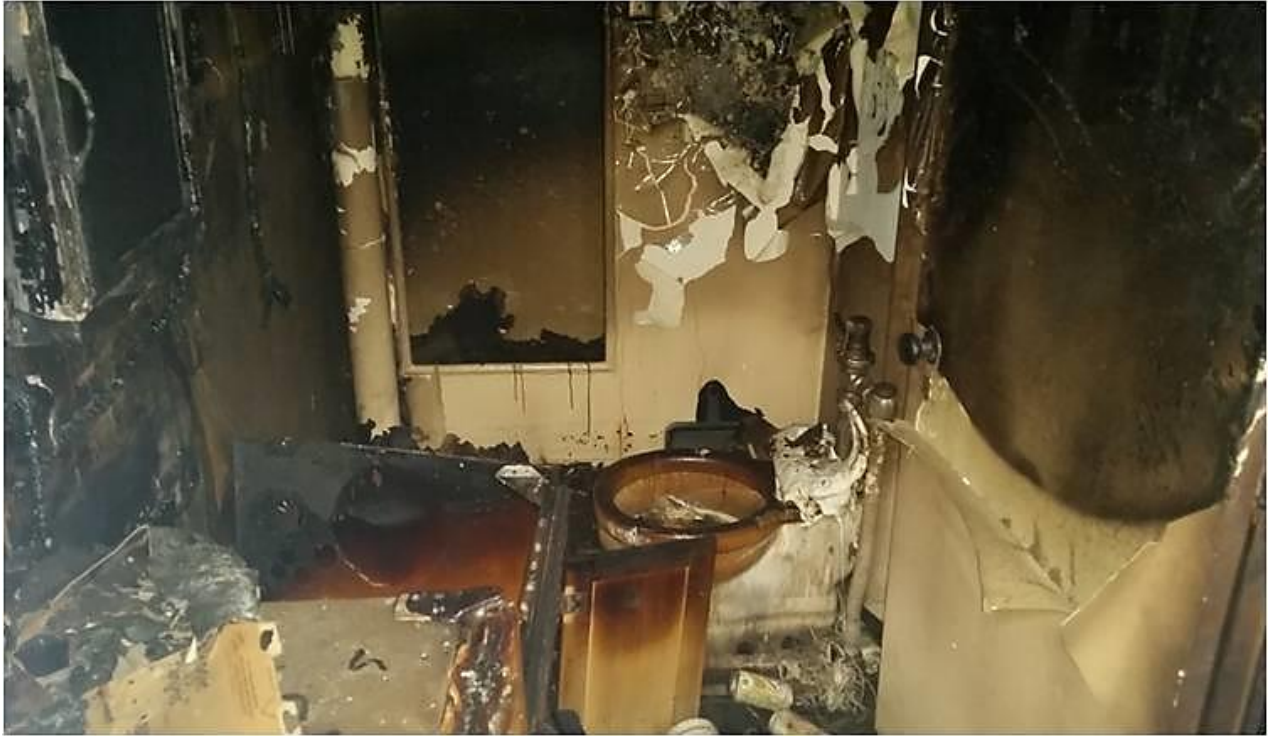
**Fire damage to one of the *Alpena* bathrooms. (Photo by Coast Guard)**

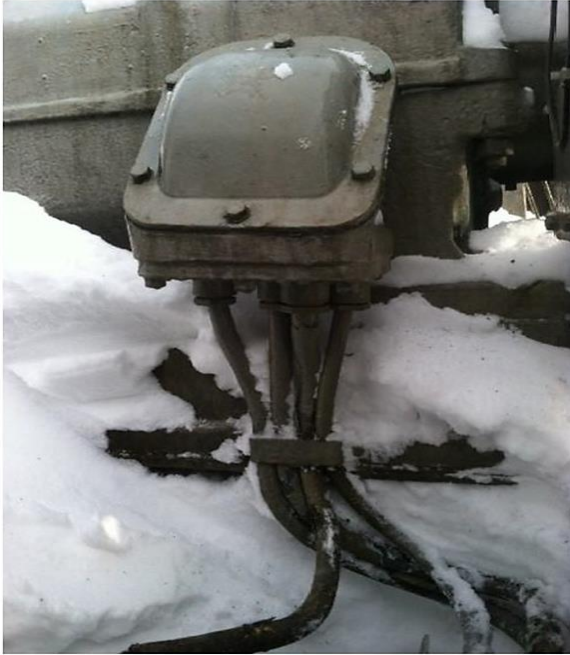
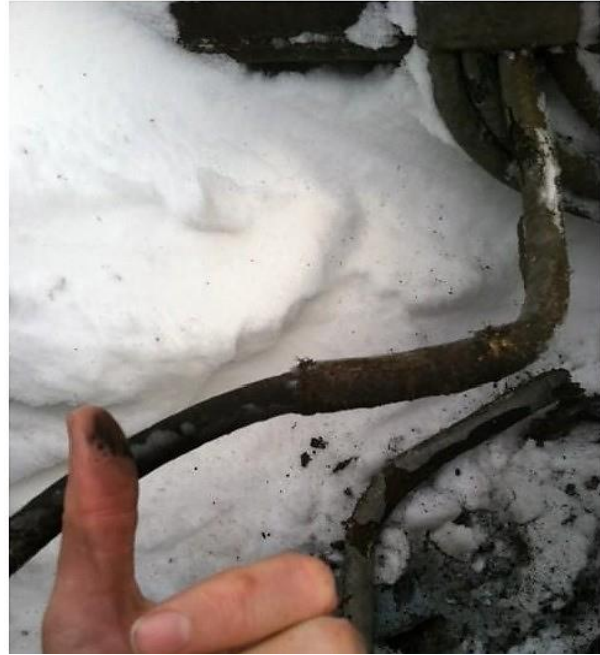
Based on both the Coast Guard and the local fire department investigations, the most likely cause of the fire was an electrical fault in the wiring from the electrical control panel to the aft winch. The electrical system for the aft winch was original to the vessel and complied with regulations for original equipment; however, it did not have the more extensive circuit protection that modern shipboard electrical systems have. (According to the Coast Guard, planned postaccident modifications to the *Alpena* would feature additional circuit protection in accordance with current regulations.) The power cable to the aft winch was completely melted for a length of 10–15 feet. Similar conductors in the same wiring bundle were not damaged, which led investigators to believe that this specific conductor experienced a fault of some kind rather than being destroyed by the heat of the ensuing fire. As further evidence to support this conclusion, the same cable’s sheathing and insulation had signs of significant deterioration on the boat deck, several decks above where the fire started, where the aft winch is located. This area of the vessel was not affected by the fire.

Left, the bundled wires running from the electrical control panel to the aft anchor winch. Right, the outer sheathing of the wire in its decayed and deteriorated condition. (Photos by Coast Guard)

Fire department investigators noted that an electrical fault at the winch (which would have resulted in high current flow in the wiring circuit) could have possibly caused further electrical faults in the winch circuit resulting in a switchboard/fuse overload.

The National Transportation Safety Board determines that the probable cause of the fire aboard the *Alpena* was a fault in the electrical wiring providing power to the aft anchor winch.

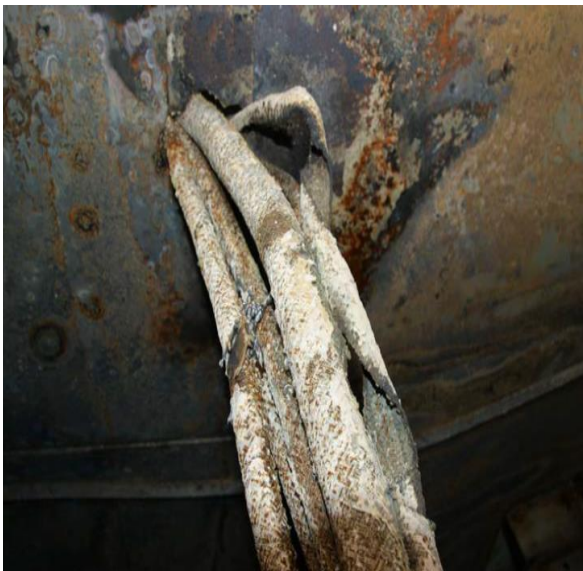
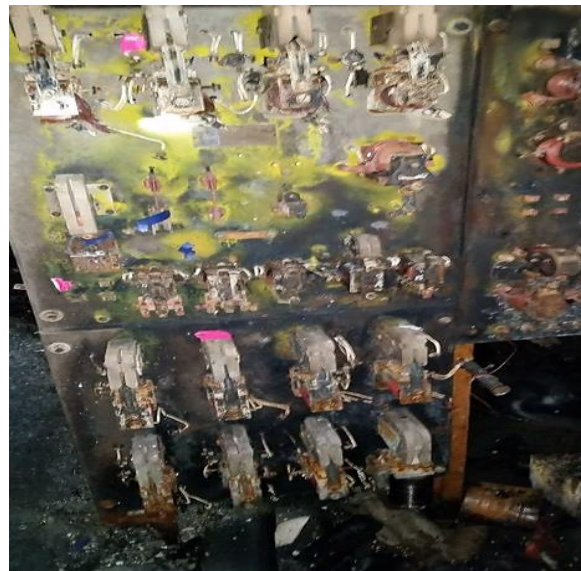
Another potential fault source could have been caused by chafing, which damages the protective sheathing and reduces the thickness of a conductor's insulation jacket over time. The wiring in the electrical control room had areas susceptible to chafing, specifically where the wires passed through sheet metal unprotected from its rough edges. According to the Coast Guard, the fire damage prevented full assessment of the pre-existing adequacy of this through-metal passage; however, planned postaccident modifications would feature protection for wire passage points.

Left, the deteriorated state of the outer sheathing insulation jacket of the wire and possible rough chafing points where the bundle passes through steel. Right, the electrical control panel where the fire may have started. (Photos by Coast Guard)
