# National Transportation Safety Board

## Marine Accident Brief

### Allision of Fishing Vessel *Ferrigno Boy* with Ventura Harbor Boatyard Travel Lift Pier

<b>Accident no.</b>	DCA15LM029
<b>Vessel name</b>	<i>Ferrigno Boy</i>
<b>Accident type</b>	Allision
<b>Location</b>	Ventura Harbor, California, 34°15.0' N 119°16.0' W
<b>Date</b>	July 29, 2015
<b>Time</b>	1030 Pacific daylight time (coordinated universal time – 7 hours)
<b>Injuries</b>	None
<b>Damage</b>	Estimated \$850,000 to the Ventura Harbor Boatyard travel lift pier
<b>Environmental damage</b>	No pollution reported
<b>Weather</b>	Clear, visibility 6.5 nautical miles, winds east-southeast at 11.4 mph, calm seas, air temperature 71°F
<b>Waterway information</b>	Ventura Harbor is a 274-acre multiple-use recreational and commercial fishing small craft harbor.

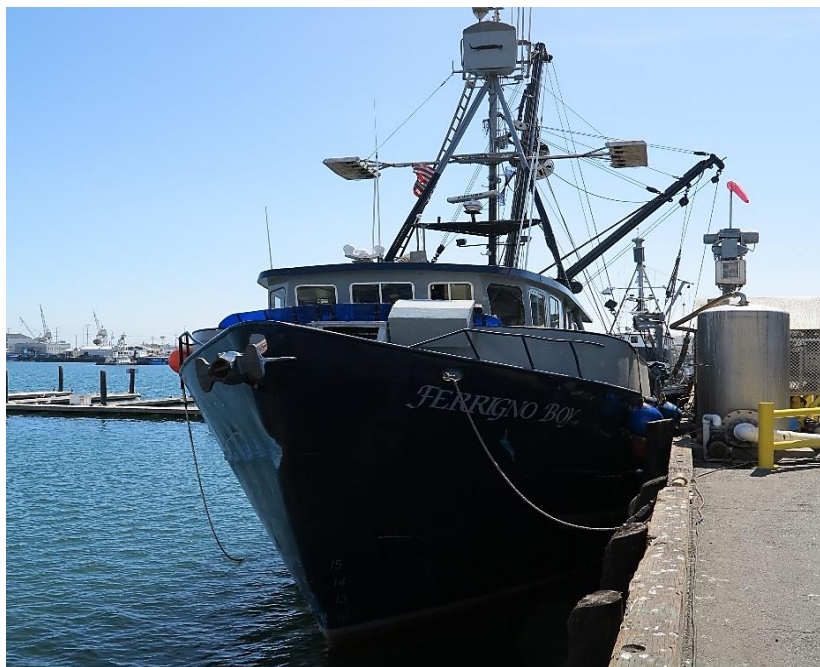
*Ferrigno Boy* pier-side in Port of Los Angeles, California, after the accident.

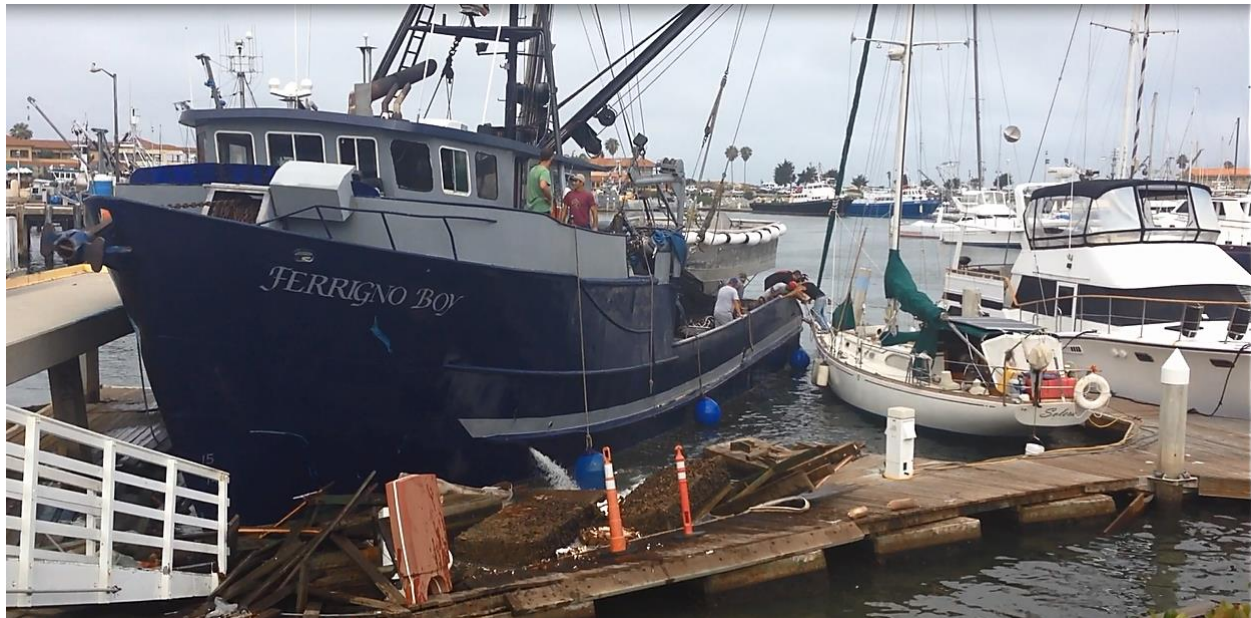
were parallel to the harbor shoreline. The recreational sailing vessel *Solera*, moored at a slip next to the travel lift pier, was also damaged during the accident when its bowsprit was impacted by *Ferrigno Boy*'s port quarter.

***Ferrigno Boy* after alliding with the Ventura Harbor Boatyard travel lift pier concrete deck, pilings, and floating docks. (Photo by Ventura Harbor Boatyard)**

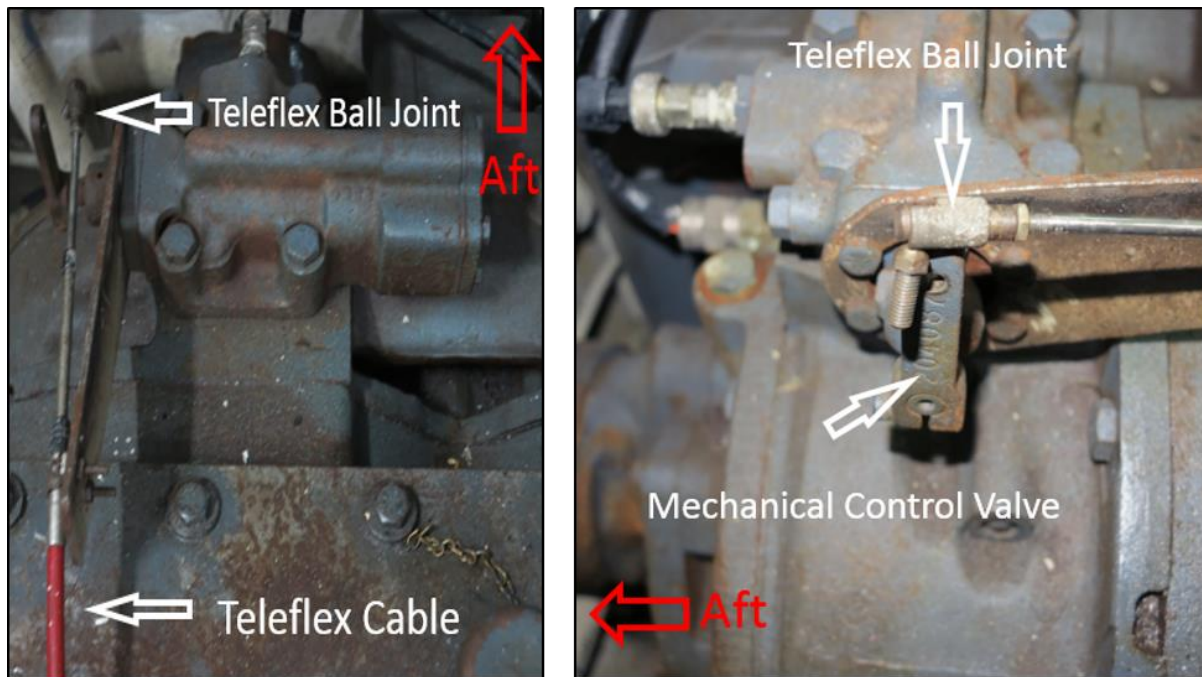
The navigation controls on the *Ferrigno Boy* consisted of an integrated throttle that controlled both the propulsion engine RPM and the transmission. The transmission coupled the engine driveshaft to the propeller shaft in either the forward or astern (reverse) direction, or decoupled the engine for neutral. The captain told investigators that he went down to the machinery spaces shortly after the accident to ensure the vessel was not taking on water and noticed that the Teleflex Morse shift cable, which linked the throttle controls on the bridge and bridge wings to the transmission's mechanical control valve, was not attached to the valve lever, as depicted in the next picture.

**Left: top view of Twin Disc main propulsion marine transmission and Teleflex Morse 33C Supreme cable with Teleflex ball joint control 33C not connected. Right: side view of Teleflex ball joint control 33C with 7/16" stud disconnected and lock washer and nut missing.**

Because the Teleflex control cable was disconnected from the mechanical control valve lever, the transmission remained in the forward position despite the captain's command inputs for neutral and reverse. As the captain applied increasing RPM with the throttle, the vessel continued to accelerate ahead until he shut down the engine.

The National Transportation Safety Board determines that the probable cause of the allision of the fishing vessel *Ferrigno Boy* with the Ventura Harbor Boatyard travel lift pier and the sailing vessel *Solera* was the fishing vessel's transmission control cable not being correctly fastened to the Twin Disc mechanical control valve shift lever in accordance with the manufacturer's recommended instructions.

The captain notified the owner and Coast Guard of the disconnected cable and reconnected it. He used two nuts on the ball joint control stud, the threaded connection to the transmission mechanical control valve lever, to prevent it from loosening again. He described for investigators the technique he used to fully tighten the second nut: using an open-ended wrench on the first nut to maintain the position, while applying torque to the second nut with a closed-end wrench. As a precautionary measure, the captain also fastened a closed-end wrench on the second nut and tied a rope around the transmission mechanical control valve prior to departing Ventura Harbor en route to the vessel's home port of San Pedro, California, a day after the accident.

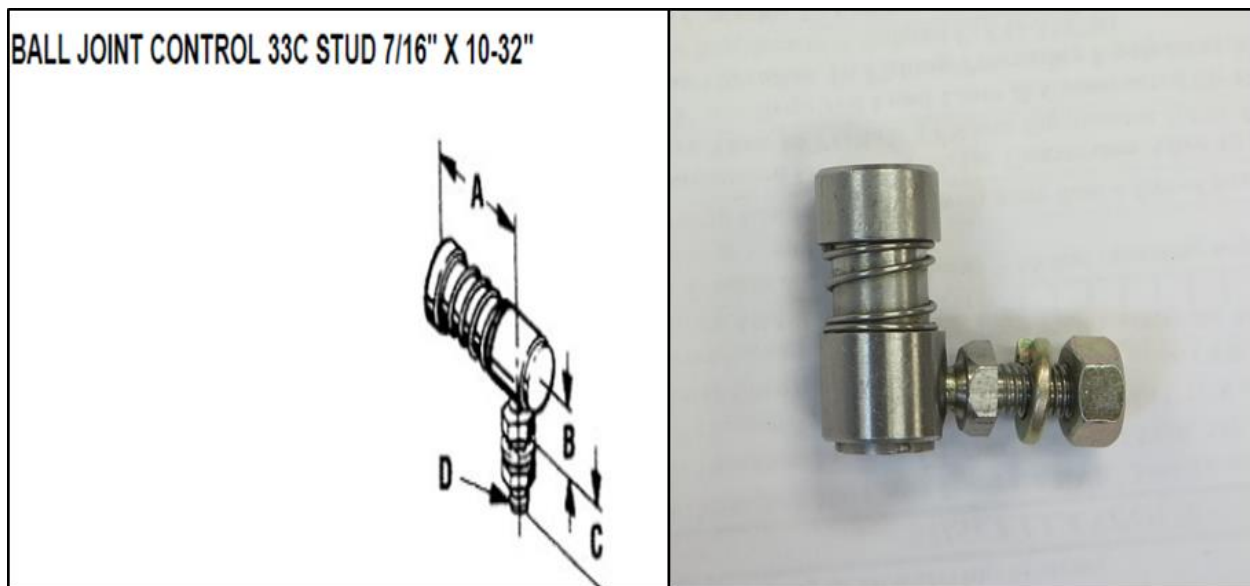
Teleflex Morse, the control system manufacturer, offers several connection kits that are compatible with the mechanical control valve installed on the *Ferrigno Boy*. According to the manufacturer, the recommended kit for this installation is the Ball Joint Control 33C stud 7/16" X 10-32" as depicted in the image below on the left. This is the same ball joint control stud kit used to fasten the cable to the mechanical control valve lever on the fishing vessel's transmission after the accident. Investigators concluded, therefore, that the disconnection was not due to an improper connection kit. Rather, it was likely due to the control cable Teleflex Morse ball joint 33C stud 7/16" X 10-32" not being correctly fastened to the Twin Disc mechanical control valve shift lever in accordance with the manufacturer's recommended connection kit nut with lock washer.

**Left: Teleflex Morse Ball Joint Control 33C with 7/16" stud. Right: Ball Joint Control 33C used to refasten the cable to the mechanical control valve lever on the *Ferrigno Boy* after the accident.**
