# National Transportation Safety Board

## Marine Accident Brief

### Collision between *Dewey R Tow* and *P. B. Shah Tow*

<b>Accident no.</b>	DCA15LM034
<b>Vessel names</b>	<i>Dewey R tow</i> and <i>P. B. Shah tow</i>
<b>Accident type</b>	Collision
<b>Location</b>	Lower Mississippi River, mile marker (mm) 937, near Columbus, Kentucky
<b>Date</b>	September 2, 2015
<b>Time</b>	1959 central daylight time (coordinated universal time – 5 hours)
<b>Injuries</b>	None
<b>Property damage</b>	\$1.1 million est.
<b>Environmental damage</b>	120,000 gallons of clarified slurry oil were released into the river; 3,392 tons of dewatered oily sediment were later recovered
<b>Weather</b>	Visibility 10 miles at twilight, northeast winds 2 mph, air temperature 80°F
<b>Waterway information</b>	Downbound on the Mississippi River in the accident area, the river bends 40 degrees to the right, from south to west, at Belmont Point. The US Army Corps of Engineers maintains the navigation channel at 9 feet deep and 300 feet wide at low water. Fleeting and provision operations take place between mm 936 and mm 942. Current at the time of the accident was 2.5 mph.

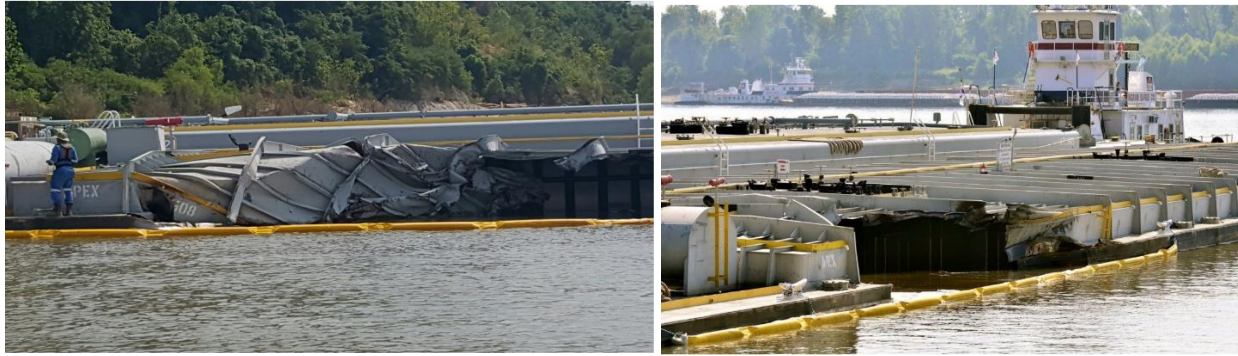
The collision breached the no. 3 starboard wing void and the no. 3 starboard cargo tank on the barge *APEX 3508*. The breach resulted in a discharge of 120,000 gallons of clarified slurry oil into the river.<sup>2</sup> Barge *APEX 1703* sustained damage to its deck cargo piping, and its cargo heater was dislodged from its mounts. The *ING 5713* sustained damage, including two punctures, over a 20-foot-wide area amidships, 6 feet from the deck knuckle, as well as a puncture near the port side of the rake. *IB1947*’s starboard bow corner was crushed and holed over a 9-foot-by-9-foot area from the 9-foot draft line down to the bottom knuckle. This damage extended about 6 feet to port from the starboard bow corner and 3 feet back on the side shell.

At left, damaged barge *APEX 3508* from *Dewey R* tow; at right, its shell and deck plate have been removed. (Photo by US Coast Guard)

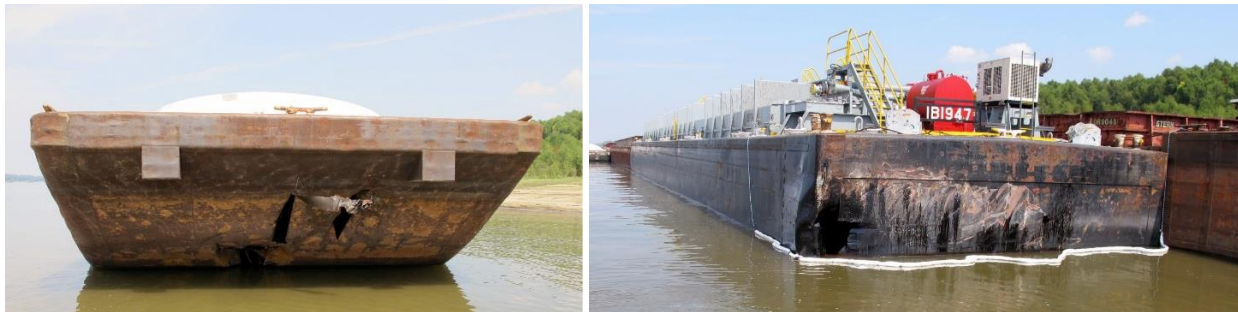
Damaged barges from *P. B. Shah* tow: at left, barge *ING 5713*; at right, barge *IB1947*.
