National Transportation Safety Board

Marine Accident Brief

Fire Aboard Containership *Gunde Maersk*

Accident no.	DCA16FM009
Vessel name	<i>Gunde Maersk</i>
Accident type	Fire
Location	Seattle, Washington
Date	December 8, 2015
Time	0509 Pacific standard time (coordinated universal time – 8 hours)
Injuries	None
Property damage	\$380,000
Environmental damage	None
Weather	Light rain, visibility 4 miles, ¹ winds south-southeast at 8.1 mph, air temperature 52°F
Waterway information	Elliott Bay, also known as the Port of Seattle, is a deep water port within Puget Sound

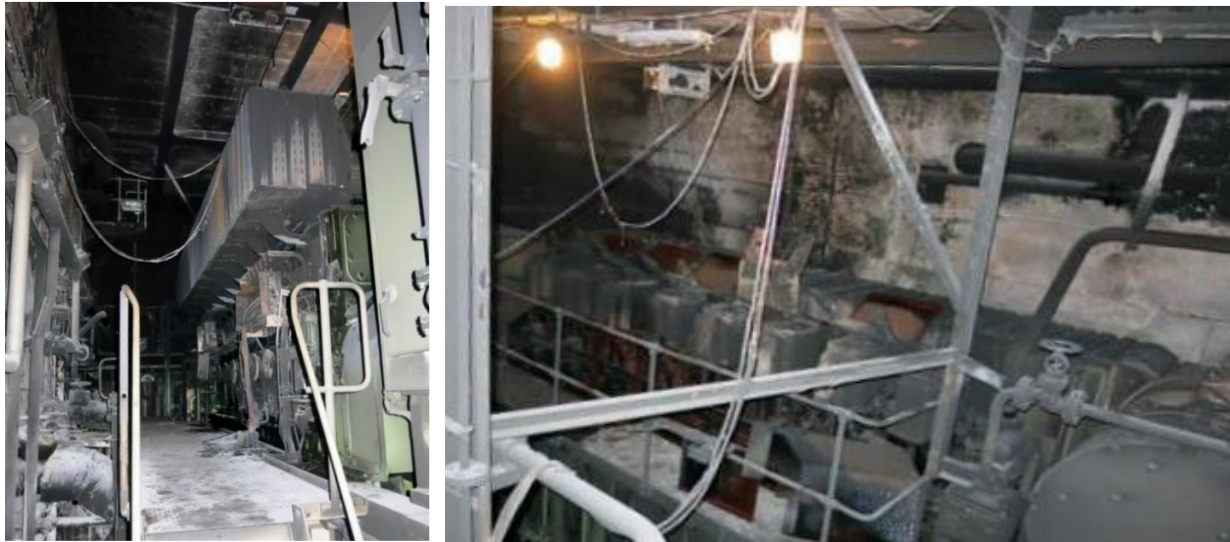
Fire damage to auxiliary engine no. 1. Left photo shows inboard side, looking forward; right photo shows the outboard side, looking aft. (Photos courtesy of Lavaretus Risk Engineering)

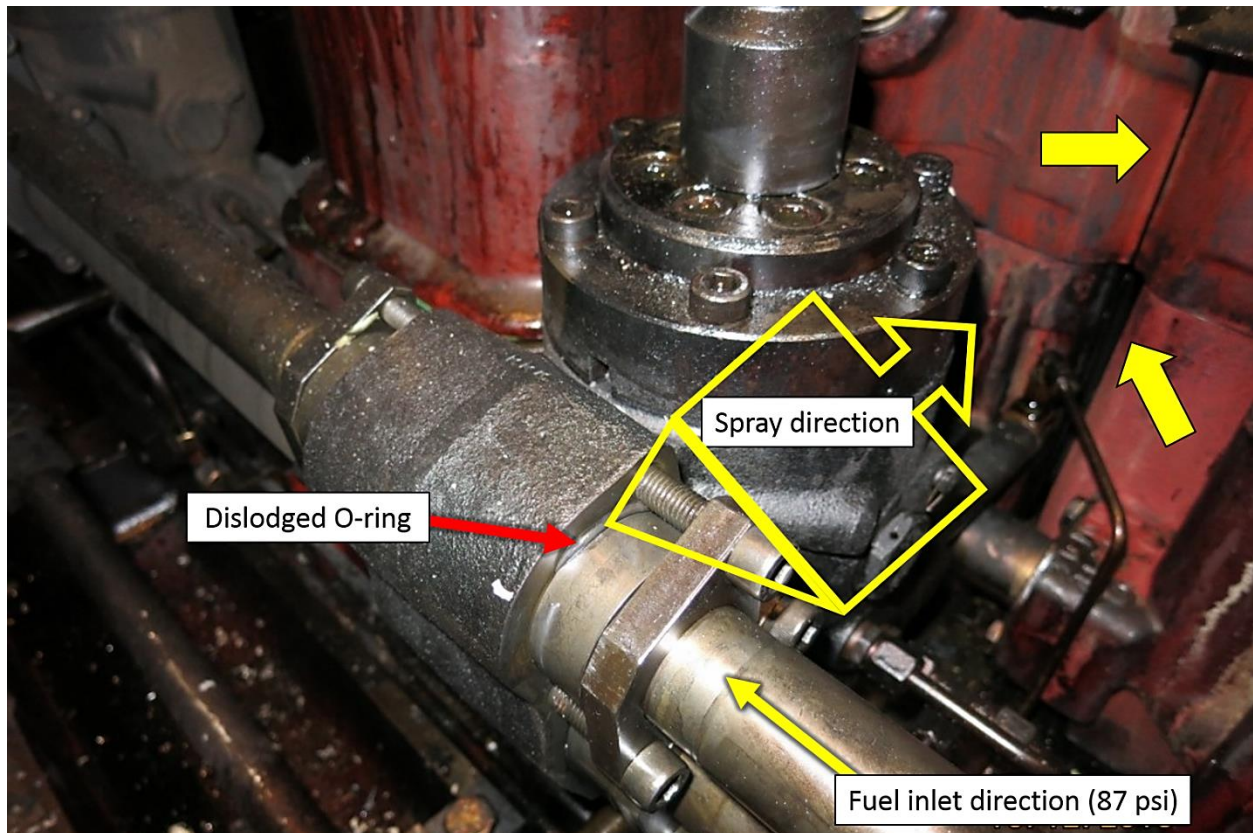
Investigators determined that the fire was caused by fuel leaking from a dislodged 1.5-inch-diameter O-ring in the fuel supply line to the no. 3 cylinder fuel injection pump, located near the top of auxiliary engine no. 1. Fuel in the supply line, pressurized to 87 pounds per square inch (psi), sprayed out around the O-ring. Some of the spray struck shields designed to prevent atomized fuel from spraying the engine room, while the remainder of the spray entered the exhaust side of the engine through the space between the cylinder heads. The fuel that struck the spray shields dripped into a fuel drain channel that ran the length of the engine under the fuel supply pipe. The fuel then drained into the 5-liter-capacity overflow tank until the tank was filled, sounding the tank overflow alarm.

Investigators found that the bolts and fitting where the leak occurred were in good condition. The NTSB performed a microscopic examination of the O-ring, and no damage or imperfections were found. It is likely that the leak occurred because the fitting was not tightened with a torque wrench as prescribed in the manufacturer's written procedures.

Location of fuel leak on Auxiliary Engine No. 1 fuel injection pump #3 (Photo courtesy of Lavaretus Risk Engineering)

Additionally, a root cause report issued by the operating company after the accident noted that procedures to replace O-rings on auxiliary engines did not include a post-repair testing procedure. Had the fuel system been tested using a standard procedure under normal operating conditions, it is possible that the leak would have been found before the fire started.
