National Transportation Safety Board

Marine Accident Brief

Fire Aboard Towing Vessel *San Gabriel*

Accident no.	DCA16FM027
Vessel name	<i>San Gabriel</i>
Accident type	Fire
Location	LyondellBasell refinery dock "D," Houston, Texas; 29°43'23"N, 95°14'06"W.
Date	February 26, 2016
Time	About 2220 central standard time (coordinated universal time – 6 hours)
Injuries	None
Property damage	\$875,000 est.
Environmental damage	None
Weather	Clear night, visibility 10 miles, north winds about 15 mph, air temperature 50°F
Waterway information	Houston Ship Channel between Simms Bayou and Light 162, about 2 miles* east of Interstate 610.

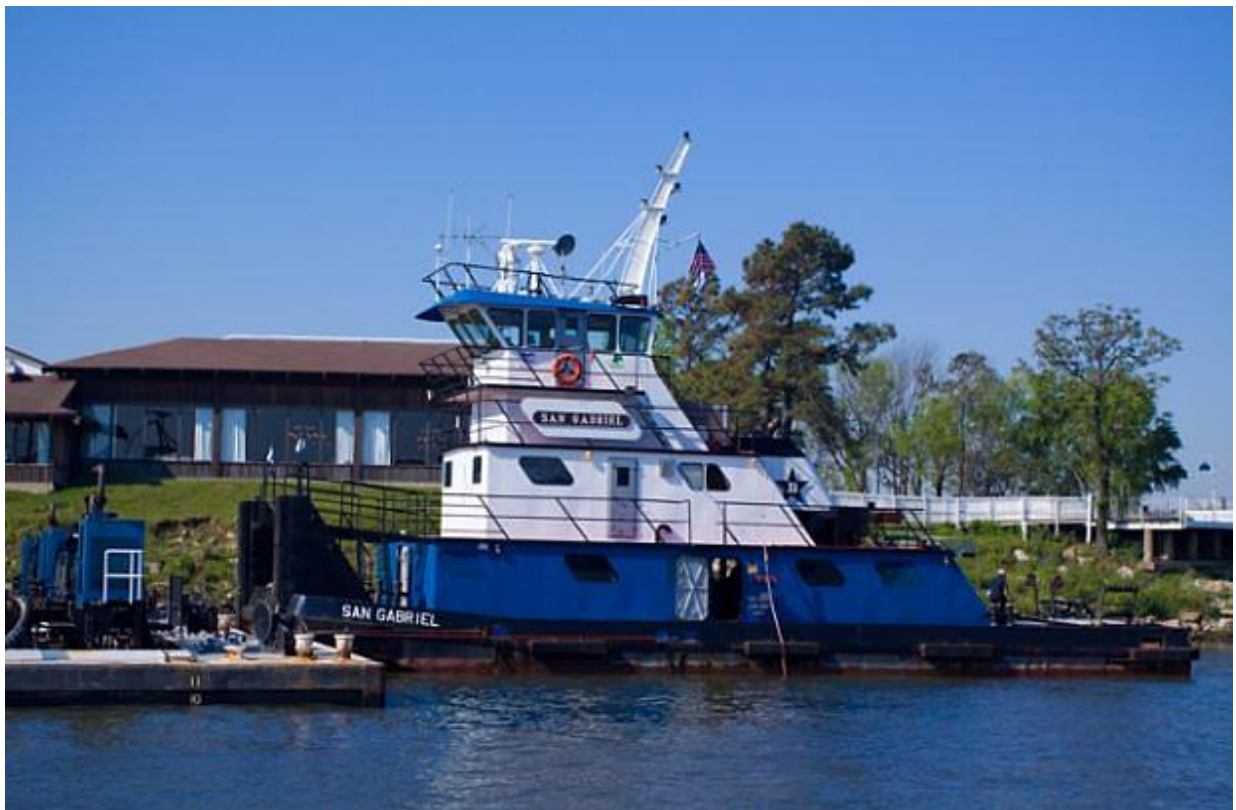
San Gabriel docked at Buffalo Marine facility in Houston, Texas, after the fire.

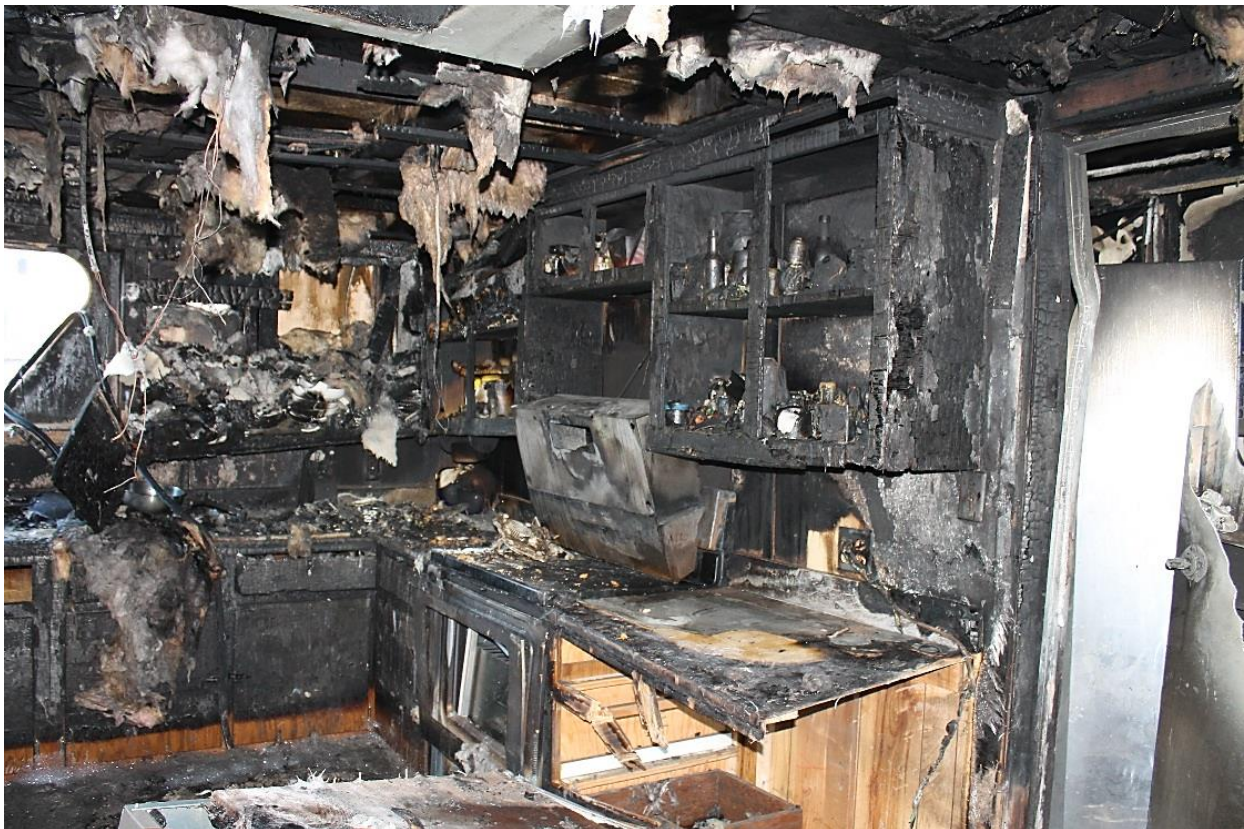
The morning after the fire, investigators and the Harris County fire marshal boarded the *San Gabriel* after dewatering was complete. They found charred interior spaces on the main deck, quarters deck, and wheelhouse deck. The heaviest heat, smoke, and water damage was located on the main deck.

Fire damage to the *San Gabriel* galley located on the main deck. (Photo by Coast Guard)

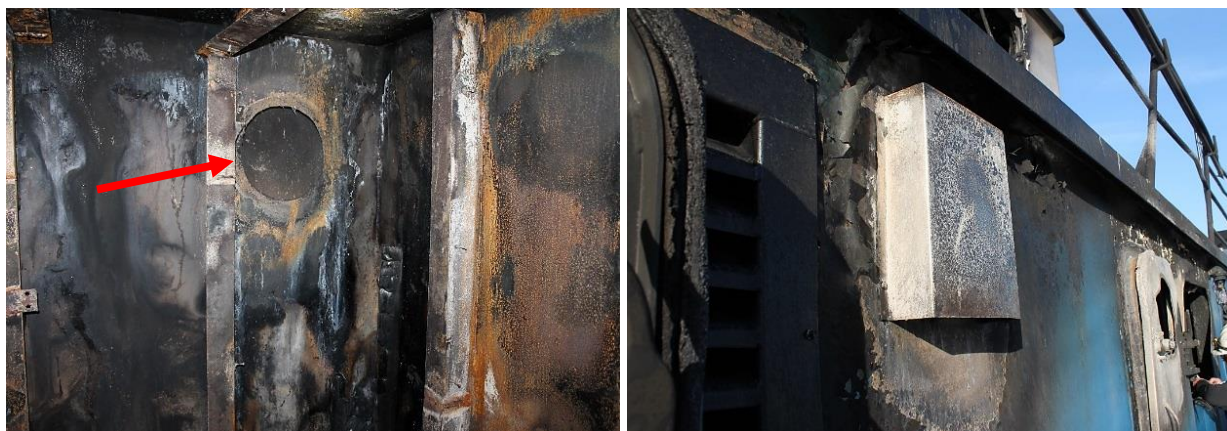
Based on a fire-pattern analysis, fire damage survey, and witness statements, the fire marshal concluded that the fire had originated in the lavatory in the area of the exhaust fan. He observed hot spots and burn patterns on the outboard bulkhead under the exhaust fan opening that were not seen anywhere else in the lavatory. Nothing remained of the suspect fan, which was burned completely. The only identifiable objects found in the lavatory debris were a ceramic toilet, fluorescent light fixture, an electrical outlet, wood framing, and small pieces of copper. There were visible signs of heat distortion of the forward port bulkhead at the top by the air conditioning ventilation duct penetrations. The aft starboard bulkhead had separated from the deck due to the heat.

At left, the opening where exhaust fan had been mounted inside lavatory. At right, heat damage to painted surface of exterior bulkhead around exhaust ventilation duct.

The National Transportation Safety Board determines that the probable cause of the fire aboard towing vessel *San Gabriel* was an electrical anomaly related to the lavatory exhaust fan located directly above combustible materials. Contributing to the extent of the damage was the captain's excessive delay in requesting shoreside assistance.

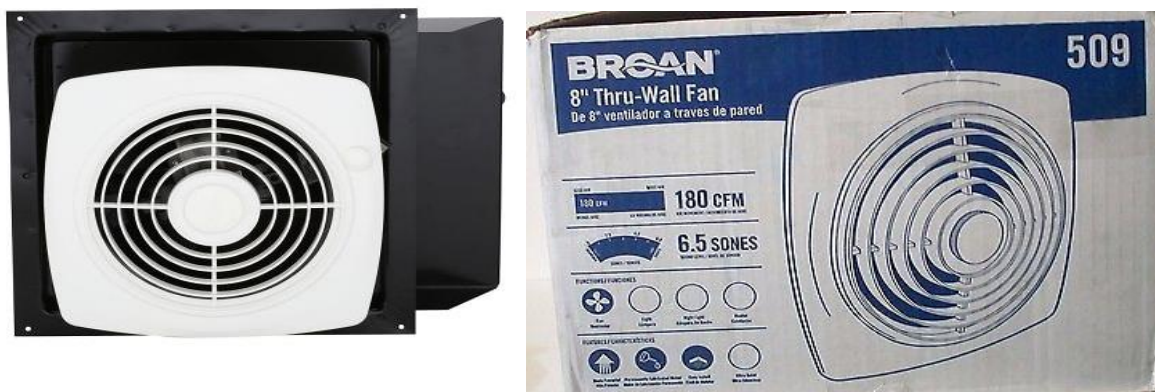
The 180-cubic-feet-per-minute, 8-inch through-wall exhaust fan in the lavatory was manufactured by Broan, model 509. According to a representative from the *San Gabriel*'s operating company, Buffalo Marine Service, the unit had been installed by an electrician in the shipyard in October 2014 to replace a failed unit. The fan manufacturer's specifications stated that the fan motor drew 1.5 amps and was not "engineered for continuous usage." Crewmembers stated that they typically had shut off the fan after use, but there were times when it had been left on.

Broan fan, model 509. (Photos from www.broan.com)
