# National Transportation Safety Board

## Marine Accident Brief

### Capsizing and Sinking of Towing Vessel *Ricky J Leboeuf*

<b>Accident no.</b>	DCA16FM037
<b>Vessel name</b>	<i>Ricky J Leboeuf</i>
<b>Accident type</b>	Capsizing and subsequent sinking
<b>Location</b>	San Jacinto River, Kirby Inland Marine fleeting area, Channelview, Texas
<b>Date</b>	April 19, 2016
<b>Time</b>	0752 central daylight time (coordinated universal time – 5 hours)
<b>Injuries</b>	One fatality and one minor injury
<b>Property damage</b>	Constructive total loss of vessel, estimated at \$900,000
<b>Environmental damage</b>	Less than 100 gallons of petroleum products and cleaning solvents were released into the river
<b>Weather</b>	Clear, visibility 10 statute miles, winds north-northwest at 7 knots, temperature 74°F
<b>Waterway information</b>	The San Jacinto River originates near Huntsville, Texas, and flows through Lake Conroe and Lake Houston, then joins the Houston Ship Channel and continues to Galveston Bay. At the time of the accident, the river gauge was 15 feet (major flood stage), and the current was 3.5 knots or greater.

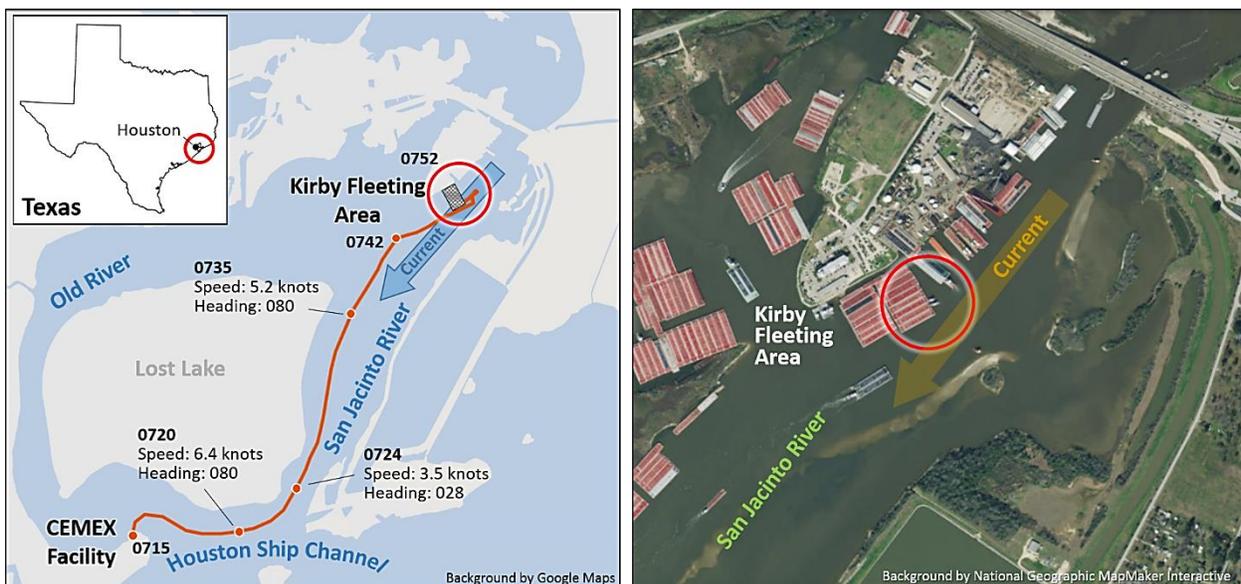
Left is the trackline of the *Ricky J Leboeuf* as the vessel transited from the CEMEX facility to the Kirby Inland Marine fleeting area. Right is a close-up satellite image of the fleeting area (image is not from accident date). In both images, the accident site is indicated by a red circle.

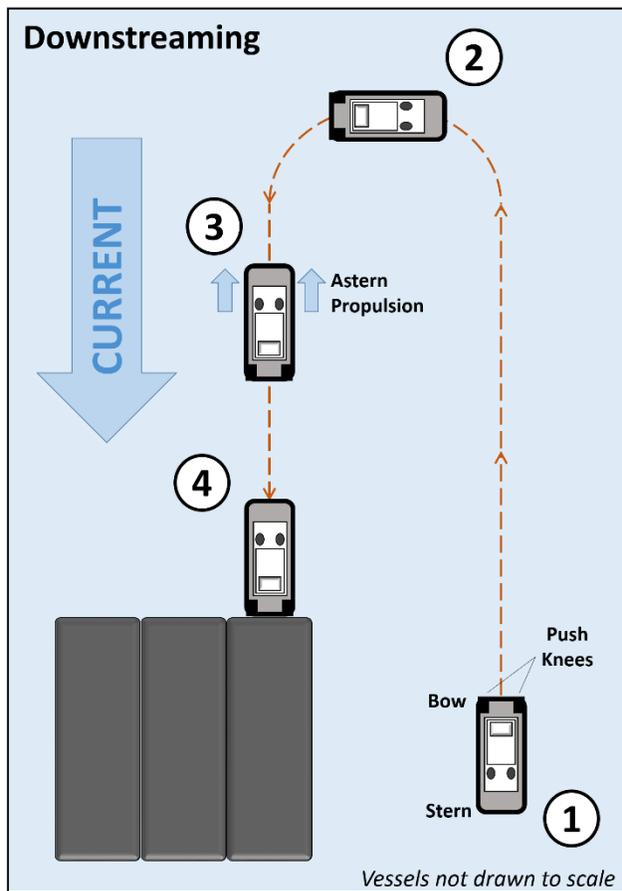
**Downstreaming:** 1) the towing vessel moves to a position upstream of the barge, 2) turns downstream, then 3) uses the current to move toward the barge while operating astern propulsion to approach at a slower speed than the current, before 4) squaring up and meeting the barge.

If the towing vessel meets the barge at an angle and there is a strong-enough current, the towing vessel may be turned sideways and pinned against the barge. A significant risk is present for the towing vessel in this instance. Water may rise up onto the deck and enter into the vessel through open doors, windows, hatches, and ventilation systems, thus causing rapid downflooding, capsizing, and sinking. An earlier National Transportation Safety Board (NTSB) report involving the uninspected towing vessel *Miss Natalie* addressed this same type of accident.<sup>1</sup>

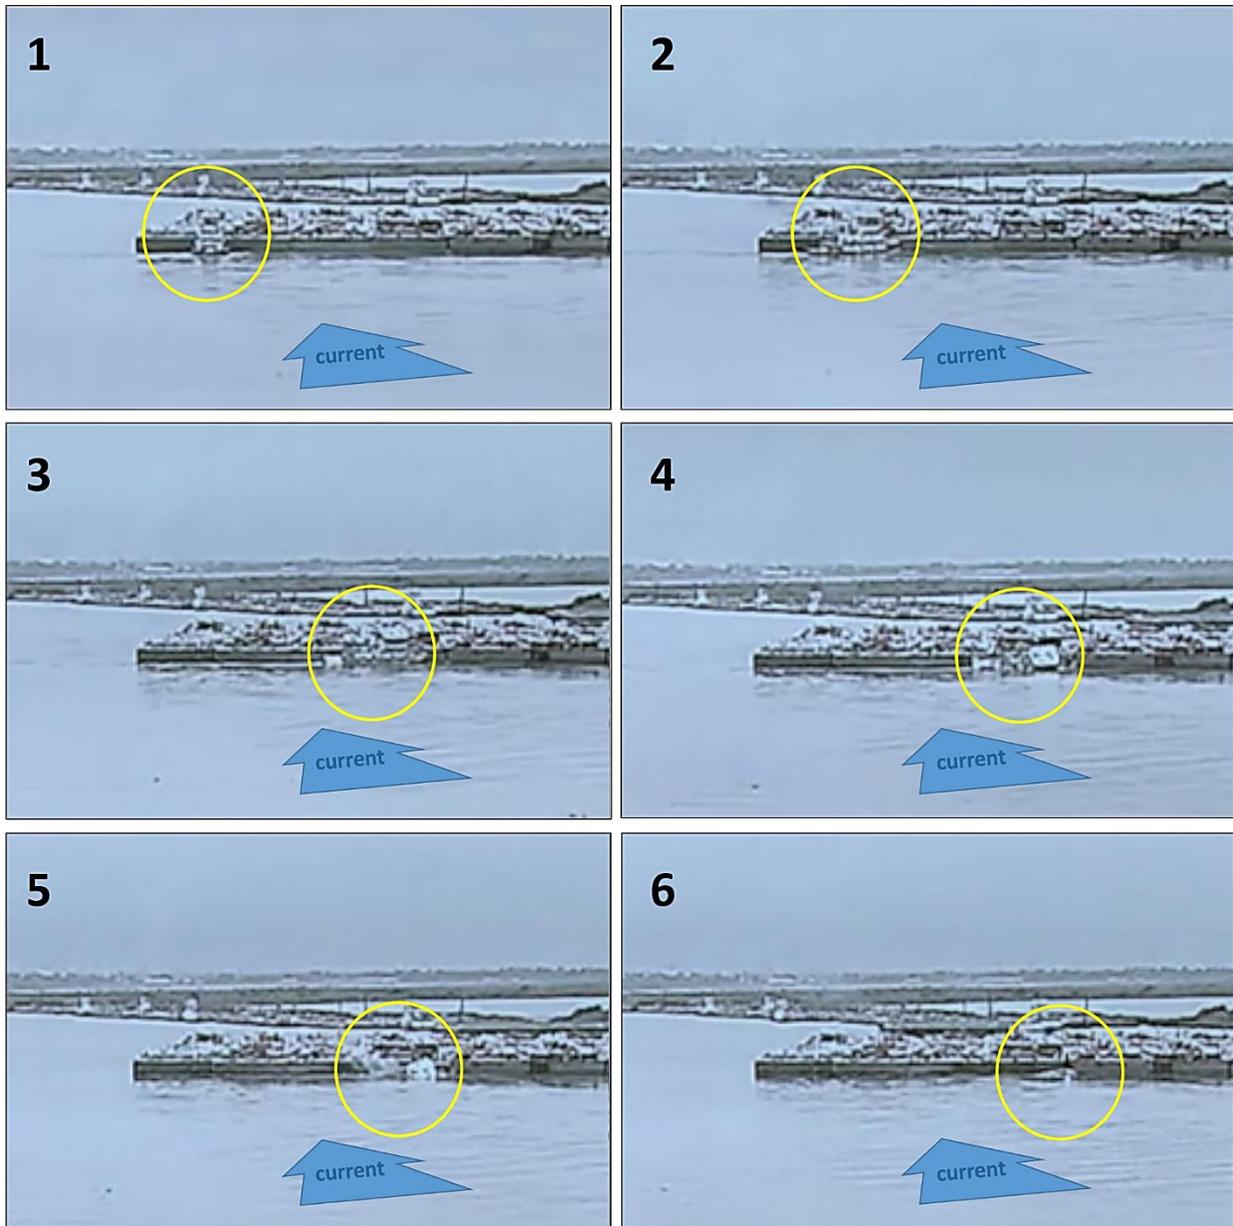
At 0752, the force of the river current acting on the *Ricky J Leboeuf*'s starboard-side hull, combined with the force applied above the water line on the vessel's port side from its contact with the stationary barges, caused the vessel to heel to starboard. Water then rapidly entered the vessel through two open doors on the main deck, flooding the hull. Consequently, the vessel rolled onto its starboard side and partially submerged, with just a small portion of its port bow remaining above water. Video of the accident captured by two separate sources shows that the starboard engine room and galley doors were open as the vessel sank. Investigators could not determine if the two doors on the port side were also open at the time of the accident.

Still-images from video of the capsizing and sinking. Image 1 shows the towing vessel attempting to face up to the first barge in the fleet. However, in image 2, the vessel has been turned to starboard where the force of the current acting on the hull below the waterline is the greatest. In images 3–5, the vessel begins to heel over, and then capsizes. In image 6, the vessel has sunk. (Video by Harris County Sheriff Department)
