National Transportation Safety Board

Marine Accident Brief

Fire aboard Commercial Fishing Vessel *Raffaello*

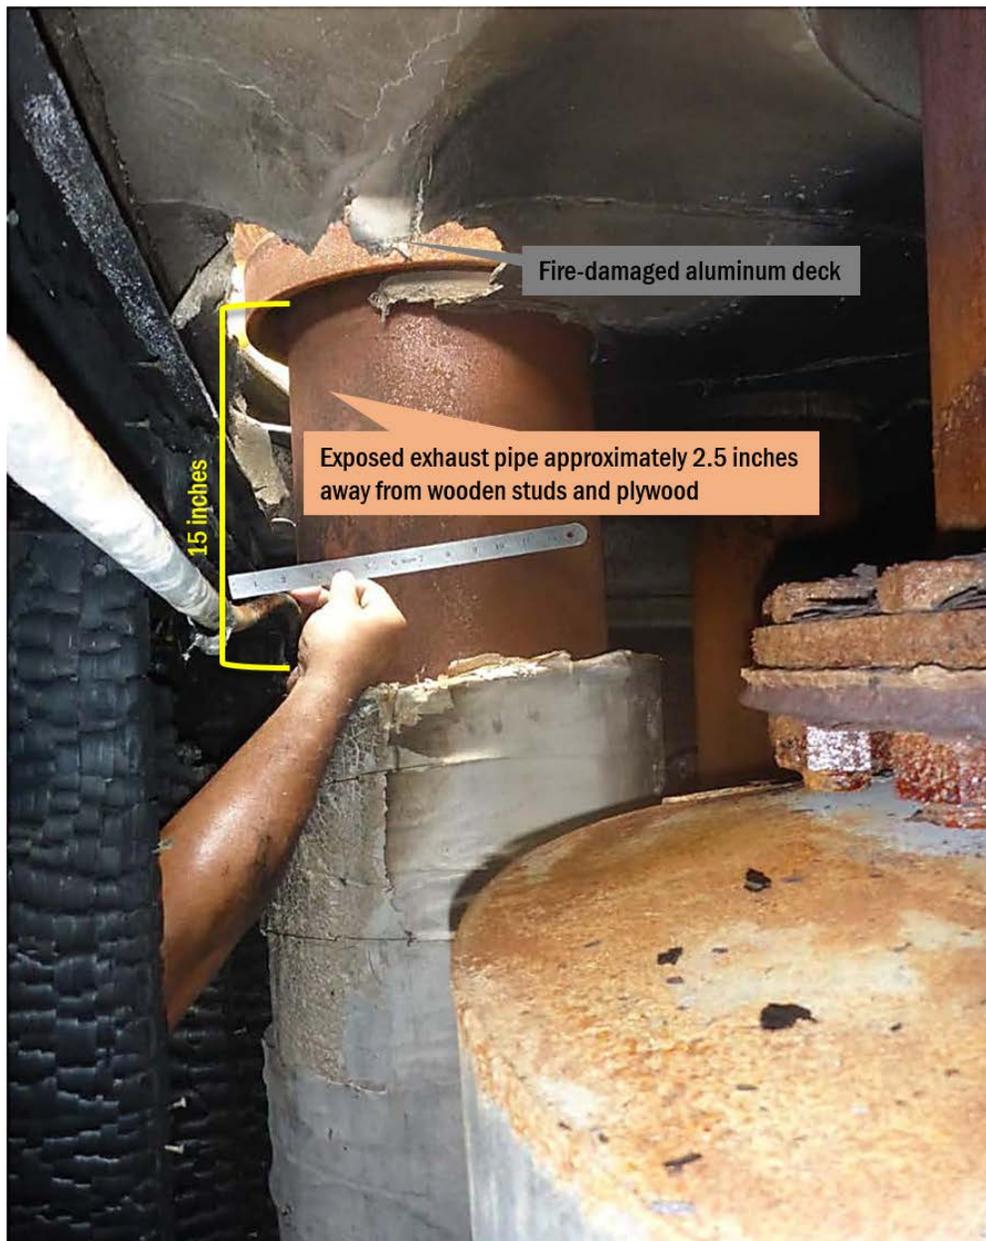
Following the fire, a Coast Guard investigator measures the distance between the wooden studs and the exhaust pipe of *Raffaello's* starboard generator, on which a 15-inch section of insulation is missing at the top. (Photo by US Coast Guard)

Investigators determined that the ignition source of the fire was a 15-inch section of the starboard generator exhaust pipe at the top of the exhaust trunk without insulation (lagging). Approximately 2.5 inches away from the uninsulated exhaust trunk were charred 2-inch-by-4-inch wooden studs and 0.25-inch plywood sheathing used for a partition of the master cabin bathroom. Investigators concluded radiant heat traveled uninhibited to the wooden partition, heating and

charring the wood until it ignited.² The fire was caused by a long process of wood deterioration known as “pyrolysis.”³

Based on testimony from the navigator, the exhaust lagging on the starboard generator was changed annually. However, investigators did not find any records or other evidence verifying that the task was accomplished each year or any evidence indicating why the insulation was missing.

The National Transportation Safety Board determines that the probable cause of the fire aboard the commercial fishing vessel *Raffaello* was the lack of insulation on the starboard generator exhaust gas pipe resulting in the ignition of combustible material in close proximity.
