National Transportation Safety Board

Marine Accident Brief

Allision of *Amy Frances* Tow with Natchez–Vidalia Highway 84 Bridge

Accident no.	DCA16FM020
Vessel names	<i>Amy Frances</i> , MM-46
Accident type	Allision
Location	Lower Mississippi River at mile marker 363.3 at Natchez, Mississippi 31°33.6' N, 091°25.2' W
Date	January 21, 2016
Time	1247 central standard time (coordinated universal time – 6 hours)
Injuries	None
Property damage	>\$542,000 est.
Environmental damage	24,654 gallons of catalytic cracked clarified oil
Weather	Visibility 10 miles, winds south at 10 mph, air temperature 71°F
Waterway information	The Lower Mississippi River near mile marker 363.3 was under an extreme high-water safety advisory from the US Coast Guard Captain of the Port due to “hazardous conditions associated with strong currents, severe outdrafts, [and] missing/off-station aids to navigation and diving buoys.”

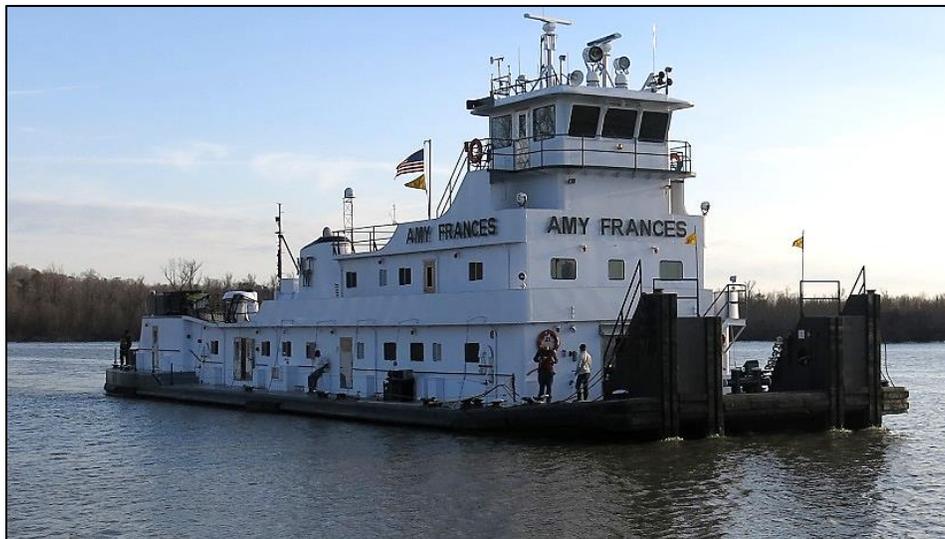
Amy Francis under way after the accident.

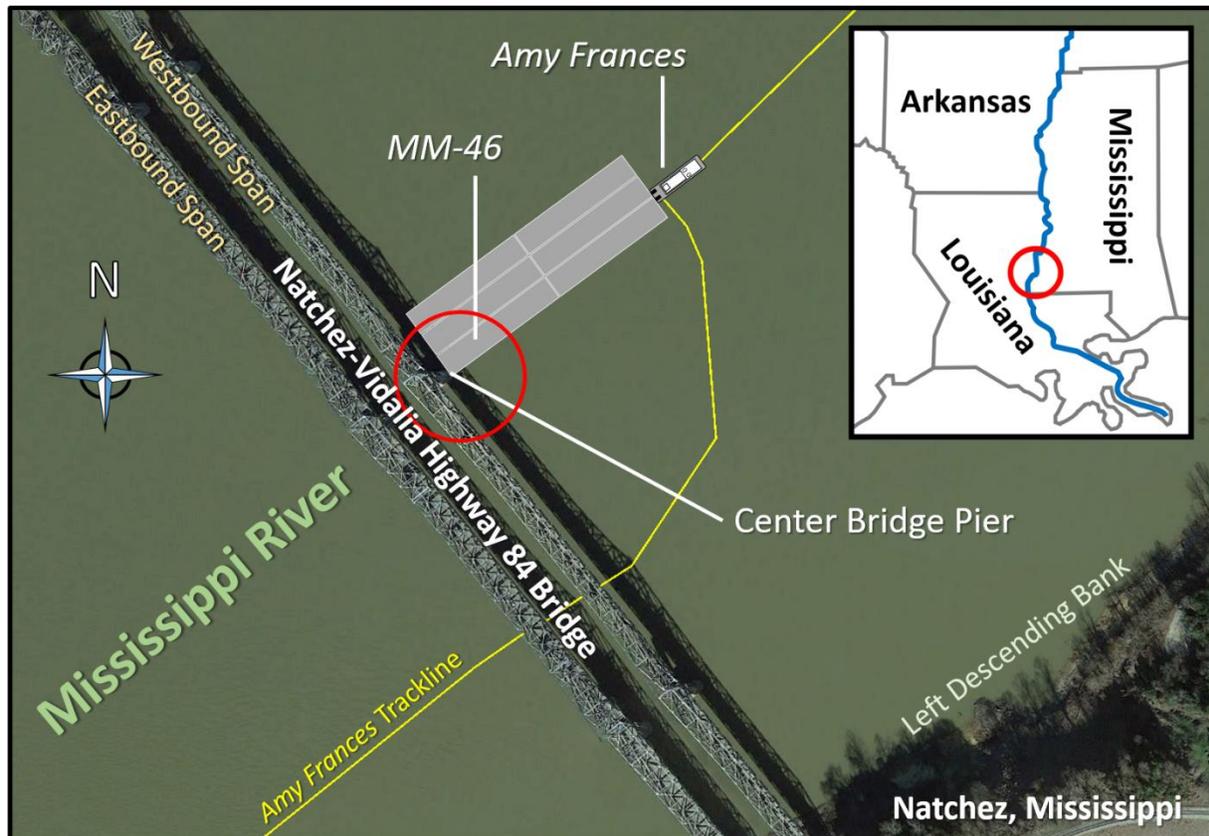
Satellite image of the accident site overlaid with a graphical depiction of *Amy Frances* tow and automatic identification system (AIS) track data. (Background by Google Earth Pro).

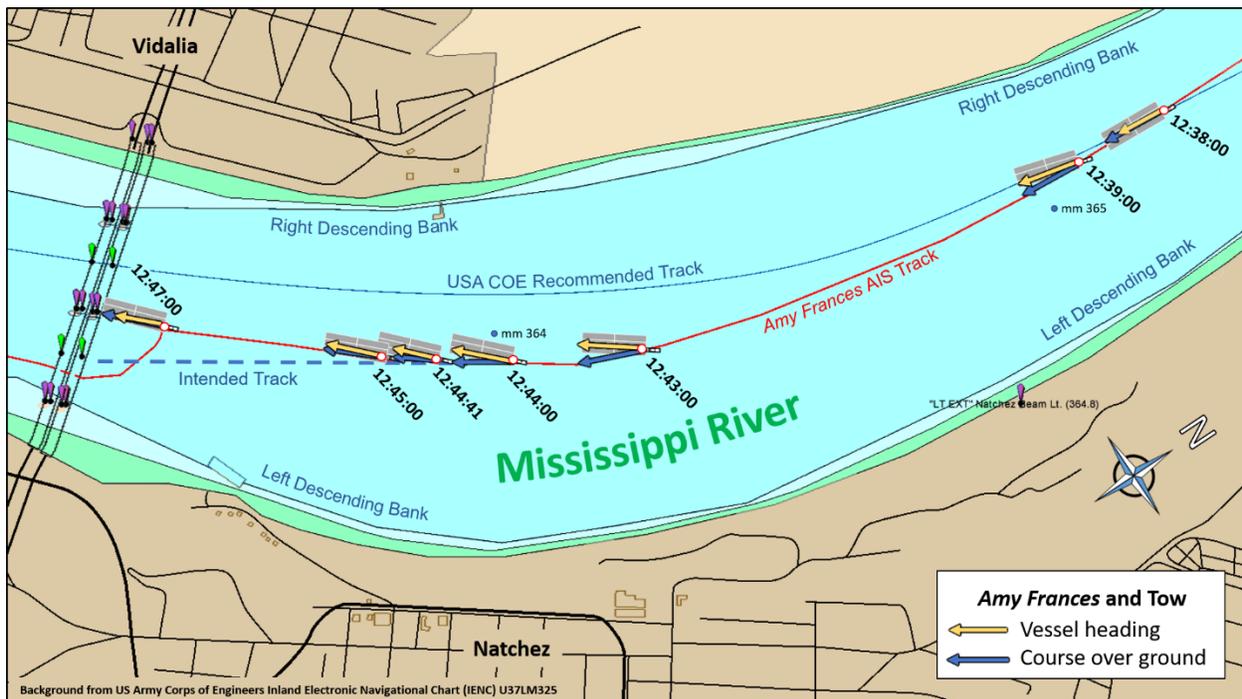
Per ECS, shortly after 1238 the vessel's heading began to shift to the right. By 1239, it was steering 196 degrees but still making good a course of 182 degrees. At 1243, as it passed mm 364.2, the *Amy Frances* was heading 228 degrees while making a course good of about 200 degrees—toward the left descending bank. At 1243:12, the vessel's heading remained the same but the course made good began coming to the right. At 1244:00, the speed was 12.9 mph, the heading was 236 degrees, and the course made good was 215 degrees. A steady course made good of 215 degrees would have, by ECS, carried the tow through the left descending channel. However, ECS showed the course made good continued to change to the right. Twenty-seven seconds later, at 1244:27, the vessel was still heading about 236 degrees. Since the course made

good continued changing to the right, ECS showed the tow would no longer pass through the left descending channel but would instead hit the left side of the center bridge pier.

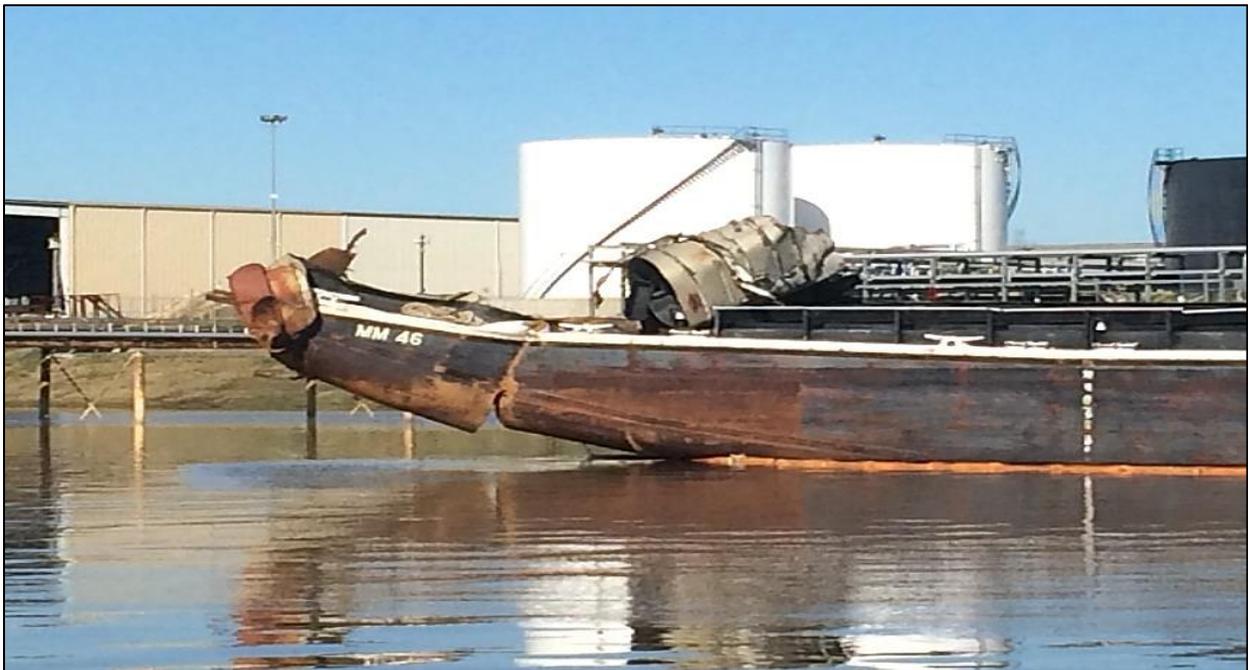
Less than 15 seconds later, at 1244:41, the vessel's heading started changing to the left while the course made good continued to the right. About 0.6 mile from the bridge, the tow was heading for the middle of the center channel pier at a speed of 13.0 mph. At 1245, with the *Amy Frances* about 0.5 mile from the bridge, the vessel was heading 230 degrees and making good a course of about 224 degrees.⁶ The tow was now headed toward the right-hand side of the center pier. About 1247, with the towing vessel backing full astern, the port side of barge *MM-46* struck the right side of the center pier at a speed of about 9.4 mph.⁷

Damaged port bow of barge *MM-46*. (Photo by US Coast Guard)
