# National Transportation Safety Board

## Marine Accident Brief

### Flooding of Dive Support Vessel *Hammerhead*

<b>Accident no.</b>	DCA16FM030
<b>Vessel name</b>	<i>Hammerhead</i>
<b>Accident type</b>	Flooding
<b>Location</b>	Newport Marine Terminal; Galveston, Texas 29°18.05' N, 094°50.07' W
<b>Date</b>	March 7, 2016
<b>Time</b>	1000 central standard time (coordinated universal time – 6 hours)
<b>Injuries</b>	None
<b>Damage</b>	\$900,000 est.
<b>Environmental damage</b>	None reported
<b>Weather</b>	Clear visibility at 10 miles,* winds south-southeast at 8.7 knots, calm seas, air temperature 69°F, water temperature 65°F
<b>Waterway information</b>	Located along the upper coast of Texas, Galveston Bay is connected to the Gulf of Mexico. It is surrounded by subtropic marshes and prairies on the mainland.

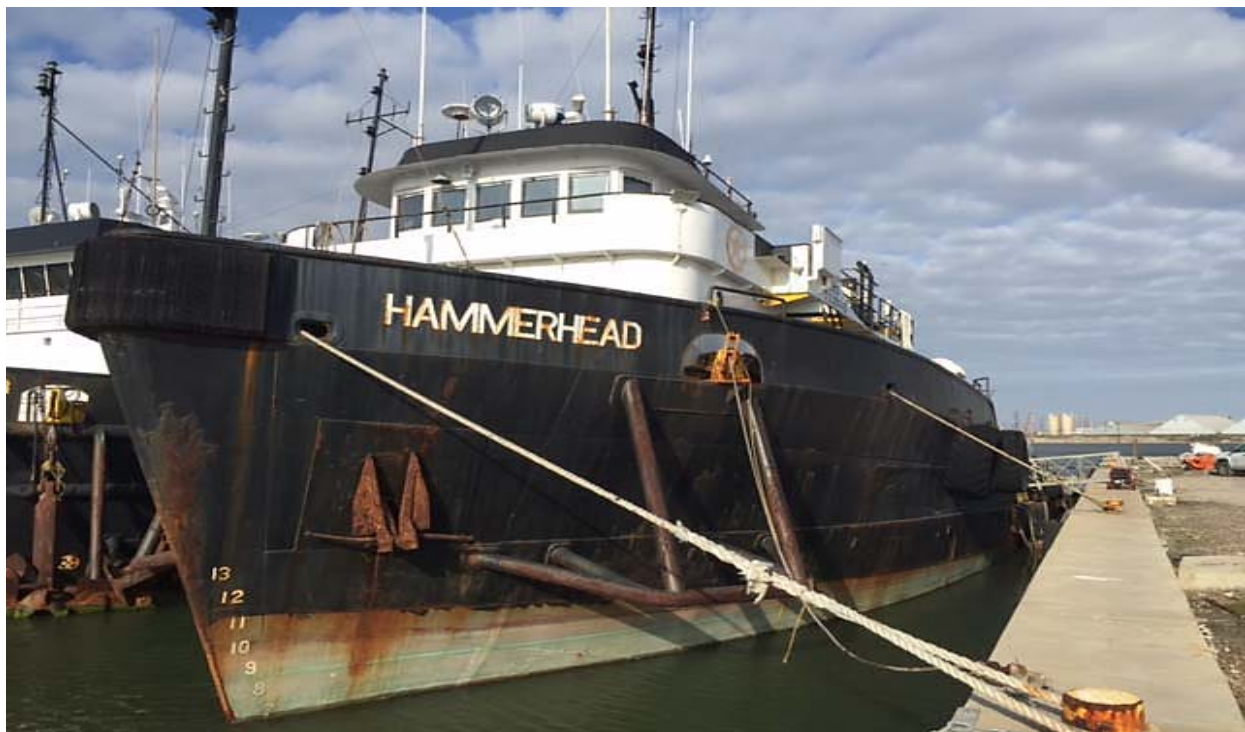
On March 7, 2016, at 1000 local time, the 164-foot-long dive support vessel *Hammerhead* was discovered partially flooded with an increased aft trim while moored alongside the pier at the Newport Marine Terminal in Galveston, Texas. The vessel was in a layup period with no one on board. There were no reports of pollution. Damage to the vessel was estimated at \$900,000.

*Hammerhead* after the flooding. (Photo by US Coast Guard)

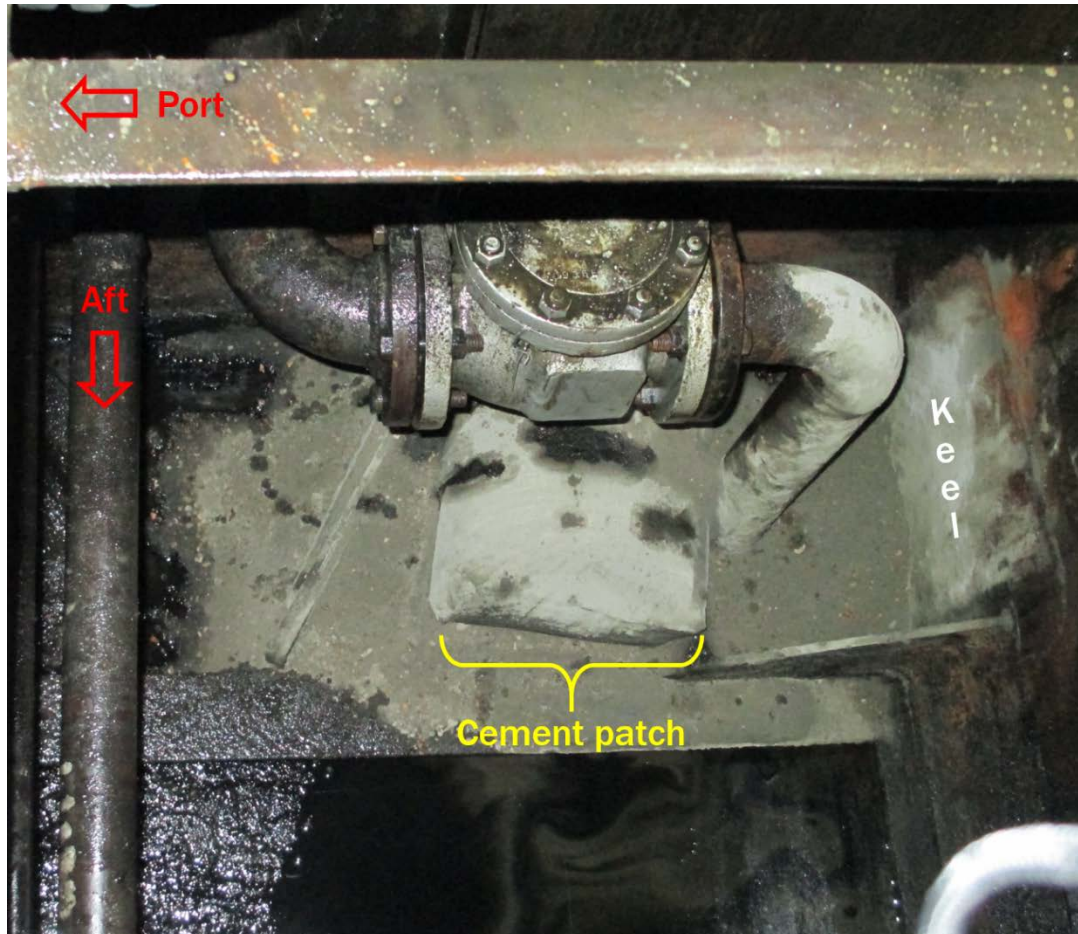
a hole found in the steel hull plating on the bottom of the vessel. To stem the flow of water, the screwdriver was wrapped in rags, then sealed with an underwater epoxy compound, and finally overlaid with five 100-pound bags of cement mix to create a temporary patch. Coast Guard representatives later examined and approved the cement patch as an acceptable temporary repair.

Temporary cement patch, located a foot to port of centerline and just forward of frame 31 in the engine room bilge. (Photo by Coast Guard)

A section of the bottom plating at frame 31 measuring 0.50 inch by 39 inches by 51 inches was cropped and replaced with steel that was approved by the American Bureau of Shipping (ABS). Two additional sections of the bottom plating were cropped and replaced due to the unacceptable results of the measured thickness, which exceeded the allowable corrosion limit. The

first piece was inserted on the port side that measured approximately 0.50 inch by 18 inches by 44 inches, and the second piece, similar in size at approximately 0.50 inch by 18 inches by 32 inches, was replaced under the center vertical keel. Coast Guard personnel conducted visual inspections and witnessed dye penetrant testing of the welded repairs; all welds tested satisfactory. Hull repairs on the vessel were accomplished in 22 days.

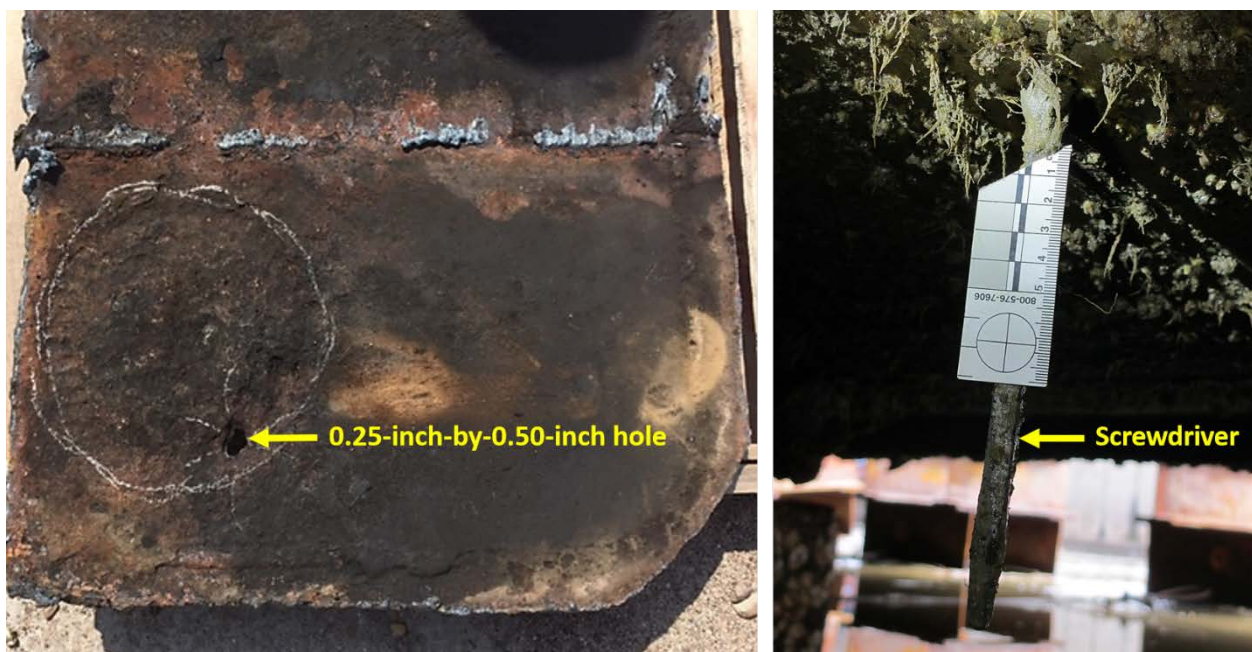
The *Hammerhead* was towed on April 19, 2016, by the tugboats *Bill Spence* and *Donna T* to the John Bludworth Shipyard nearby in Galveston, where an ultrasonic examination was conducted on the hull plating to determine its thickness. The source of the water intrusion originated from the 0.25-inch-by-0.50-inch hole in the bottom plate, located a foot to the port of the centerline and just forward of frame 31 below the engine room.

**At left, the hole found near frame 31 of the bottom plating. At right, the screwdriver placed in the hole as a temporary repair. (Photos by Coast Guard)**

As the primary method for corrosion control, the marine coating in the engine room bilge was severely degraded on the interior bottom plating. The bare steel bottom plates were exposed to seawater, particulate matter, suspended solids, chemicals and detergents, and diesel fuel and lubrication oil.

The National Transportation Safety Board determines that the probable cause of the engine room flooding of the dive support vessel *Hammerhead* was the localized corrosion of an aging hull structure resulting from the operating company's lack of oversight and maintenance in preserving the hull's metal plating with an adequate marine coating and cathodic protection system.

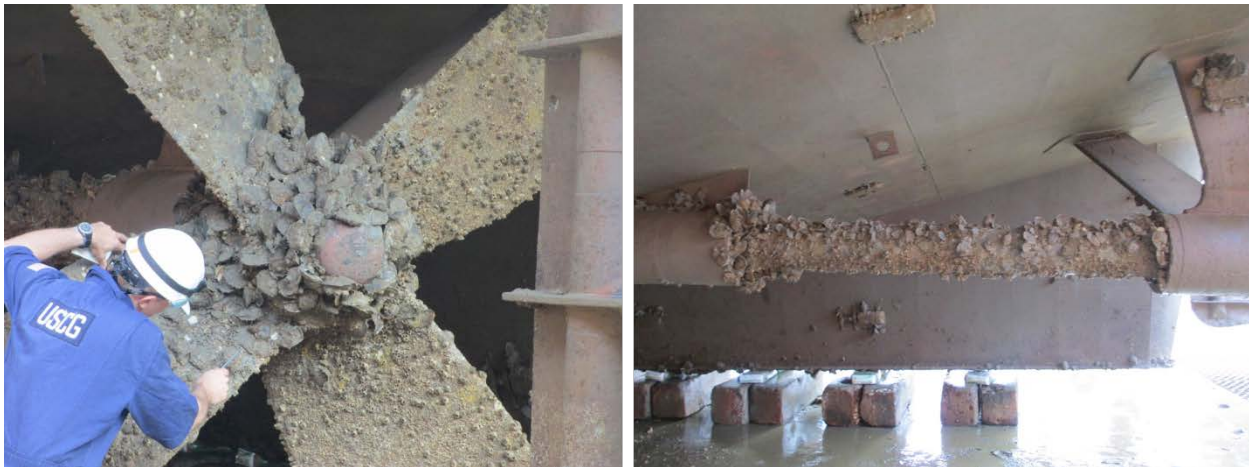
Marine growth flourished on the idle vessel, blocking and narrowing cooling water intake piping. Clusters of barnacles, mollusks, algae, and sea hair were found on and around the tail shafts, propellers, and rudders. According to the vessel's International Anti-fouling System Certificate, the exterior hull coating was applied during the March 2014 drydock. It was found to be in fair condition, in view of the coating failures that were concentrated around large marine-growth clusters and inlet piping, which developed during the vessel's 15-month layup.

**At left, a Coast Guard inspector examines the condition of the port propeller. At right, marine growth on the port tail shaft. (Photos by Coast Guard)**
