# National Transportation Safety Board

## Marine Accident Brief

### Allision of Passenger Vessel *Adventure Hornblower* with San Diego Seawall

<b>Accident no.</b>	DCA16FM035
<b>Vessel name</b>	<i>Adventure Hornblower</i>
<b>Accident type</b>	Allision
<b>Location</b>	Navy Pier, San Diego Bay, California, 32° 42.9' N, 117° 10.4' W
<b>Date</b>	March 31, 2016
<b>Time</b>	1255 Pacific daylight time (coordinated universal time – 7 hours)
<b>Injuries</b>	Several minor passenger injuries
<b>Damage</b>	Pier damage \$715,000 est., vessel damage over \$344,000
<b>Environmental damage</b>	None reported
<b>Weather</b>	Clear visibility, little to no wind, calm seas, air temperature 64°F
<b>Waterway information</b>	San Diego Bay is a crescent-shaped bay located 10 miles northwest of the US/Mexico border. The port of San Diego, which occupies much of the bay, hosts a major US Navy base and has numerous commercial marine facilities. <sup>1</sup>

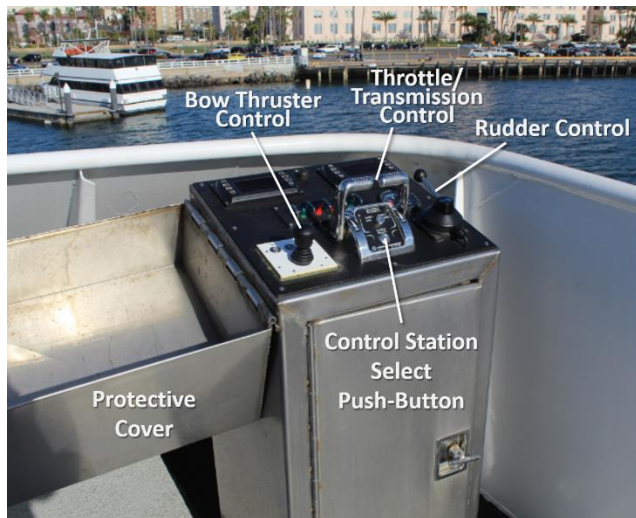
Starboard wing station control box.

The control boxes at the wing stations were covered when not in use; however, passengers were permitted to walk or stand in the vicinity of the stations. When the captain reached the starboard wing station, she had to ask passengers to move out of the way so that she could access the box. This passenger interference had the potential to introduce distraction for the crew of the *Adventure Hornblower* when attempting to access the control box. Although not a factor in the accident, allowing passengers in this area also created an environment whereby a passenger could have tampered with, or unintentionally bumped into, the vessel's controls.

Vessel controls that are located outside the bridge/wheelhouse and are accessible to non-crewmembers present the opportunity for tampering and may lead to the distraction of the operator. Owners and operators should designate a perimeter around these stations and ensure the area is secured when in operation.

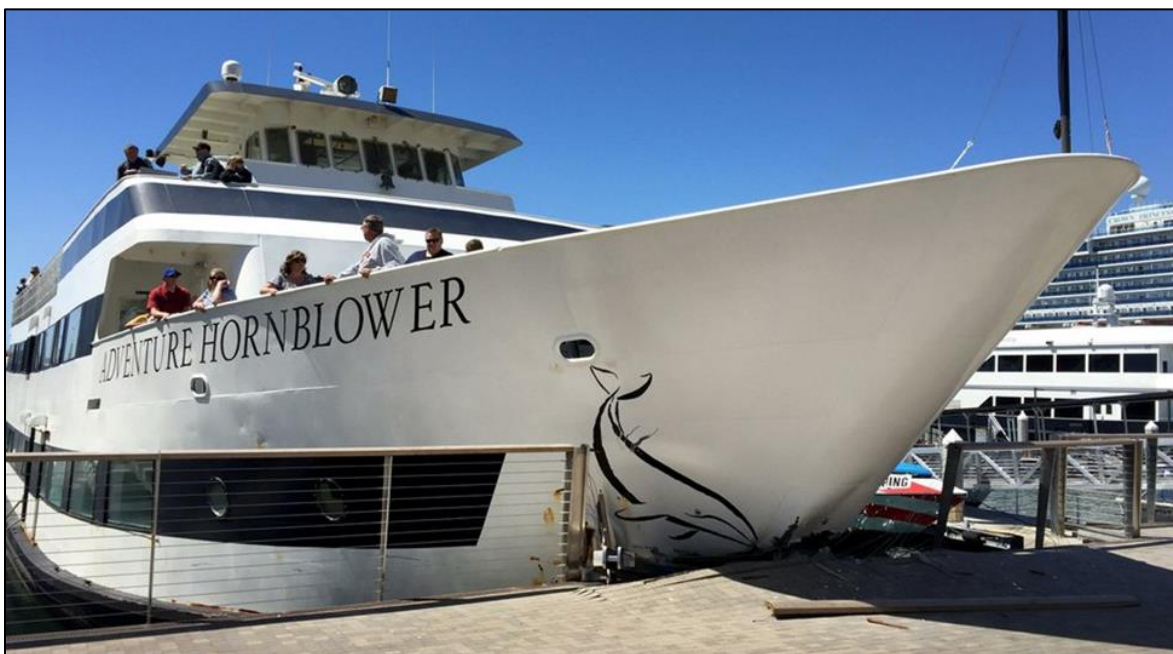
***Adventure Hornblower* after alliding with the San Diego seawall. (Photo by Coast Guard)**

About an hour after the allision, Coast Guard officials determined that the *Adventure Hornblower* could be safely moved from the seawall. The vessel was moved by tugboat to the embarkation pier to offload passengers. Damage to the pier as a result of the accident was estimated at \$715,000, while damage to the *Adventure Hornblower* totaled over \$344,000.

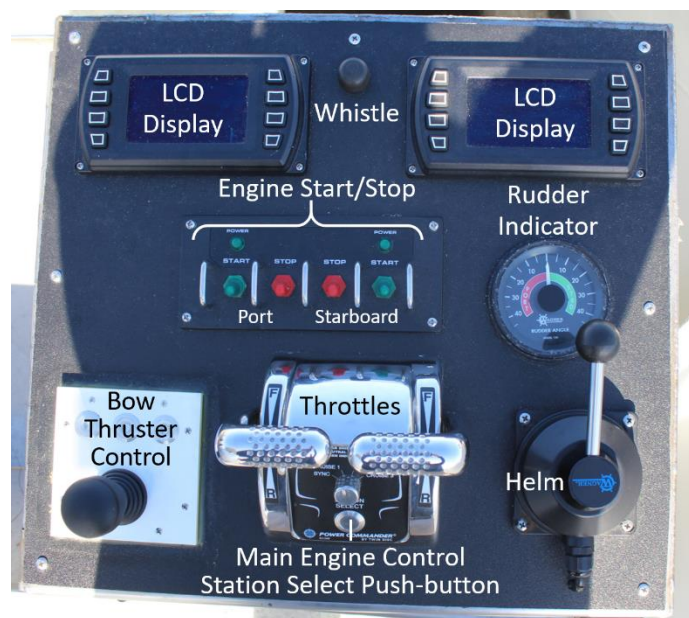
In addition to the potential for passenger interference with the port and starboard wing stations, the design of the stations did not provide the operator with an alarm or the necessary information to determine if the controls were responding appropriately. From where the captain was standing at the wing station, she had no information as to whether her throttle command corresponded to the direction of travel. The wing stations and wheelhouse were also not designed nor required to have instrumentation that provided positive indication of thrust direction to the operator. An indicator would have increased the likelihood of early detection of improper propulsion response and permitted prompt action. A "wrong way" indicator or deviation alarm was also not required based on regulations under which the vessel was operating at the time of the incident. Deviation alarms audibly and visually alert operators in the shortest possible time should the propeller not respond to a command. Steering and propulsion are vital systems on a vessel, and, as such, should have alarms at remote propulsion control stations that clearly notify the operator in the event of a critical failure. In the last 10 years, the NTSB investigated two other

Close-up of wing station controls.

The captain told investigators that there were no alarms on the starboard wing station. The LCD displays at the wing station provided only engine information. No alarm or fault codes were recorded by the Twin Disc EC300 control system during the accident indicating an actuator failure. The only actuator fault code that the system was designed to provide was an overcurrent failure. However, even if that fault condition existed, it would have provided only a visual indication—the neutral position indicator LED would have flashed on the control when the lever was in neutral position. No audible alarm would have sounded at the station. The first officer was not required to be in the wheelhouse during docking maneuvers, so any alarm at that location would have gone

Current technology allows vessels to be constructed and fitted with automated instrumentation and alarms that alert the operator in the event of critical failure; however, they are not required by regulation. The negative consequences of an undetected loss of propulsion control are elevated for passenger vessels because they carry more people on board, often transit in confined waterways, and dock frequently. Owners and operators are encouraged to install instrumentation that provides a positive indication of propulsion thrust direction and/or a deviation alarm at bridge/wheelhouse and remote propulsion control stations. Such indications/alarms increase the likelihood of early detection of improper propulsion response, thereby allowing the operator time to take effective corrective action.

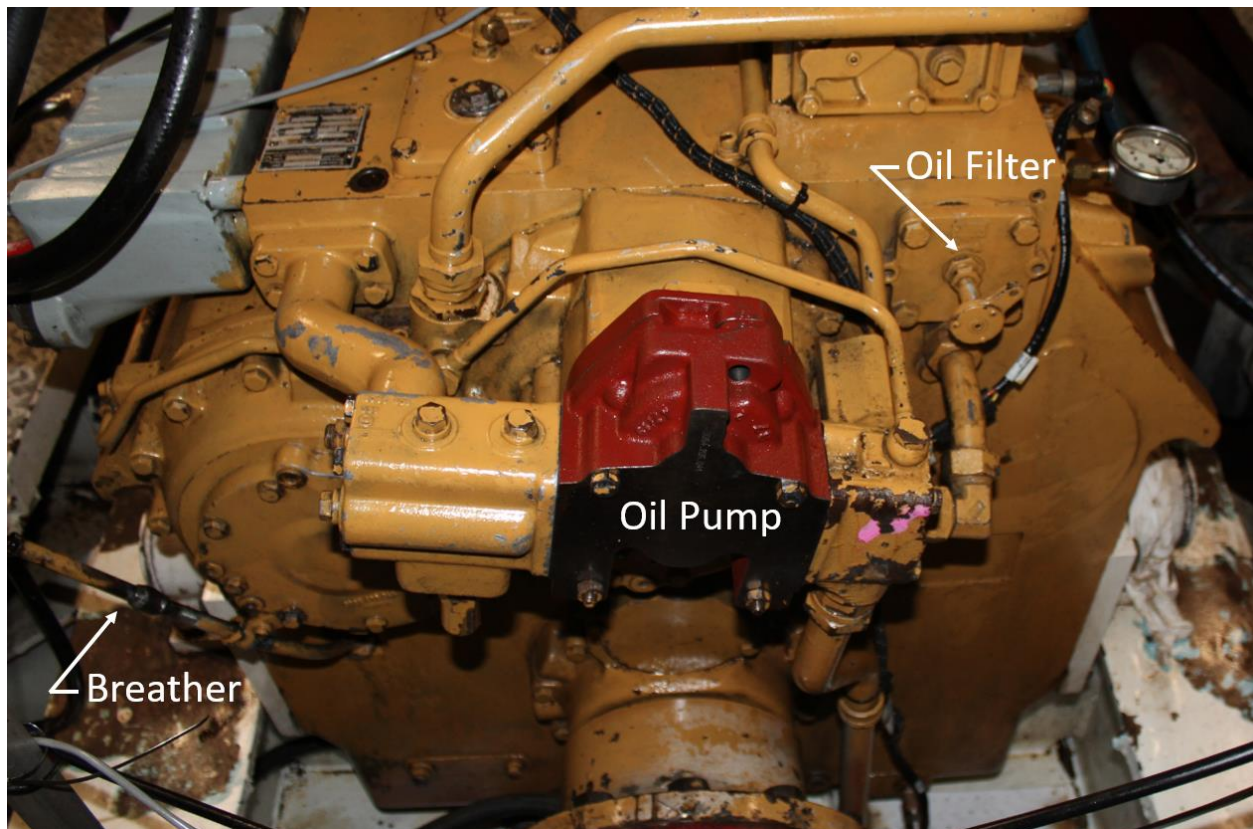
In addition to the oil leaks previously noted, the postaccident inspection revealed other discrepancies with the port transmission. The gearbox breather, which was integrated into the dipstick housing, had been welded shut at some unknown time, preventing proper ventilation of the transmission.<sup>6</sup> The sealed breather pressurized the system causing fluid leakage at the output shaft and seals. Furthermore, pressure remained in the system when the vessel was not in operation, adversely impacting the transmission's mechanical seal. A significant amount of oil was reported in the port bilge.

The transmission's oil filter knife edge ratchet was not engaging to turn as designed, leaving metallic and non-metallic debris to build up in the oil filter housing and on the filter. The debris reduced the flow of oil through the system that cooled and lubricated the clutch discs and gears. The transmission's engine-driven oil pump (red housing in the photo below) was replaced about 4 months before the accident due to low oil pressure. The problem was reported by a vessel captain who said that the transmission was "slipping," a condition that occurs when not enough hydraulic pressure is being produced to engage the gears. Low fluid levels can also contribute to

**Close-up of port ZF marine transmission with welded breather, oil filter, and replaced oil pump.**

This accident illustrates the potential safety hazards of failing to follow the equipment manufacturer’s recommended maintenance procedures and schedules. Without necessary maintenance, equipment cannot be relied on to perform as designed. Mariners should review manufacturer manuals and guidance on a regular basis to ensure conformance with recommended maintenance plans.

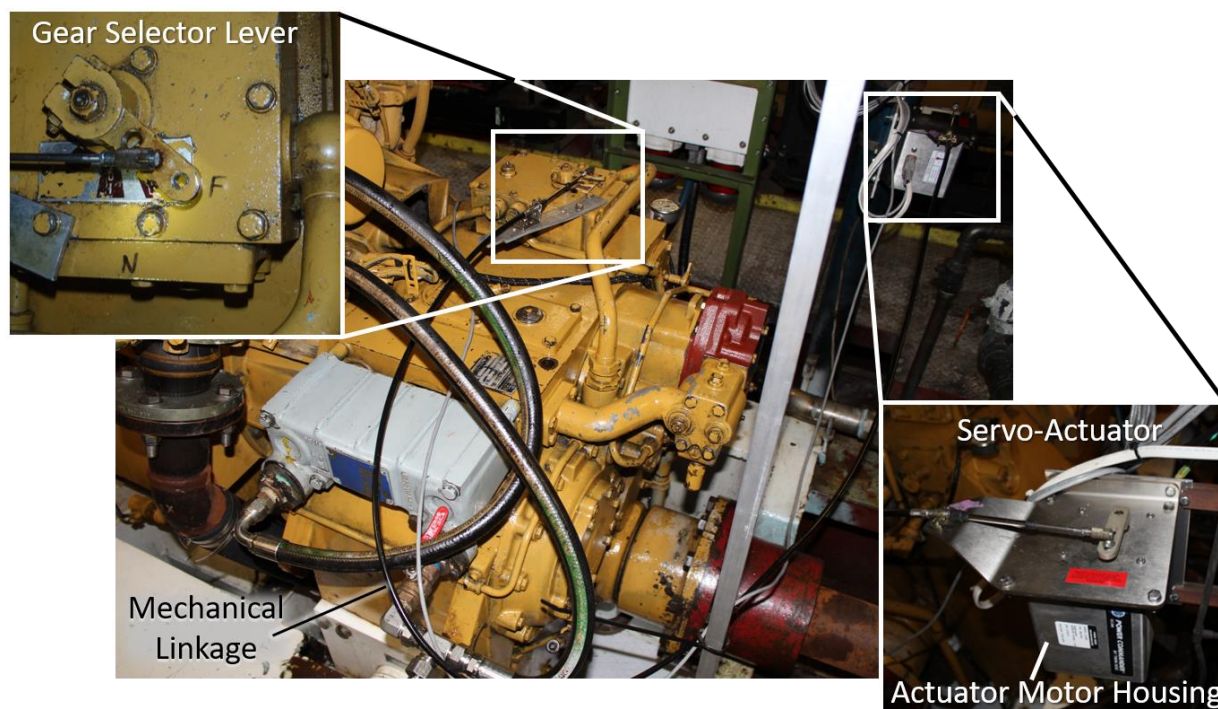
As the *Adventure Hornblower* approached the pier on the accident date, the port transmission failed to respond to the captain’s helm orders. Investigators believe that the fault occurred between the servo-actuator, the mechanical linkage, and the control unit, most likely due to neglected maintenance to the port transmission and control system.

Port ZF marine transmission with close-up of the gear selector lever for the mechanical control unit in the forward position as found immediately after the accident. Also shown is a close-up of the Twin Disc control system servo-actuator. (Photos by Coast Guard and NTSB)

The National Transportation Safety Board determines that the probable cause of the allision of the *Adventure Hornblower* with the Navy Pier and the downtown San Diego seawall was a failure of the port transmission to disengage from the forward propulsion position due to the operating company’s lack of adherence to the transmission manufacturer’s recommended periodic maintenance schedule and the lack of routine maintenance and upkeep of the propulsion system’s equipment. Contributing to the accident was the lack of instrumentation to provide positive indication of thrust direction or an alarm to indicate the propulsion control system was not responding properly to the captain’s commands.
