National Transportation Safety Board

Marine Accident Brief

Allision of Tanker *Nordbay* with Docks and Water Intakes

Accident no.	DCA16FM023
Vessel name	<i>Nordbay</i>
Accident type	Allision (two)
Location	Lower Mississippi River at mile markers 104 and 94; New Orleans, Louisiana
Date	February 2, 2016
Time	2213 central standard time (coordinated universal time – 6 hours)
Injuries	None
Property damage	\$6.4 million est.
Environmental damage	None
Weather	Overcast, visibility 8 miles, south winds at 17–24 knots, air temperature 73°F, water temperature 44°F
Waterway information	Lower Mississippi River near New Orleans. The river stage was 14.2 feet and falling, with a current of 4–5 knots. At New Orleans, the extreme difference between high and low stages is 17 feet, with the mean difference being about 8 feet. The project depth of the river is 45 feet and is maintained by the US Army Corps of Engineers.

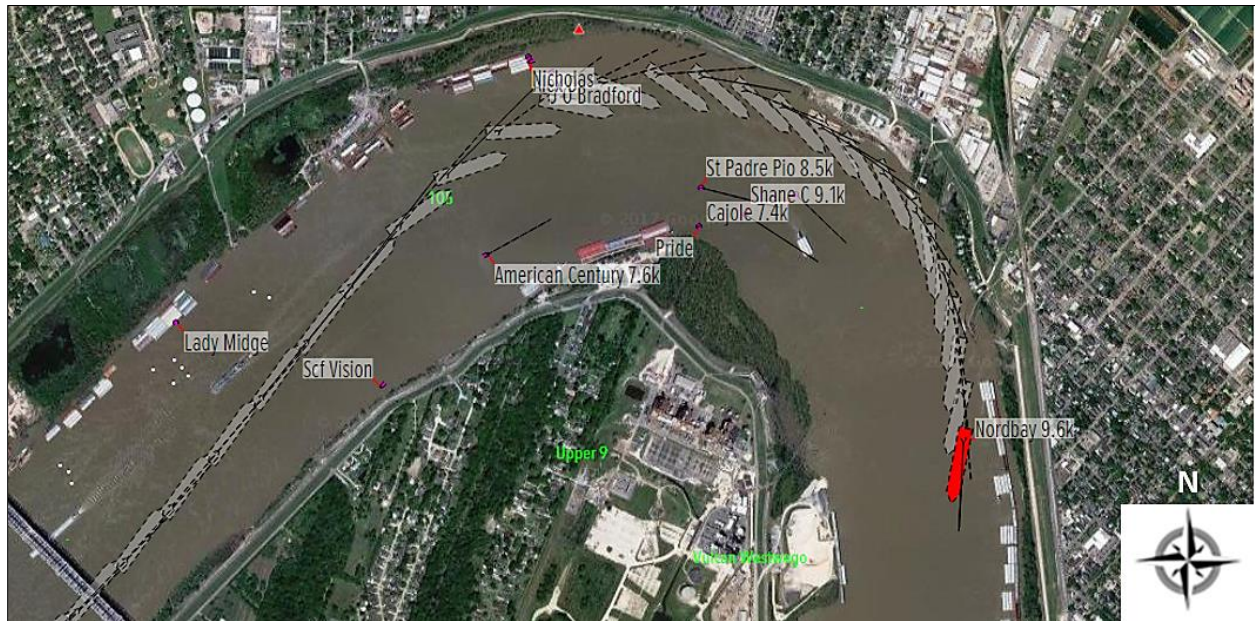
Satellite image overlaid with automatic identification system (AIS) trackline of the *Nordbay* at Nine-Mile Point. Background traffic positions may not be accurate. (Source www.mrtis.com; Background by Google Earth)

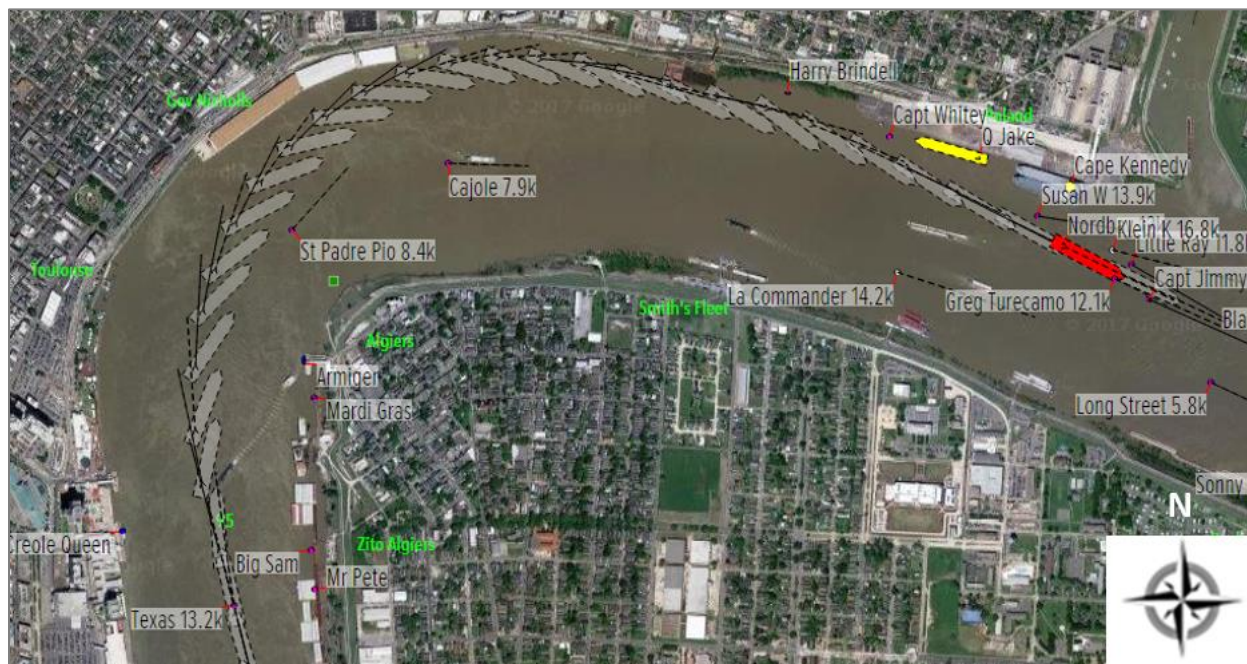
Satellite image with overlaid AIS trackline of the *Nordbay* (in red) at Algiers Point. Background traffic positions may not be accurate. (Source www.mrtis.com; Background by Google Earth)

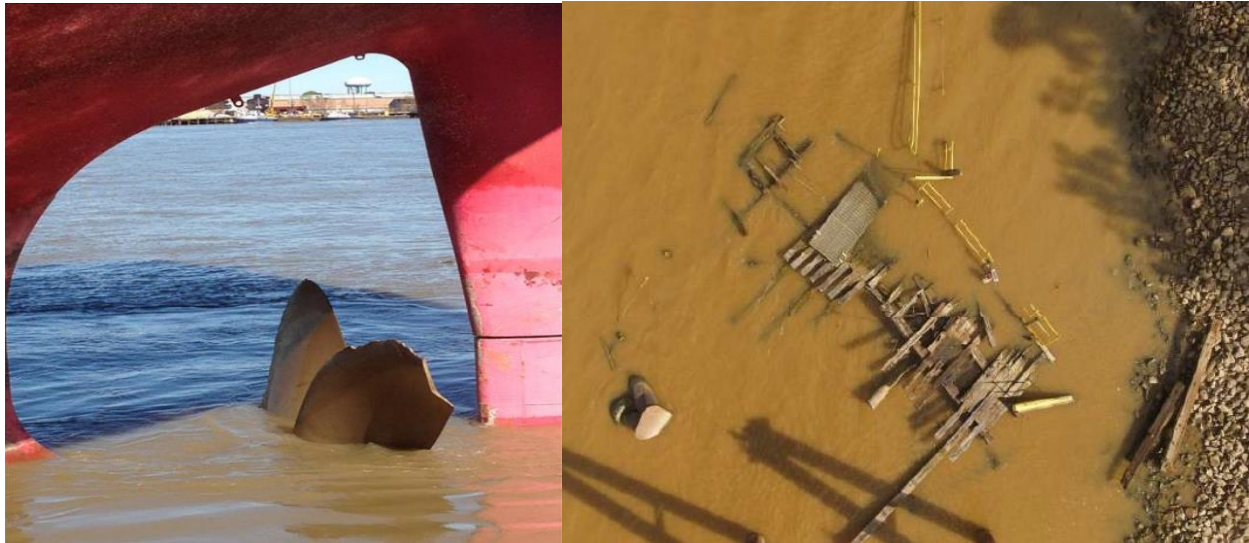
- A DNV-GL survey of the *Nordbay* found damage to the vessel's five propeller blades (indentations, sharp edges, and notches) and contact-damage to the aft portside shell plating above the waterline. Further, inset hull plating and buckling of longitudinal webs was found in ballast tank no. 6, the ballast double bottom, and the pump room. Damage to the *Nordbay* was estimated at \$400,000.

- The River Transport Services (RTS) barge dock and mooring dolphin structures were destroyed and determined not to be serviceable. Cost of replacement was estimated between \$1.5 and \$4 million.

At left, *Nordbay*'s damaged propeller (photo by DNV-GL). At right, the destroyed River Transport Services dock (photo by Infinity Engineering Consultants).
