National Transportation Safety Board

Marine Accident Brief

Grounding of Articulated Tug and Barge *Nathan E Stewart/DBL 55*

Accident no.	DCA17RM001
Vessel name	<i>Nathan E Stewart/DBL 55</i>
Accident type	Grounding
Location	Edge Reef, off Athlone Island in Seaforth Channel, northwest of Bella Bella, British Columbia, Canada
Date	October 13, 2016
Time	0108 Pacific daylight time (coordinated universal time – 7 hours)
Injuries	None reported
Damage	\$12 million est.
Environmental damage	Approximately 29,000 gallons of fuel and lube oil released
Weather	Light rain, visibility 6–10 miles, winds east 10–20 knots, gusts to 25 knots, seas 3 feet, air temperature 48°F*
Waterway information	The Seaforth Channel is part of the Inside Passage between Seattle, Washington, and Juneau, Alaska. The bottom and shoreline in that area is predominantly rocky.

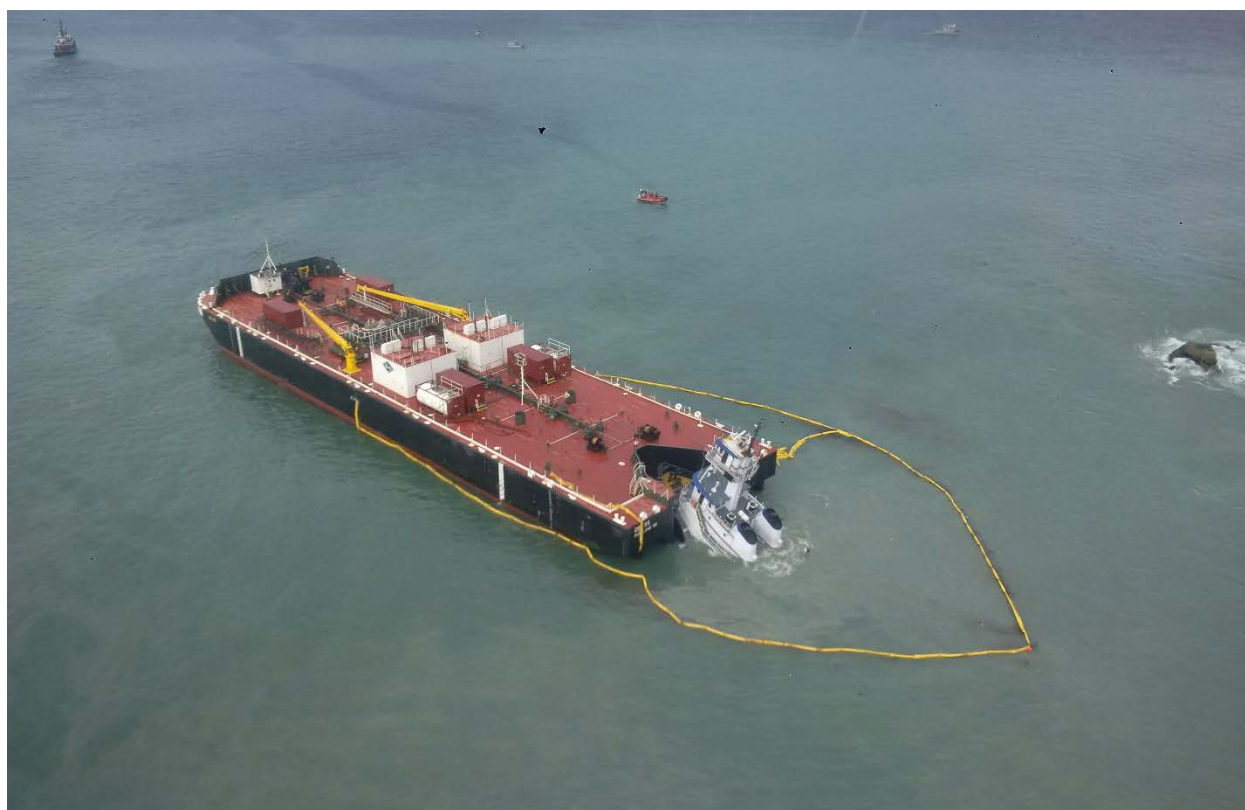
Around 0530, the crew attempted to surround the vessel with an oil containment boom, which had been stored on the *DBL 55*; however, the sea state and winds caused the boom to part at one or more of the connection points and open into the surrounding water. While continuing to monitor the fuel transfer operation, the chief engineer discovered that water had begun to enter the bilge from an area near the bottom of the forward no. 1 starboard fuel tank. He estimated that the rate of flooding was initially a gallon per minute. The chief engineer did not use the vessel's fixed bilge suction system at first because the bilge contained only fuel and oil with very little water at the time. He also stated that the fluid in the bilge was in the forward area of the engine room away from the bilge suction.

An oil containment boom was deployed around the ATB following the grounding. (Photo by Canadian Coast Guard)

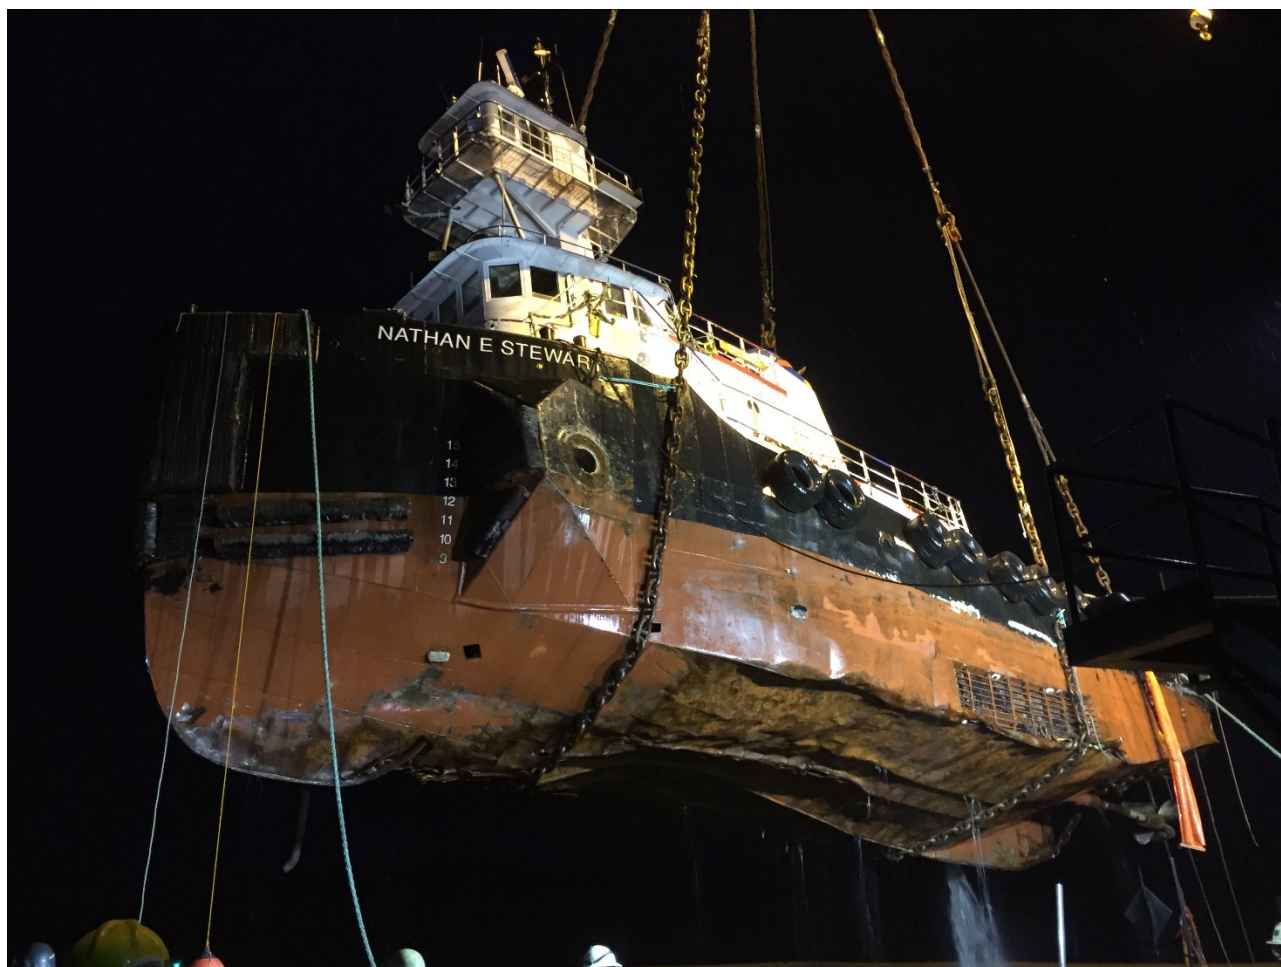
Nathan E Stewart, shortly after being hoisted by the heavy-lift floating crane *D.B. General*. (Photo by Kirby Offshore Marine)

On November 14, nearly a month after the accident, the *Nathan E Stewart* was raised by a salvage team using the heavy-lift floating crane *D.B. General* and then placed on the deck barge *MLT 4000-2* to be towed to Surrey, British Columbia. A postaccident survey of the *Nathan E Stewart* revealed extensive deformation of the bottom of the vessel's hull with multiple

penetrations in the hull plating.⁶ The transverse and longitudinal hull framing was distorted throughout the vessel. The blades on the port propeller were severely damaged, as well as the shaft bracket; the propeller shaft was also bent. The starboard propeller, which was not attached to the shaft, also had severe blade damage, and the shaft bracket was missing; the starboard propeller shaft was significantly bent upwards. Both rudders were broken off. One of the JAK coupling pins was fractured and found in two pieces. The tugboat was considered a constructive total loss at an estimated value of \$6.4 million.
