# National Transportation Safety Board

## Marine Accident Brief

### Grounding of Fishing Vessel *St. Dominick*

<b>Accident no.</b>	DCA17FM008
<b>Vessel names</b>	<i>St. Dominick</i>
<b>Accident type</b>	Grounding
<b>Location</b>	Pumicestone Bay on the northwest side of the long west extension of Unalaska Island, Alaska, 53° 32.2' N, 167° 06.0' W
<b>Date</b>	March 6, 2017
<b>Time</b>	0009 Alaska standard time (coordinated universal time – 9 hours)
<b>Injuries</b>	None
<b>Property damage</b>	\$1.1 million
<b>Environmental damage</b>	None reported
<b>Weather</b>	Good visibility, winds south gusting to 25 knots, air temperature about 39°F
<b>Waterway information</b>	Pumicestone Bay is 7 miles long and runs in a generally east direction when coming from sea, but has an abrupt north and east S-turn about 4 miles from the entrance. The bay is 1.5 miles wide at the entrance but narrows rapidly to less than 0.5 mile.

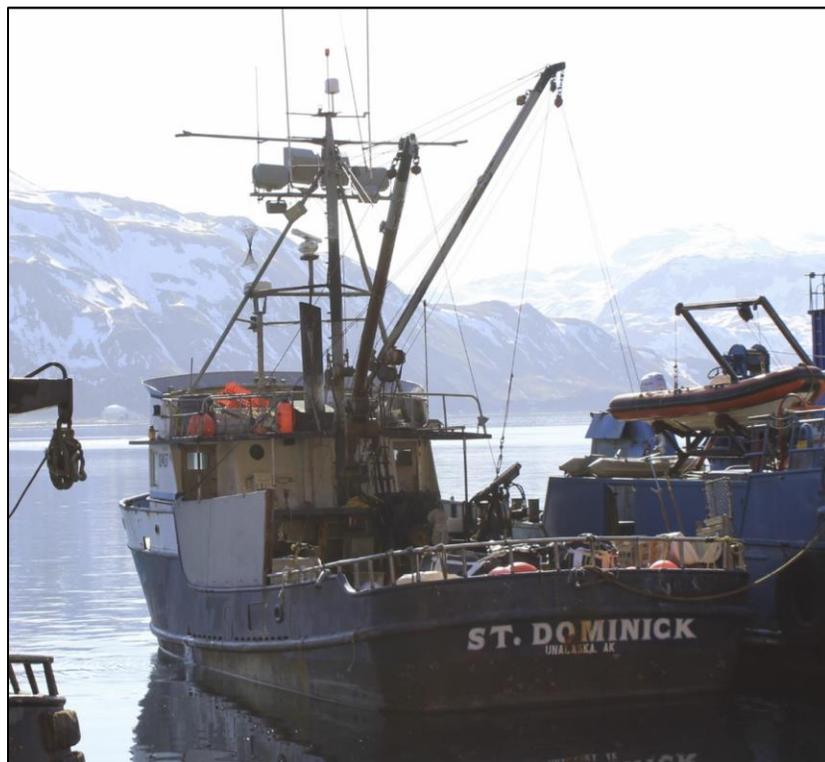
On March 6, 2017, about 0009, the uninspected commercial fishing vessel *St. Dominick* grounded in Pumicestone Bay, Alaska. The engine room flooded within 10–20 minutes of the grounding, and the four crewmembers abandoned the vessel a short time later. None of them were injured, and no pollution was reported. The vessel, valued at \$1.1 million, was deemed a constructive total loss.

*St. Dominick* at Dutch Harbor, Alaska, postaccident. (Photo by US Coast Guard)

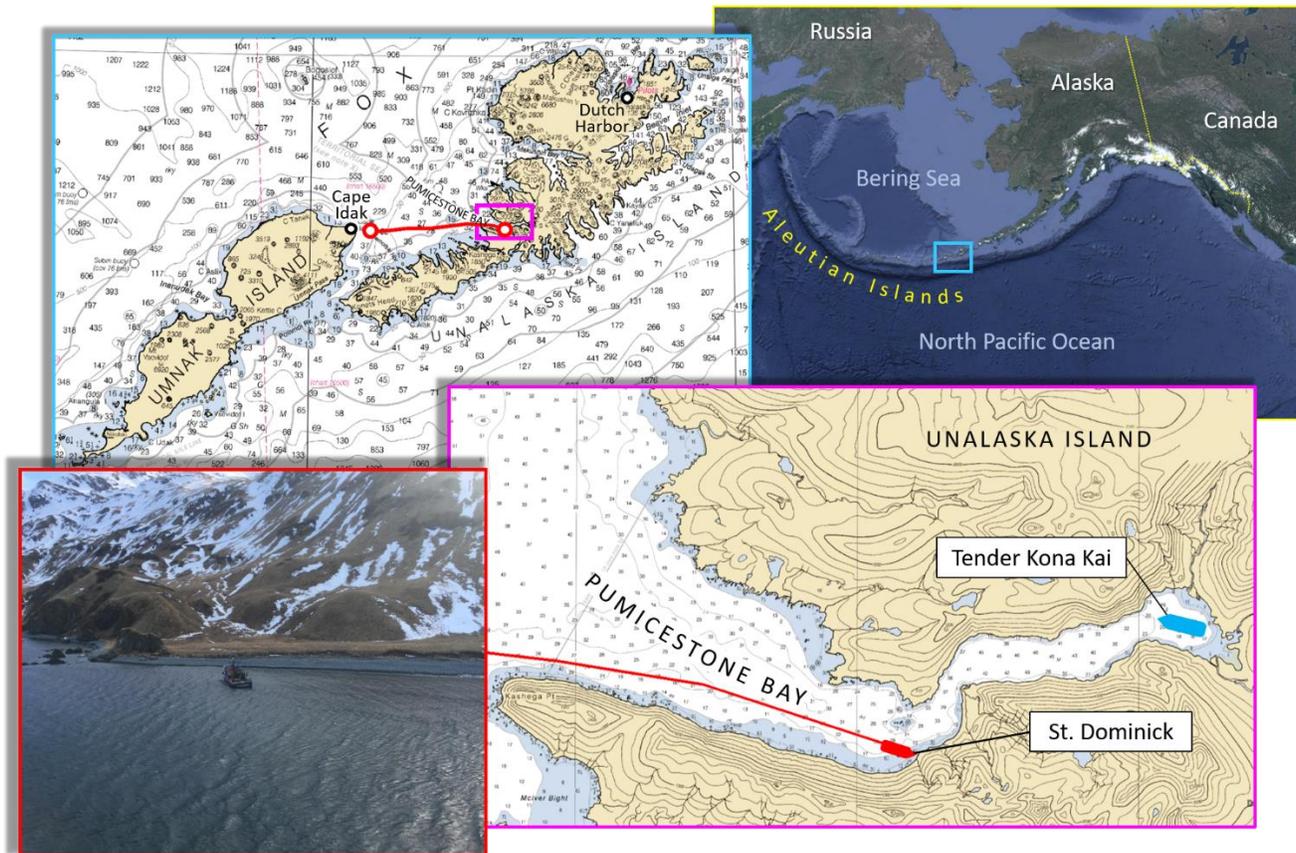
Chart tracings received from the *St. Dominick*'s electronic charting system and confirmed by National Oceanic and Atmospheric Administration (NOAA) fisheries tracking showed a straight-line track from off Cape Idak into Pumicestone Bay of about 093 degrees. Somewhere between the fishing area and the grounding site, the captain set the auto-pilot (which kept the vessel on a heading) and fell asleep. Pumicestone Bay predominantly trends to the east when proceeding from sea but contains an S-turn about 4 miles from the entrance. With the captain asleep, the *St. Dominick* failed to negotiate this turn and, while making a speed of about 7 knots, grounded on the southern shore of the bay about 0009 on March 6. According to the captain and a deckhand, the watch alarm sounded sometime after the vessel grounded.

Track of the *St. Dominick* from fishing grounds off Cape Idak to grounding location in Pumicestone Bay. (Charts by NOAA [16011, 16515]; location data from NOAA fisheries tracking; satellite image by Google Earth Pro; photo by Coast Guard)
