National Transportation Safety Board

Marine Accident Brief

Allision of *Marguerite L. Terral* Tow with Krotz Springs Railroad Bridge

| Accident no. | DCA17FM017 |

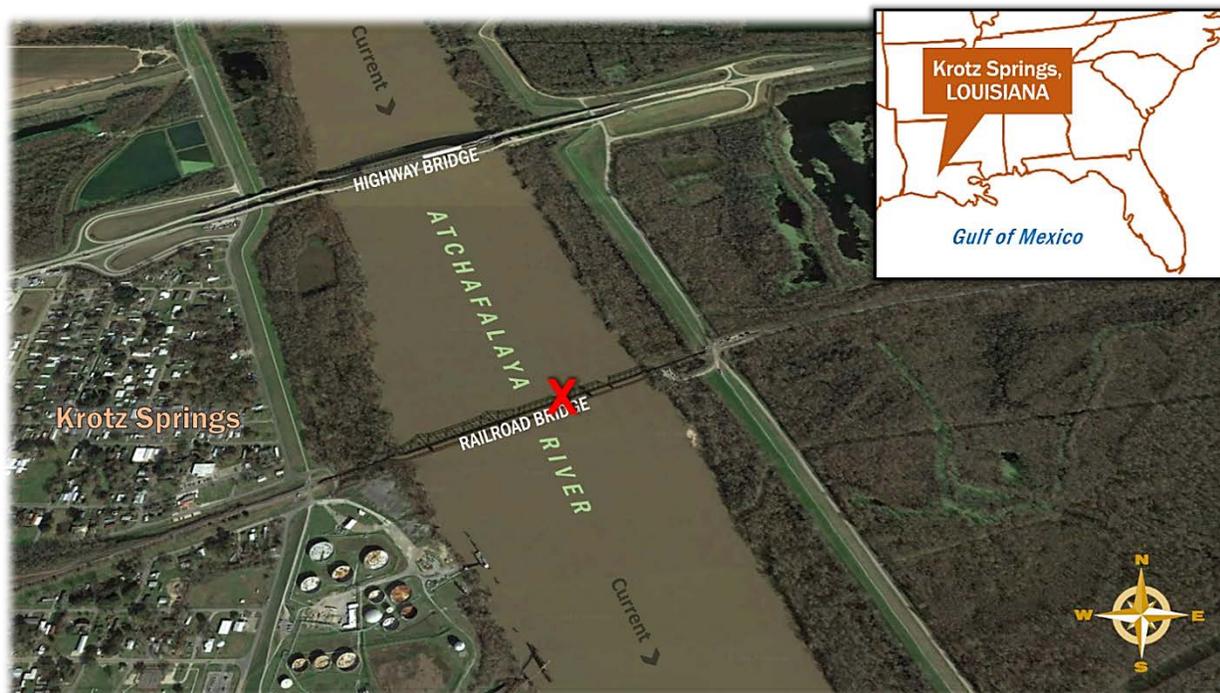
Marked by a red X, the site where the *Marguerite L. Terral* tow allided with a pier of the railroad bridge on the Atchafalaya River in Krotz Springs, Louisiana. (Background by Google Earth Pro)

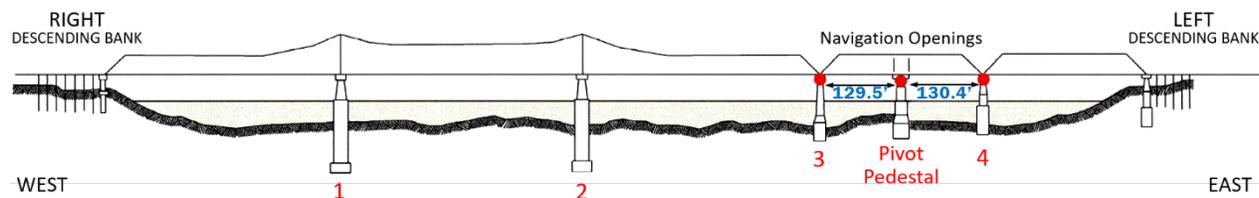
A drawing of the Krotz Springs Railroad Bridge while looking upriver. The piers have been numbered in this report for identification purposes only. (Image courtesy of US Army Corps of Engineers)

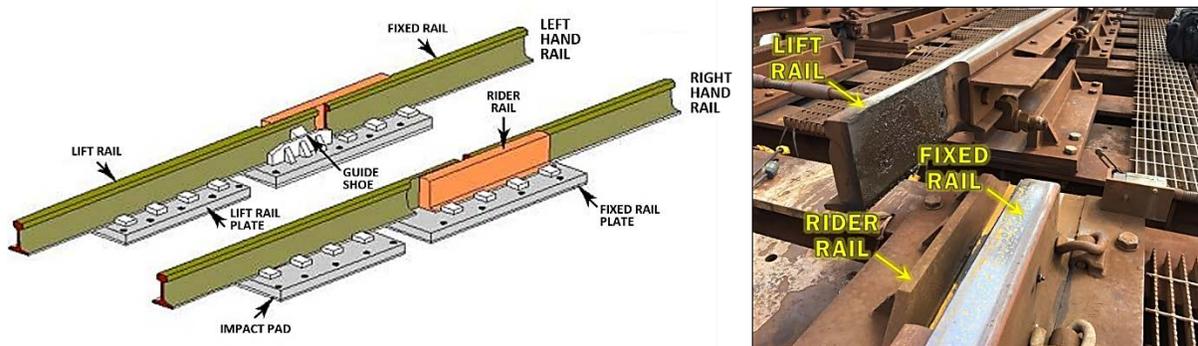
The force of the impact also caused pier no. 3, which supported the western portion of the fixed-bridge structure, to shift horizontally. Multiple large-diameter positioning pins and bolts attaching the northern and southern truss-mounting plates to the caisson were sheered. The fixed portion of the bridge truss on the western side shifted horizontally as well, causing a misalignment of the lift rail with the fixed and rider rails. The total damage resulting from the allision exceeded \$4 million.

At left, an illustration of a section of a lift rail properly aligned with the fixed and rider rails. Conversely, at right, the misalignment of the lift rail on the Krotz Springs Railroad Bridge following the allision. (Graphic courtesy of CMI-Promex)
