National Transportation Safety Board

Marine Accident Brief

Allision of *Steve Plummer* Tow with CSX Railroad Bridge

Accident no.	DCA17FM009
Vessel name	<i>Steve Plummer</i> and barges <i>HMT301</i> , <i>H4128B</i> , and <i>HMT316</i>
Accident type	Allision
Location	Cumberland River, mile 190.4; Nashville, Tennessee 36° 10.27' N, 086° 46.68' W
Date	March 11, 2017
Time	1120 central standard time (coordinated universal time – 6 hours)
Injuries	None
Damage	\$71,355 to the barges; \$1,715,112 to the upstream bridge guard pier
Environmental damage	None
Weather	Overcast, visibility 7 miles, winds north at 12 mph, air temperature 35°F
Waterway information	Cumberland River, downtown Nashville. The river had a projected navigational depth of 9 feet at a normal pool reading of 16.8 feet. At the time of the accident, the river gage was 23.5 feet and rising due to heavy precipitation from the previous day, corresponding to a navigational depth of 15.7 feet.

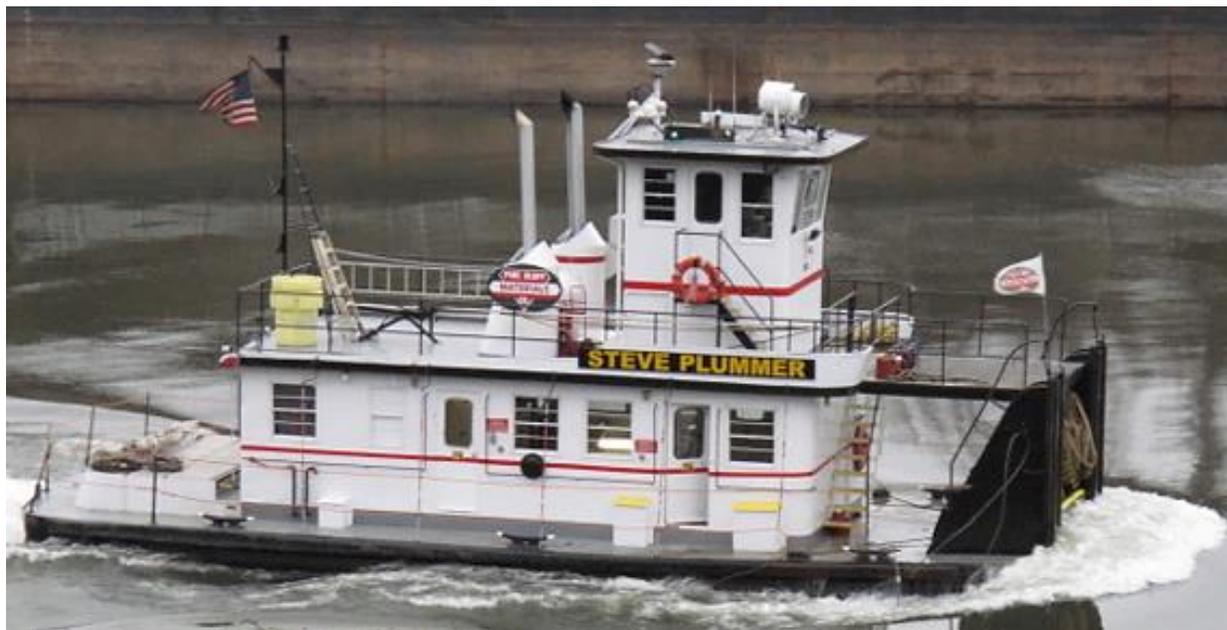
The undamaged *Steve Plummer* under way after the accident.

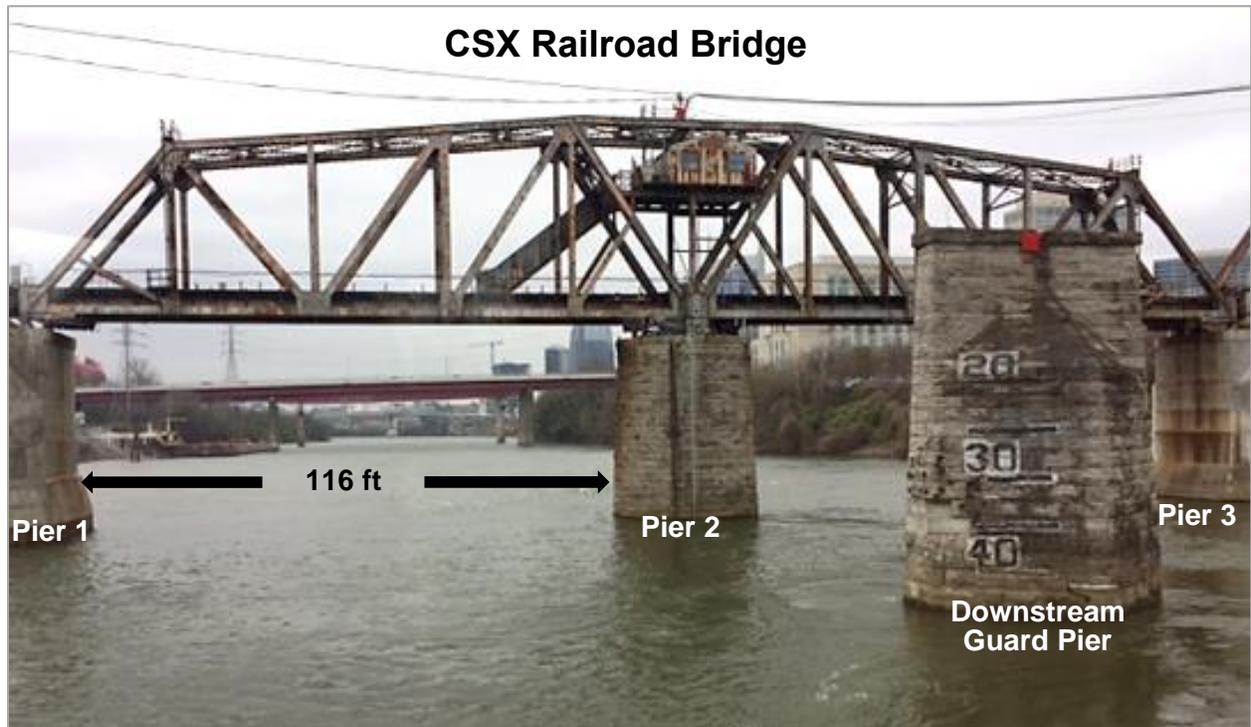
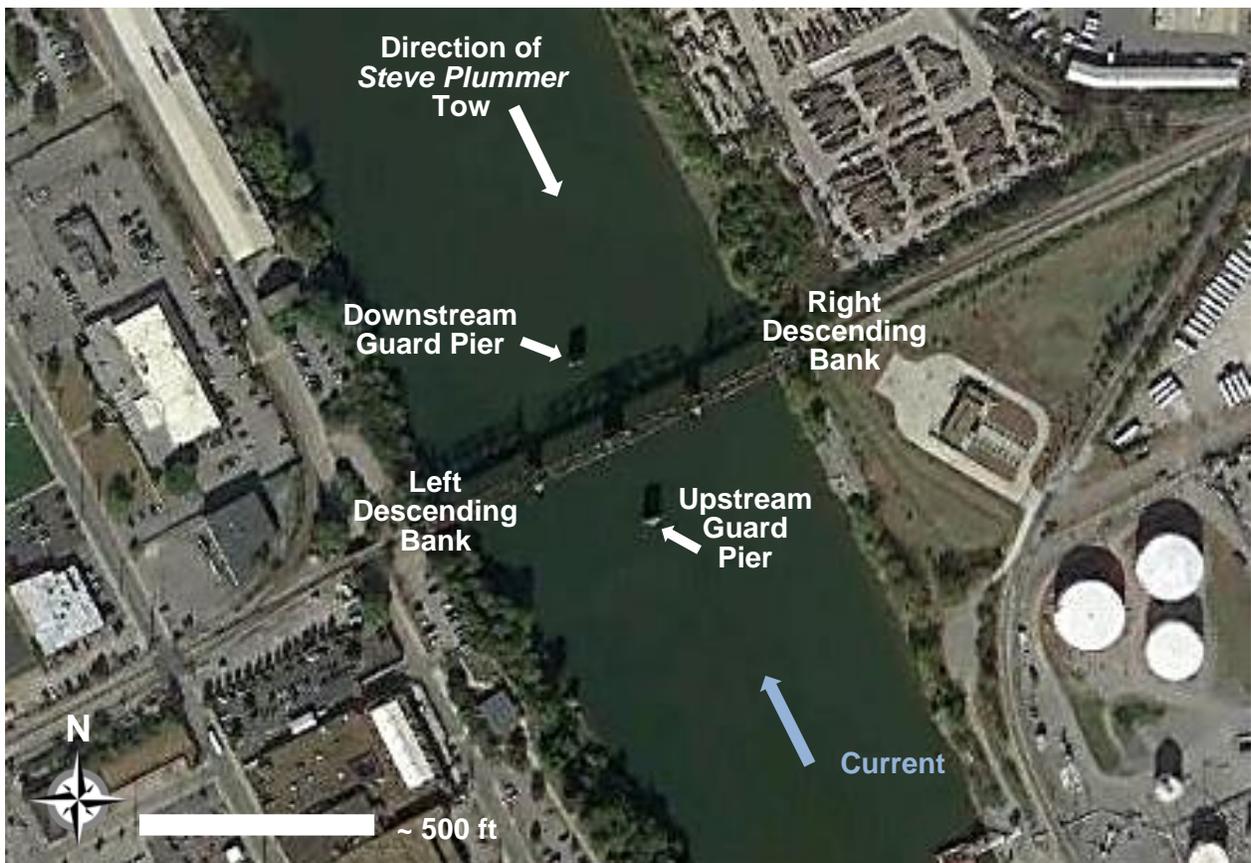
Top, the approximate vantage point of the *Steve Plummer* tow as it approached the CSX Railroad Bridge from downstream. (Photo by Coast Guard) Bottom, aerial view of the CSX Railroad Bridge and the guard piers. (Background by Google Earth)

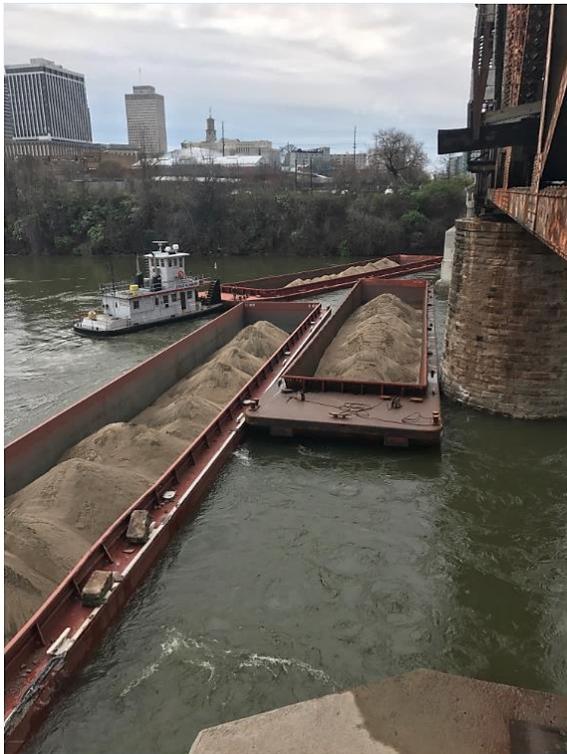
Barges from the *Steve Plummer* tow pinned against the upstream side of the CSX Railroad Bridge. (Photo by Coast Guard)

As the *Steve Plummer* tow approached the bridge, the pilot positioned the tow to transit through the opening near the right descending bank; however, he noticed that the tow was being set toward the middle of the river. He then tried to correct for the set by increasing speed and adjusting the rudders. *HMT301*, the lead barge, successfully passed beneath the bridge span and past the upstream guard pier. However, at 1120, the second barge, *H4128B*, allided with the guard pier and caused pieces of stone to break off and fall onto the barge deck and into the river. The pilot sounded the general alarm, reversed the throttles, and shifted the rudders to prevent third barge *HMT316* from hitting the guard pier and to keep the forward barges from wrapping around it, but to no avail. *HMT316*'s stern struck the upstream guard pier, causing it to collapse into the river. The wire lines connecting the barges parted, and the barges drifted with the current, becoming pinned against the bridge.

The *Steve Plummer* and *HMT301* were undamaged. The other two barges had the following damage: *H4128B* had a 20-inch inset to the no. 5 starboard void space, which cost \$33,253 to repair. *HMT316* sustained a hole about 3 feet by 5 feet to the no. 1 port void space below the waterline about 15 feet aft of the forward bulkhead. The void space flooded to the waterline and had to be dewatered. The cost to repair *HMT316* was \$38,102. The upstream guard pier was destroyed by the allision. A replacement pier, constructed with corrugated steel, was built to the same dimensions and position as the original, for a total cost of \$1,715,112. The new guard pier was completed on September 21, 2017.

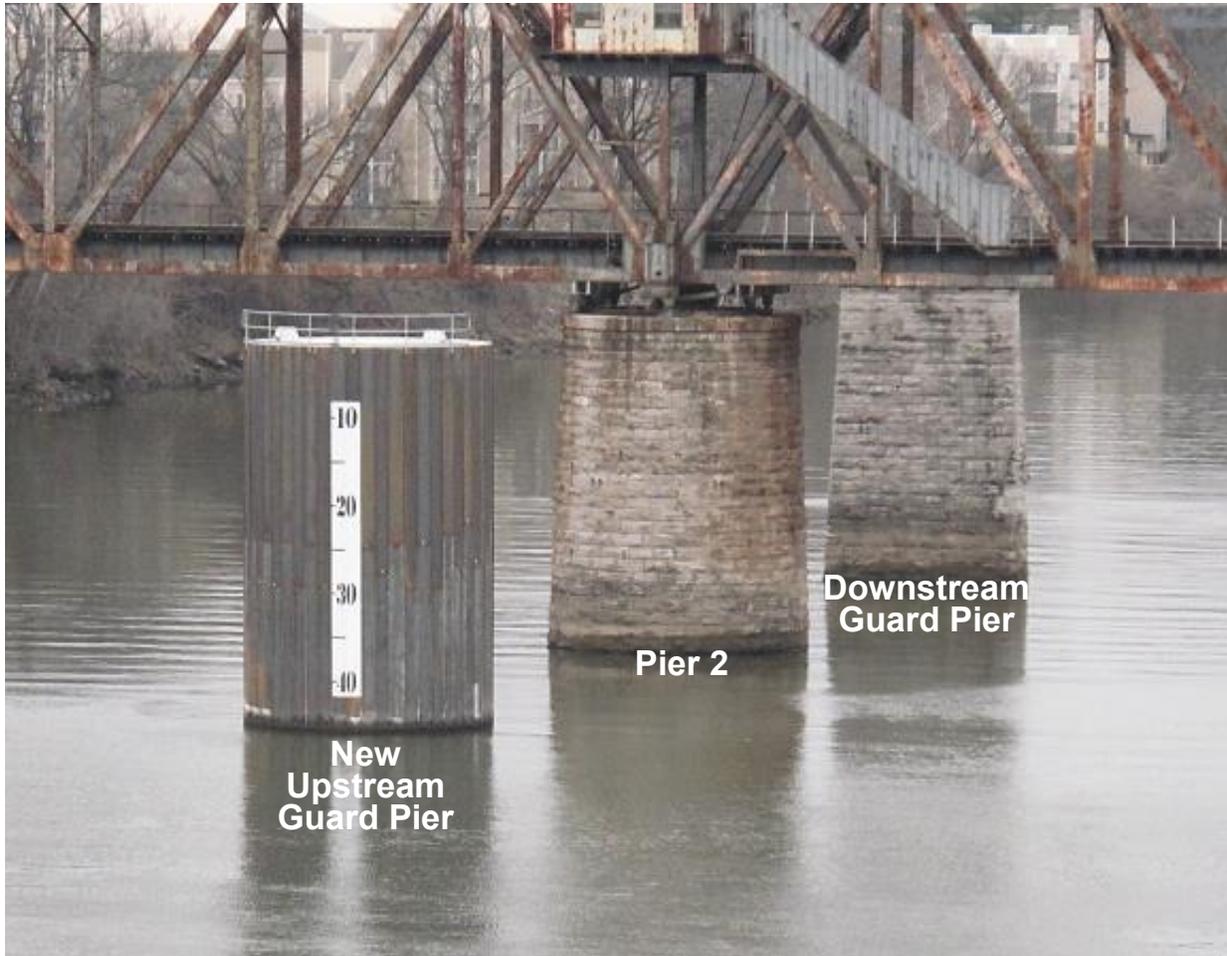
Looking downstream at the CSX railroad bridge with the swing span closed. From left, the new steel upstream guard pier, pier 2 (the center/axis pier of the swing span), and the downstream guard pier.
