National Transportation Safety Board

Marine Accident Brief

Contact of Crane Barge *Troy McKinney* with Overhead Power Lines

Accident no.	DCA17FM016
Vessel name	<i>Troy McKinney</i>
Accident type	Contact with power lines
Location	Harvey Canal, Harvey, Louisiana; 29°51.5' N; 090°03.9' W
Date	June 7, 2017
Time	2018 central daylight time (coordinated universal time – 5 hours)
Injuries	None
Property damage	About \$440,000
Environmental damage	None reported
Weather	Good visibility, winds north at about 8 mph gusting to nearly 20 mph; air temperature 80°F ¹
Waterway information	The Harvey Canal is part of the Intracoastal Waterway, maintained by the US Army Corps of Engineers, and is located opposite the city of New Orleans, Louisiana. The canal connects the Mississippi River to extensive inland waterways south of the city.

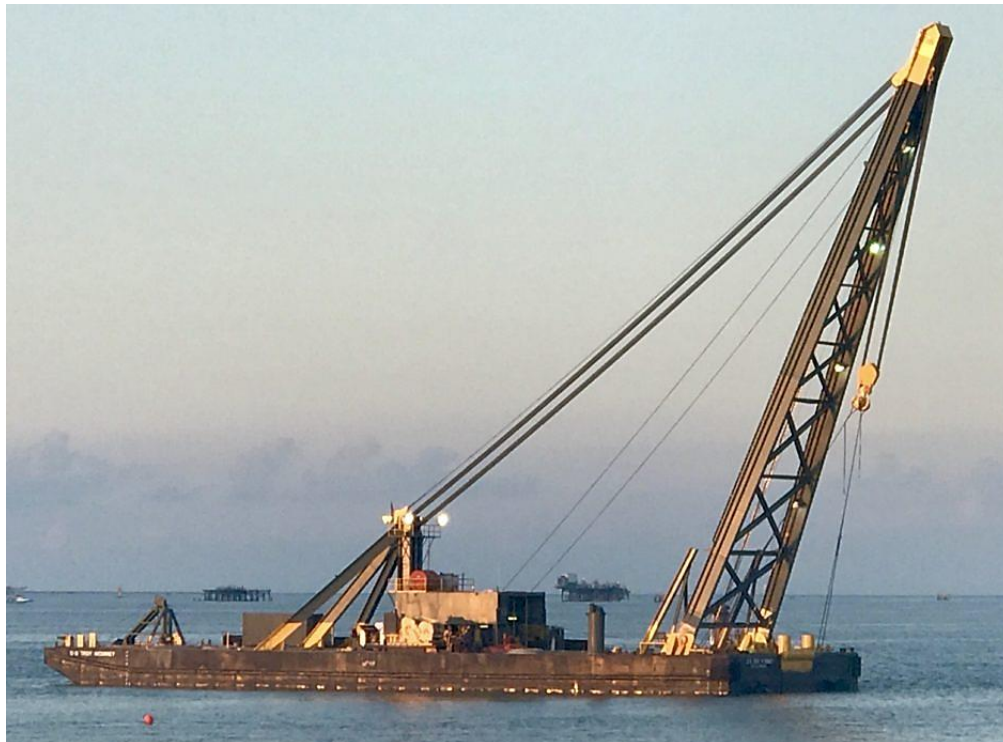
Troy McKinney. The A-frame boom is mounted on the barge's stern. (Photo by McKinney Salvage and Heavy Lift)

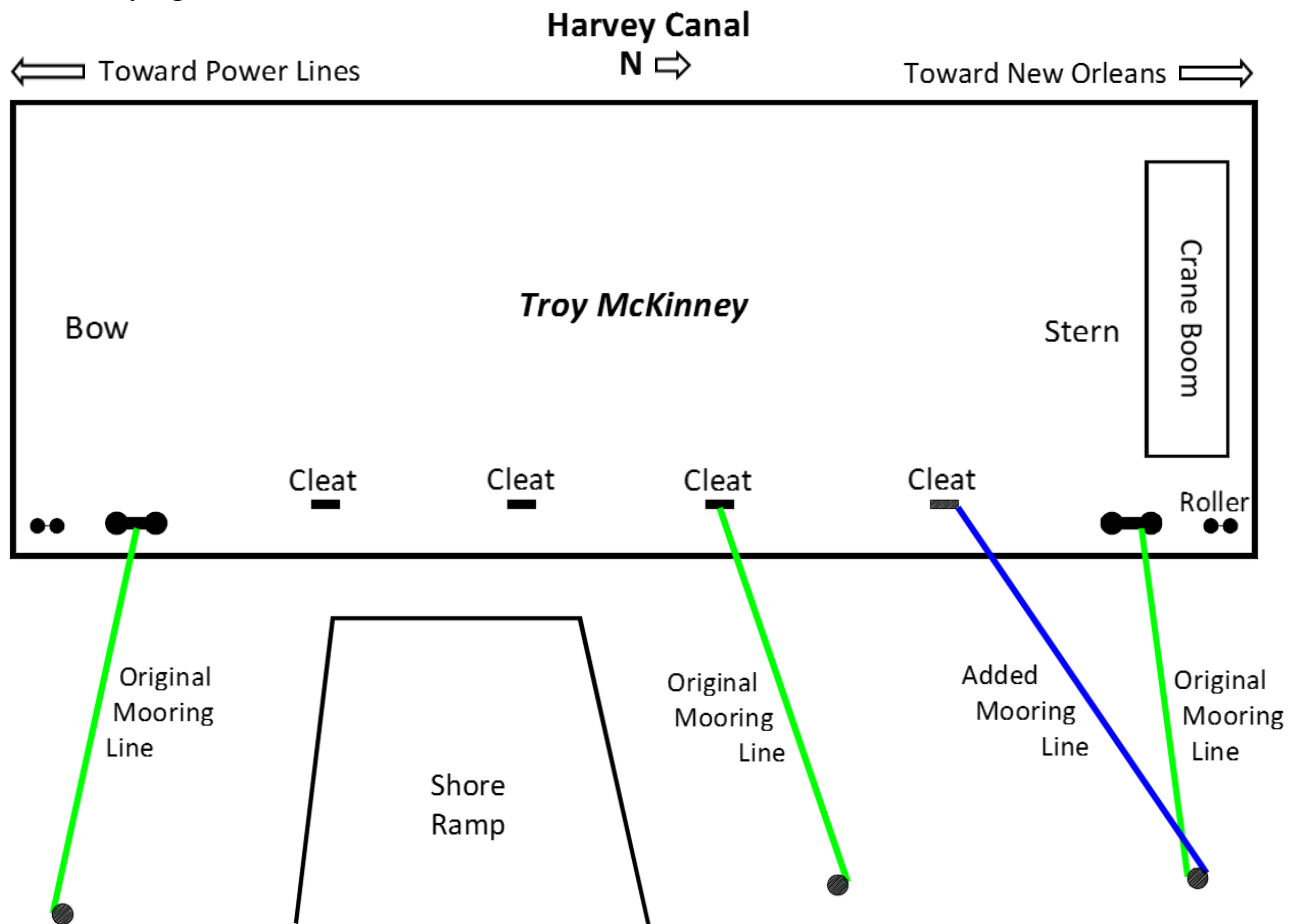
another mooring line to shore, in addition to the three lines already placed on May 17. He told investigators he had “no idea” why he attached the additional line, only that he did so because the line was lying on the deck.

Mooring-line arrangement for *Troy McKinney* on June 1 (6 days before the accident). (Image based on original drawing by the president of McKinney Salvage and Heavy Lift)

In addition, investigators looked to sources of information pertaining to mooring arrangements and found passages relating to proper mooring in Charles F. Chapman's *Piloting, Seamanship, and Small Boat Handling* and R.S. Crenshaw's *Naval Shiphandling*. According to Crenshaw, spring lines run parallel to the keel of the vessel and prevent the vessel from moving forward and aft. According to Chapman, bow lines are led from a bitt on the vessel and run forward as far as possible to prevent the vessel from moving astern; "conversely, a stern line, properly, leads from the after bitt to a distant pile or bollard on the dock astern of the boat, to check [the vessel] from going ahead." Investigators compared the way the mooring lines were led from *Troy McKinney* to the berth at the Chet Morrison facility to illustrations found in Crenshaw and Chapman. The barge's stern line (which could have prevented the vessel from moving ahead/to the south) had a nearly perpendicular lead from the barge to the shore and did not lead to a distant shoreside piling or bollard. The extra line placed by the president, although offering a more secure mooring, had a northerly lead of about 45 degrees to the vessel's keel, rather than nearly parallel to the keel. Investigators therefore believe that the *Troy McKinney*'s mooring lines were led from vessel to shore at an angle insufficient to prevent the barge from moving forward, or to the south, as the *Gail Cecilia* tow passed. Forward and aft movement is best prevented by forward- and aft-leading lines.

The National Transportation Safety Board determines that the probable cause of crane barge *Troy McKinney* striking and damaging overhead power lines was its insufficient mooring arrangement, which did not prevent the barge from excessive movement and breaking away.

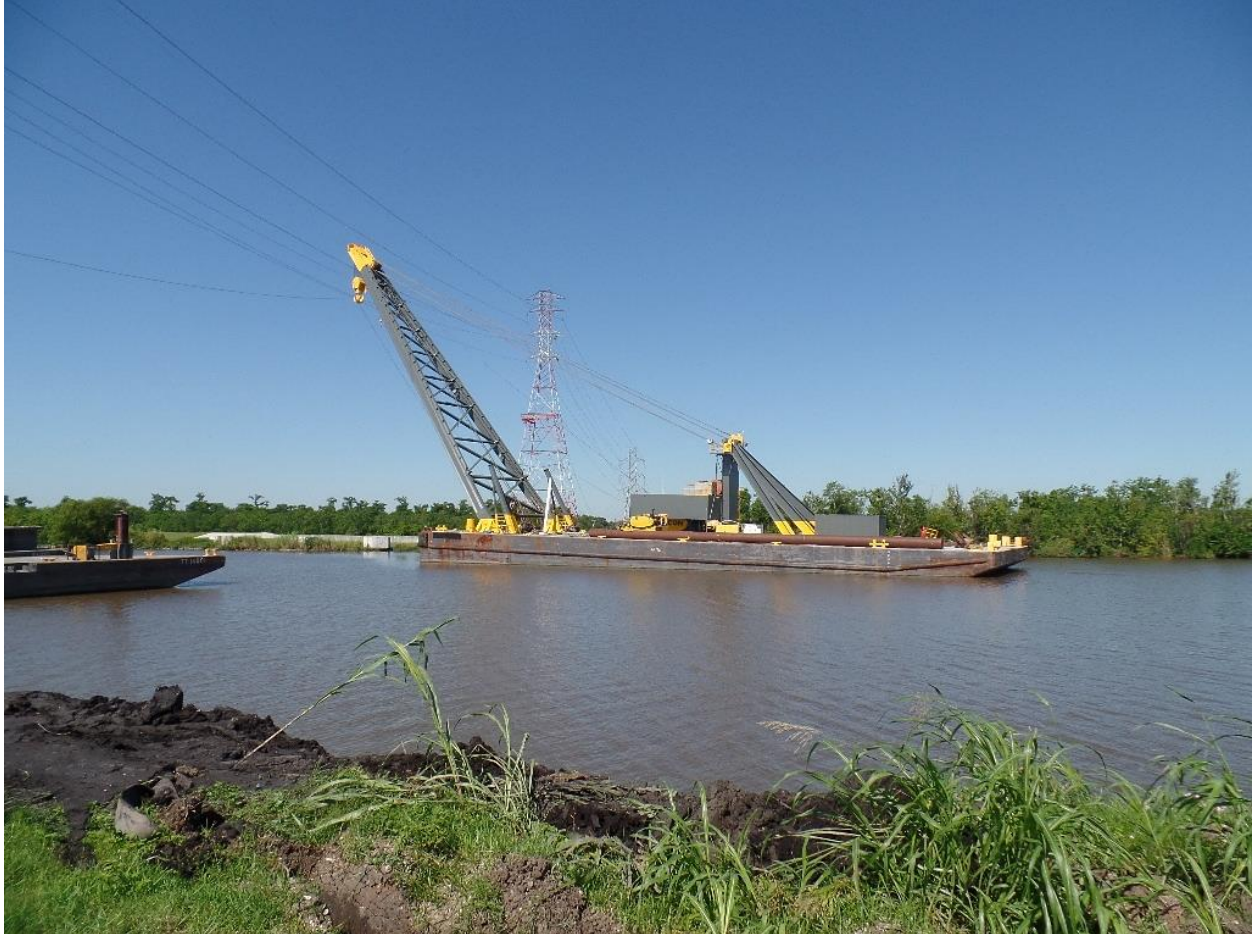
On the evening of June 7, 2017, the unmanned crane barge *Troy McKinney* broke free from its mooring and struck overhead power lines crossing the Harvey Canal in Harvey, Louisiana. No pollution or injuries were reported. Damage to the crane barge was negligible, but damage to the power lines totaled about \$440,000.

to break away from the berth. The *Troy McKinney*'s stern (northern end) moved away from the berth first and then, about a minute and a half later, the rest of the barge moved off the berth and drifted south. About 16 minutes later, the video showed flashes in the direction of the barge and the Entergy New Orleans power lines.

***Troy McKinney*'s crane resting against power lines. (Photo by Coast Guard)**
