# National Transportation Safety Board

## Marine Accident Brief

### Grounding and Sinking of Towing Vessel *Eric Haney*

<b>Accident no.</b>	DCA17FM020
<b>Vessel name</b>	<i>Eric Haney</i>
<b>Accident type</b>	Grounding and sinking
<b>Location</b>	Upper Mississippi River, mile marker 13.4, near Cairo, Illinois 37°05.479' N, 89°16.263' W
<b>Date</b>	July 8, 2017
<b>Time</b>	2342 central daylight time (coordinated universal time – 5 hours)
<b>Injuries</b>	None
<b>Property damage</b>	\$4.3 million est.
<b>Environmental damage</b>	Oil sheen observed
<b>Weather</b>	Visibility 10 miles or greater, sky conditions clear, winds south at 5 knots (5.8 mph), air temperature 77°F, no precipitation reported in previous 24 hours
<b>Waterway information</b>	The Upper Mississippi River measured 27.7 feet high on the river gauge (at Cape Girardeau). The current was estimated at 3 mph.

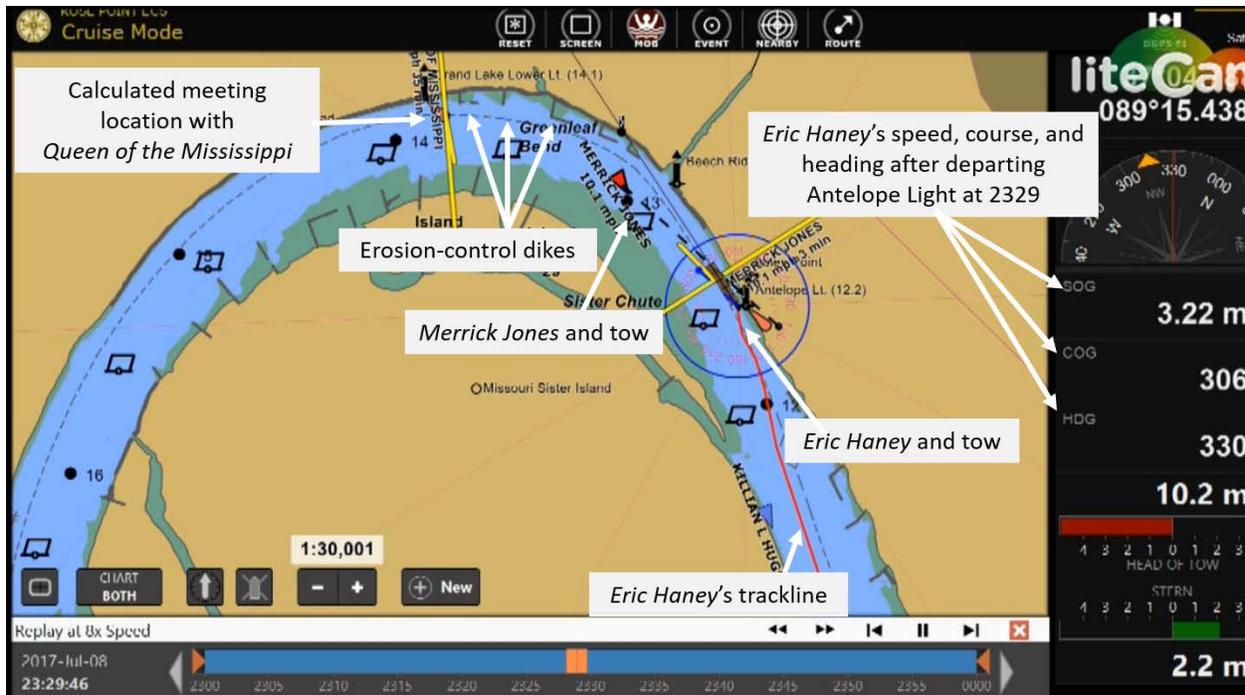
At 2329, before the *Merrick Jones* and its tow passed, the pilot got the *Eric Haney* under way and began moving upriver along the left descending bank, as confirmed by the ECS. At 2332, the pilot steered the *Eric Haney* 10 degrees to starboard toward the left descending bank as the *Merrick Jones* passed.

**Screenshot of Rose Point ECS at 5-mile scale showing *Eric Haney* (trackline in red) after vessel departed Antelope Light at 2329 while *Merrick Jones* was upriver.**

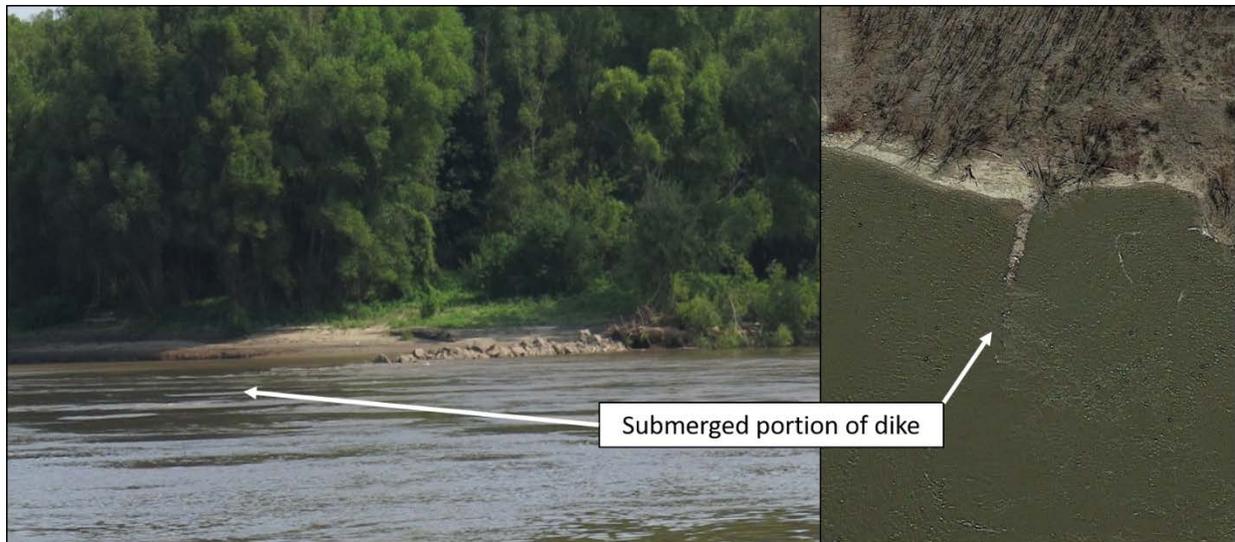
Along the left descending bank of the river between mm 13 and 14 in the bend, five partially submerged erosion-control dikes constructed of rock and stone protruded from the shoreline. The purpose of the dikes was to reduce strong currents around the river bend and prevent erosion of the riverbank. The pilot had set the ECS at a 3-mile scale; however, as he stated in a postaccident interview, he did not see the dikes on the display. Just before reaching the dikes, the pilot believed he was about 100 feet off the shoreline.

At left, view of partially submerged erosion-control dike photographed on July 12, 2017, when river height was 28.5 feet. On the day of the accident, the river was 27.7 feet high, according to river gauge at Cape Girardeau. At right, aerial view photographed on March 3, 2017, when river height was 22.5 feet. (Satellite image from Google Earth)

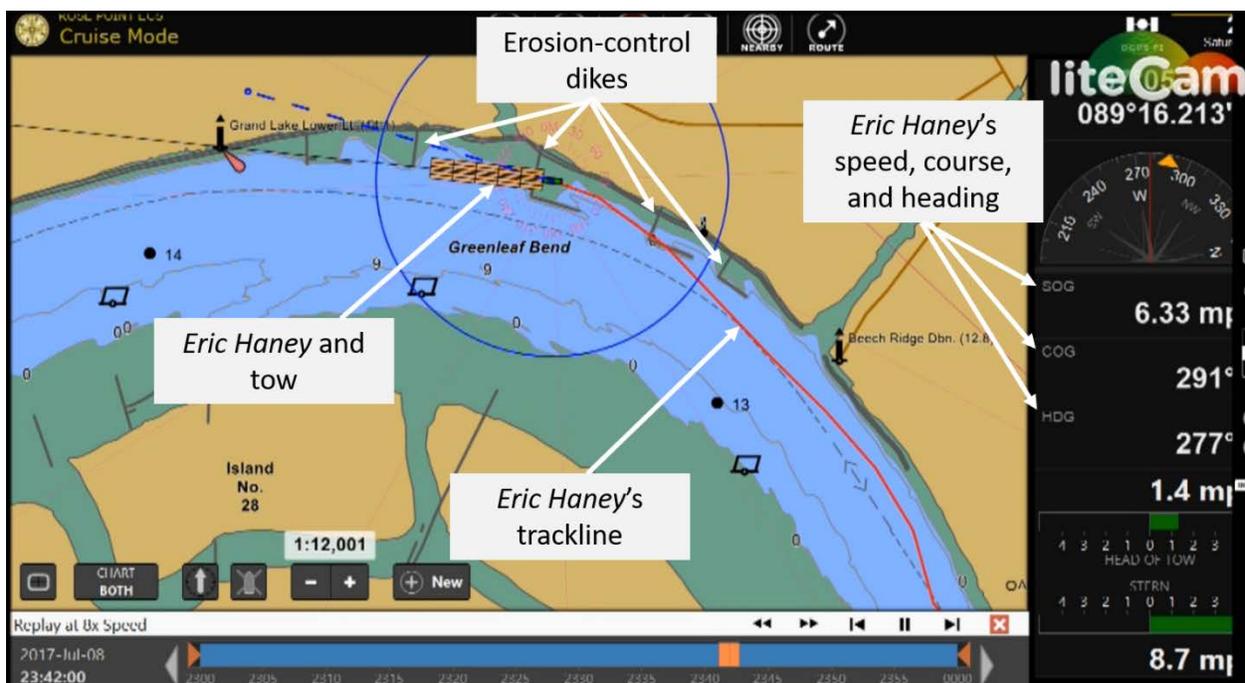
As the *Eric Haney* proceeded upriver along the left descending bank at about 6 mph, the pilot felt the boat strike something and stop abruptly. He stopped the engines and then put them in reverse, but the vessel would not move. The captain came to the wheelhouse and stated that he thought the vessel was on a dike. When the captain zoomed in the view on the ECS display, the dikes appeared larger on the screen.

Screenshot of Rose Point ECS at 2-mile scale showing *Eric Haney* seconds before vessel struck dike.

After the accident, investigators viewed a display of the accident area at different levels of detail using a shoreside version of Rose Point ECS. At the 6-mile scale the dikes were removed from the display, but at the 3-mile scale they were visible on the display.

Mariners using electronic chart systems (ECS) should be aware that aids to navigation, hazards, and other map features may not be represented on the displays at certain range scales. Mariners should use appropriate range scales for their routes on ECS displays to identify potential hazards while navigating.

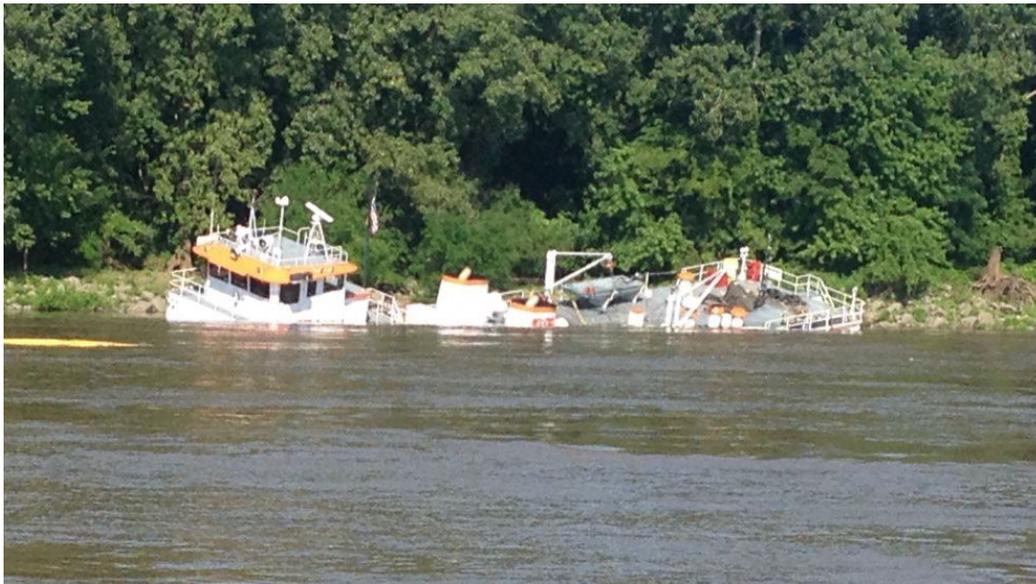
The captain and pilot ensured that all crewmembers were awake and accounted for. After determining that the towboat was taking on water in the forward hold, the pilot contacted nearby vessels to inform them of the ingress of water and made a distress call to the US Coast Guard. Crewmembers started pumps to remove the water, but the pumps could not keep up with the incoming flow. All crewmembers boarded one of the barges, which were still attached to the *Eric Haney*. A few minutes later, the current freed the *Eric Haney* and its barges from the dike, and they began to drift downriver. About an hour and a half later, a towboat came alongside the drifting *Eric Haney* and barges. After the crew of the *Eric Haney* climbed onto the assisting towboat, the other vessel pushed the sinking *Eric Haney* into the right descending bank near mm 9. The vessel continued to take on water and partially sank, but the bridge and part of the stern remained above the waterline. The barges broke free and were later recovered.

*Eric Haney* after sinking. (Photo by Coast Guard)

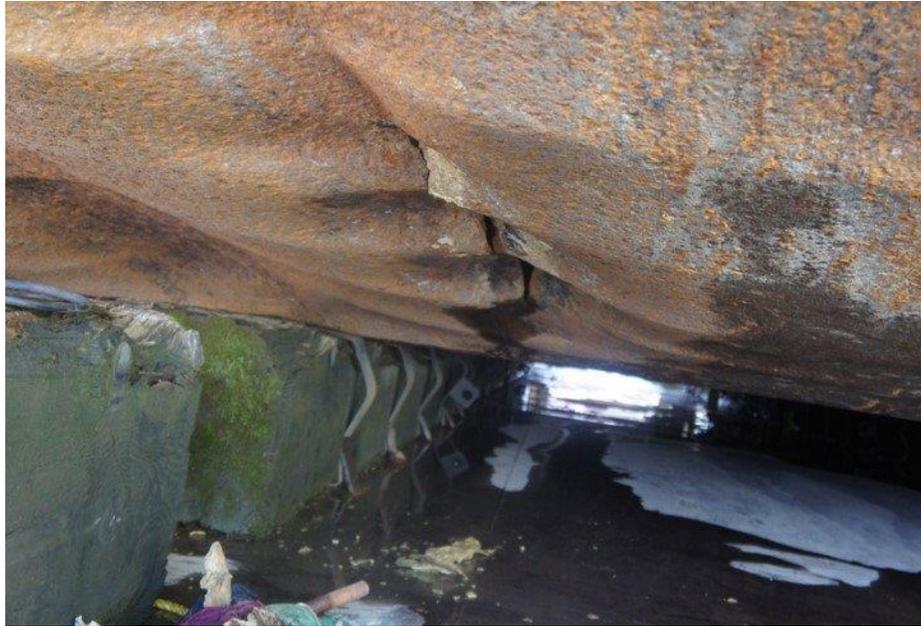
The *Eric Haney* was brought to the surface by a salvage team on July 22 and drydocked later that day for inspection and repairs. The bottom hull plating in the area of the bow was punctured over a length of 5.5 feet, as was the plate under the potable water tanks located in the deck locker compartment. Also sustaining damage were 7 transverse bottom frames supporting the bottom plate and the starboard tow knee. All interior spaces, except for a section of the pilothouse and steering compartment, were water-damaged and contaminated with diesel fuel and oil. The total damage was estimated at \$4.3 million. However, none of the barges were damaged in the accident.

**Damaged bottom hull plating of the *Eric Haney* after the accident. (Photo by Coast Guard)**

The National Transportation Safety Board determines that the probable cause of the grounding and subsequent sinking of the *Eric Haney* was the pilot's failure to identify a charted navigation hazard (erosion-control dike) during towing operations.
