# National Transportation Safety Board

## Marine Accident Brief

### Allision of *James H Hunter* Tow with Dock and Fire Boat

<b>Accident no.</b>	DCA17FM015
<b>Vessel names</b>	<i>James H Hunter</i> (and barges <i>PBM 403</i> , <i>PB 2013</i> , and <i>PBM 141</i> ) and <i>Nashville Fire Boat No. 9</i>
<b>Accident type</b>	Allision
<b>Location</b>	Cumberland River, mile marker 191.1; Nashville, Tennessee; 36° 9.7' N, 86° 46.3' W
<b>Date</b>	June 6, 2017
<b>Time</b>	2250 central daylight time (coordinated universal time – 5 hours)
<b>Injuries</b>	None
<b>Property damage</b>	\$300,000 est.
<b>Environmental damage</b>	None
<b>Weather</b>	Partly cloudy, visibility 10 miles, wind 8 mph from the north-northeast, air temperature 65°F
<b>Waterway information</b>	Cumberland River, downtown Nashville. Minimum channel depths are maintained by the US Army Corps of Engineers. The river had a projected navigational depth of 9 feet at a normal pool reading of 16.8 feet. At the time of the accident, the river gage was 26 feet, corresponding to a navigational depth of about 18.2 feet.

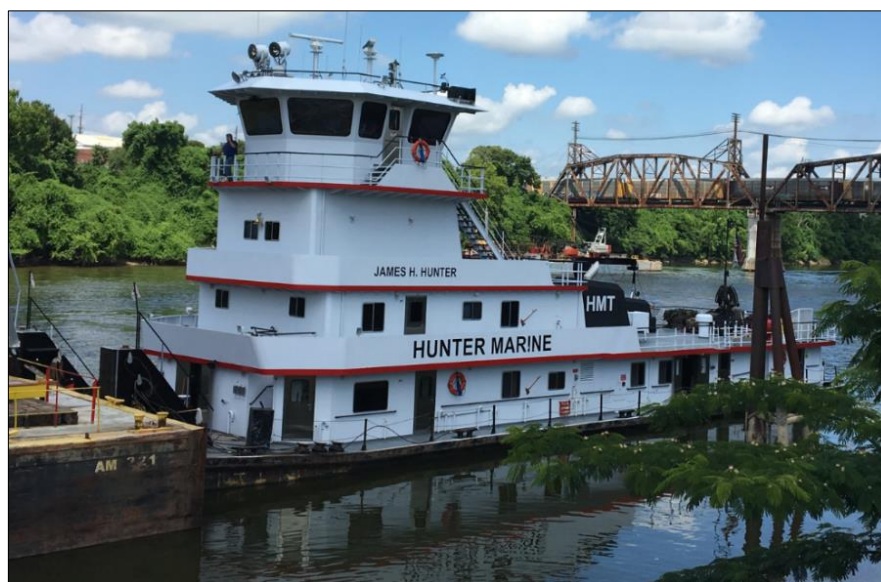
*James H Hunter* after the accident in the Cumberland River.

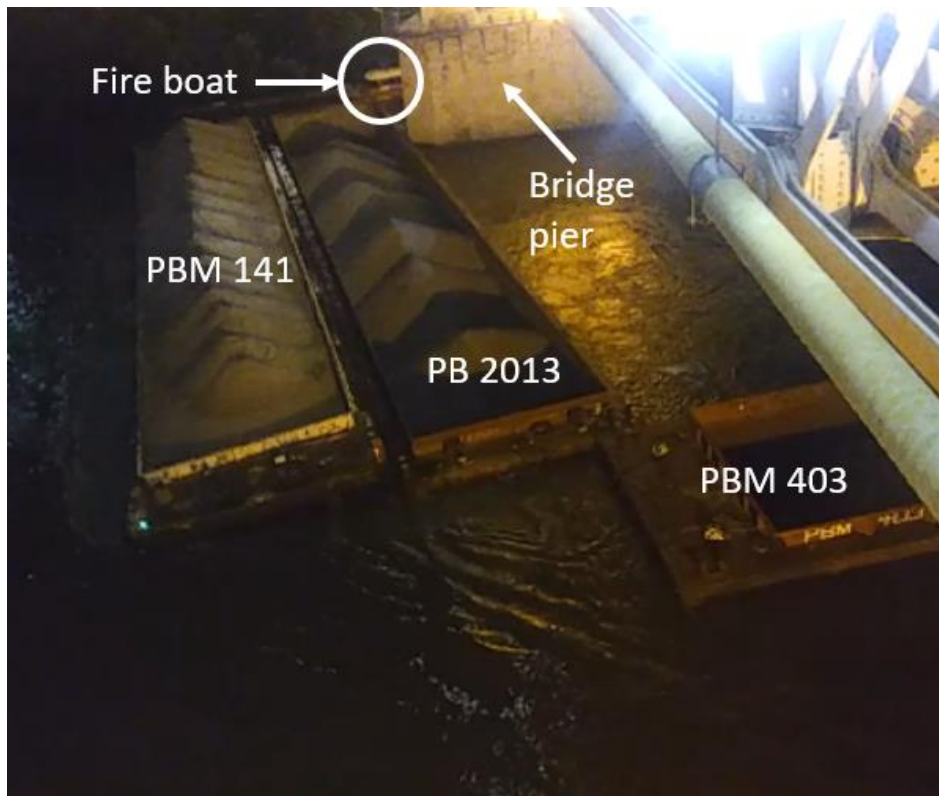
The three barges, fire boat, and pedestrian bridge pier about 2254. (Image taken from witness video)

The *James H Hunter* and the three barges drifted downriver with the middle and head barge topped around toward the left descending bank pedestrian bridge pier. About that time, the *Charlie Everhart* crewmembers unfaced (disconnected) their vessel from the *Spirit* barge and went to the fire boat, where they secured it to their starboard side. The *Charlie Everhart* then went to the starboard side of the *James H Hunter* and put two crewmembers on *PBM 403* to help the *James H Hunter* crew secure *PB 2013* back to *PBM 403*. The towing vessel *Charles B Holman*, which was about 1 mile upriver working at the PBM fleeting facility, headed to the accident location after hearing the radio call. About 2259, the *Charles B Holman* crew secured *PBM 141*, released the coupling connecting it to *PB 2013*, and took *PBM 141* upriver to the PBM fleeting facility.

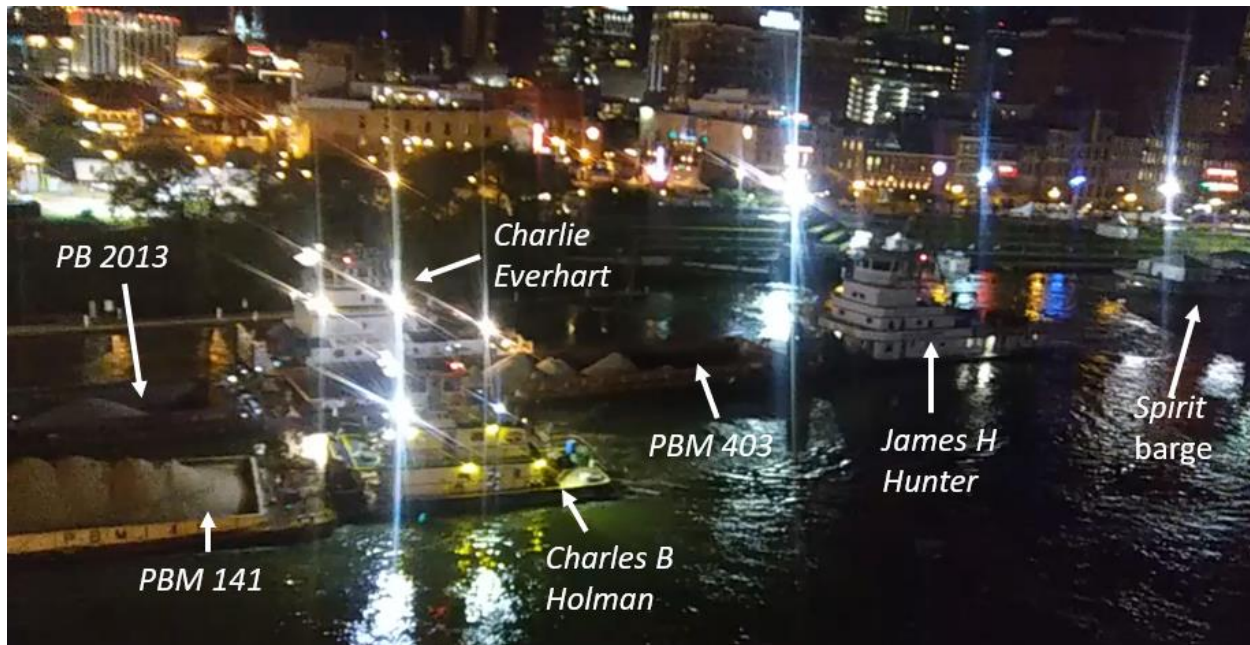
*James H Hunter* (faced up to PBM 403), *Charlie Everhart*, and *Charles B Holman* (faced up to PBM 141). (Image taken from witness video)
